Connector Terminal Appearance Comparison :-

Connector Terminal Soldering Result :-

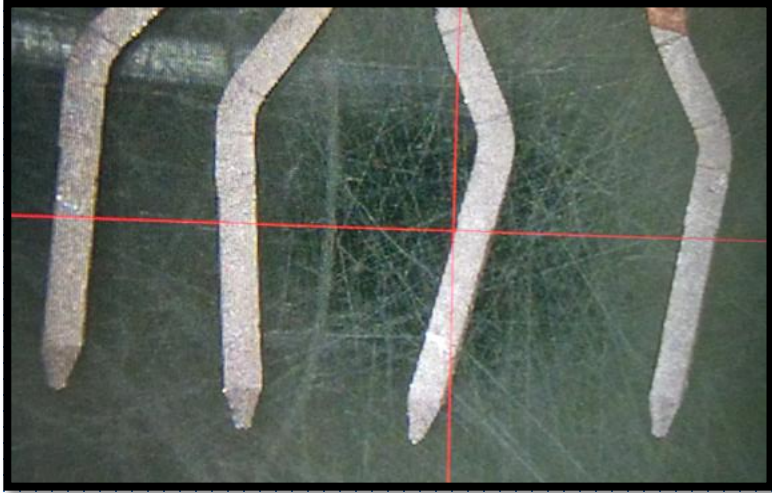
Connector Terminal A
product

Observation – Plating on A Product Connector terminal done on all 4 side
But In B product connector plating done on 2 side only.

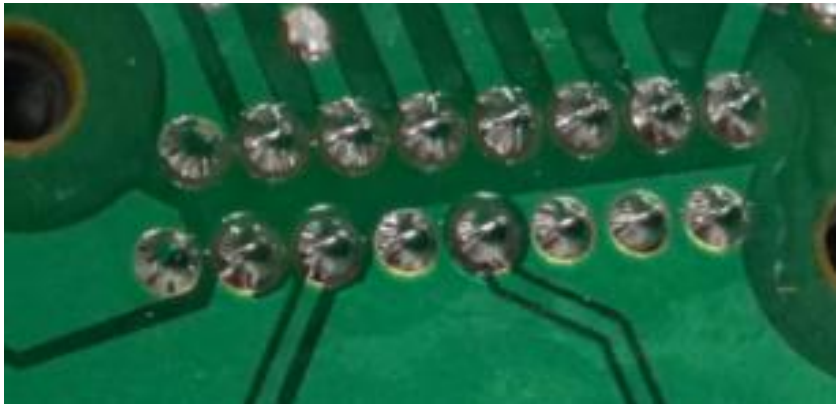
Connector Terminal

Soldering Result a product -
OK

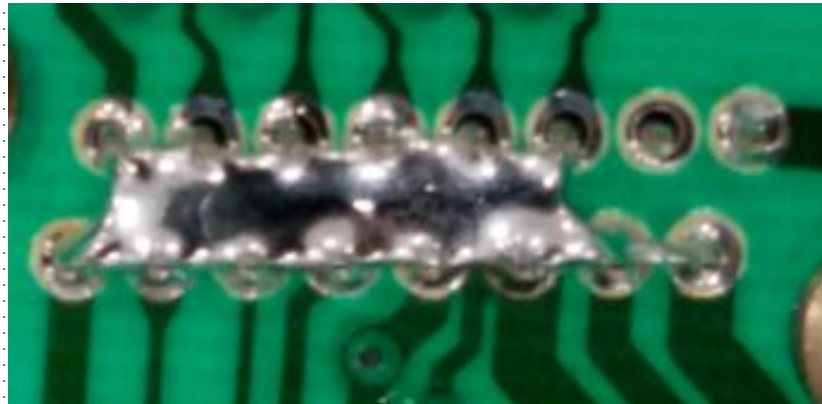
Connector Terminal

Soldering Result B product -
NG

Remarks – Uneven Plating may cause for terminal soldering issue
