Solving the ENIG Black Pad Problem: An ITRI Report on Round 2

F.D.Bruce Houghton
Celestica, Inc.
North York, Ontario, Canada

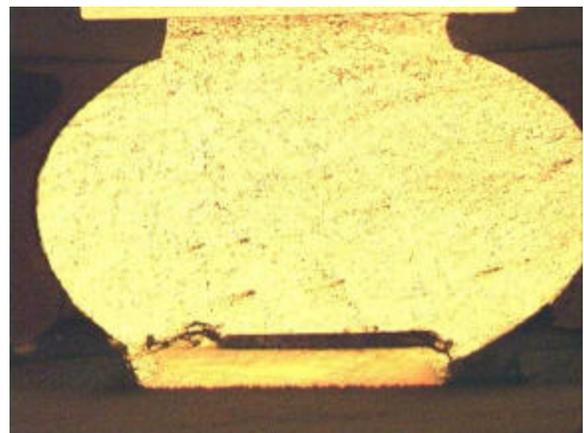
Figure 1- BGA Ball with Cracked Ball Joint

Figure 1 shows a cross section of a BGA solder joint with a crack along most of the nickel interface.

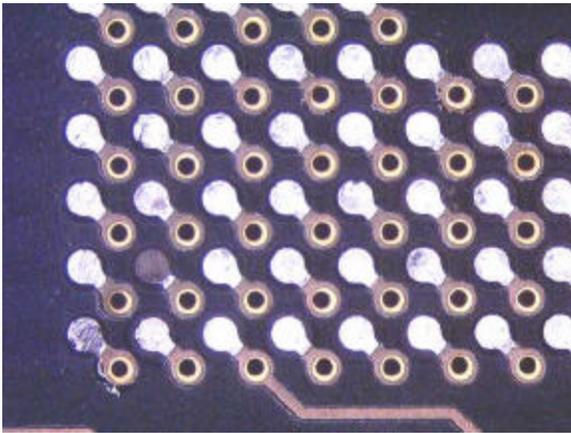
Figure 2 – BGA Site with One Black Pad

Figure 2 shows a BGA site after a component has been removed and the excess solder wicked off the pads. One pad is very dark to black in appearance.

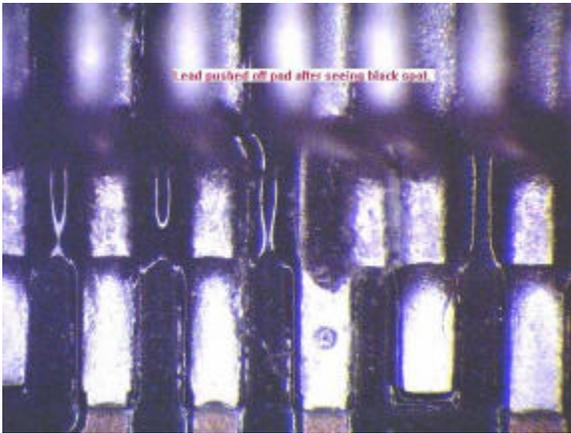
Figure 3 – QFP with Cracked and Shifted Lead

Figure 3 shows a group of QFP leads with one lead pushed to one side. The solder has lifted off the pad along the nickel interface and remains adhered to the QFP lead.

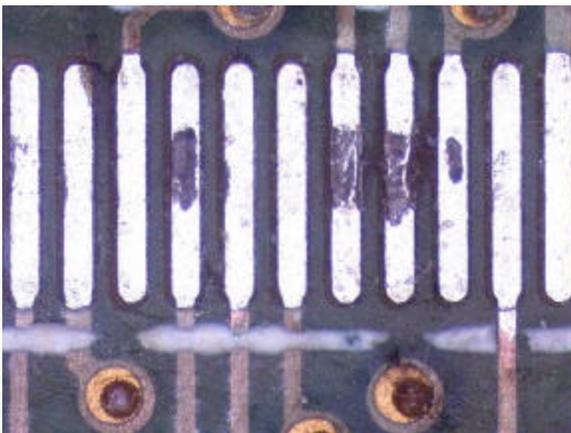
Figure 4 – QFP Black Pads after Solder Wick

Figure 4 shows a QFP site after the component has been removed and the excess solder wicked off the pads. Three pads have varying degrees of a black pad appearance.

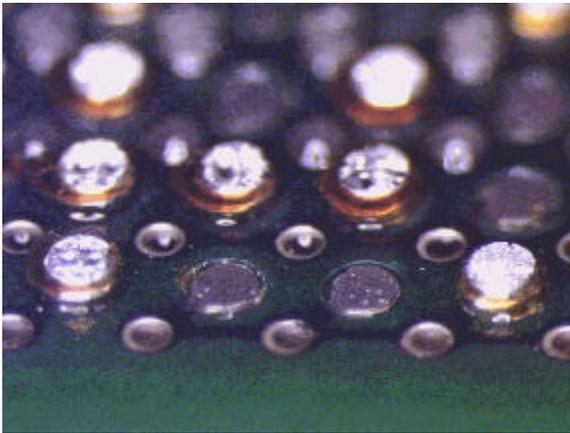
Figure 11 – Instron Bad Pull Result

If the nickel to solder bond is a problem, then the failure could occur at either interface #3 or #5. The solder would separate from either of these surfaces, leaving the pad still attached to the FR4 and a potentially 'black pad' on the nickel surface. Fractures at either of these surfaces was considered a bad failure mode in Round 1 and likewise for Round 2.

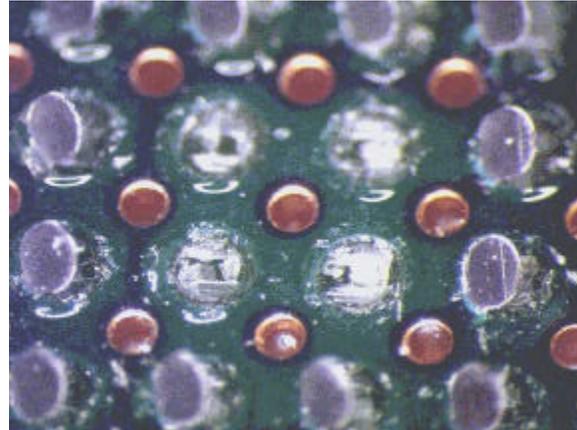
Figure 12 – Instron Good Pull Result

If all of the solder joints between nickel and bulk solder are solid joints, then the failures should all occur at the board BGA copper pad to FR4 with either the pad lifting at interface #7, or being totally ripped off the board at interface #8.
