## Troubleshooting the STM32F429 board and restoring its operation

Let's look at how the troubleshooting was carried out using such a system on the STM32F429 board.

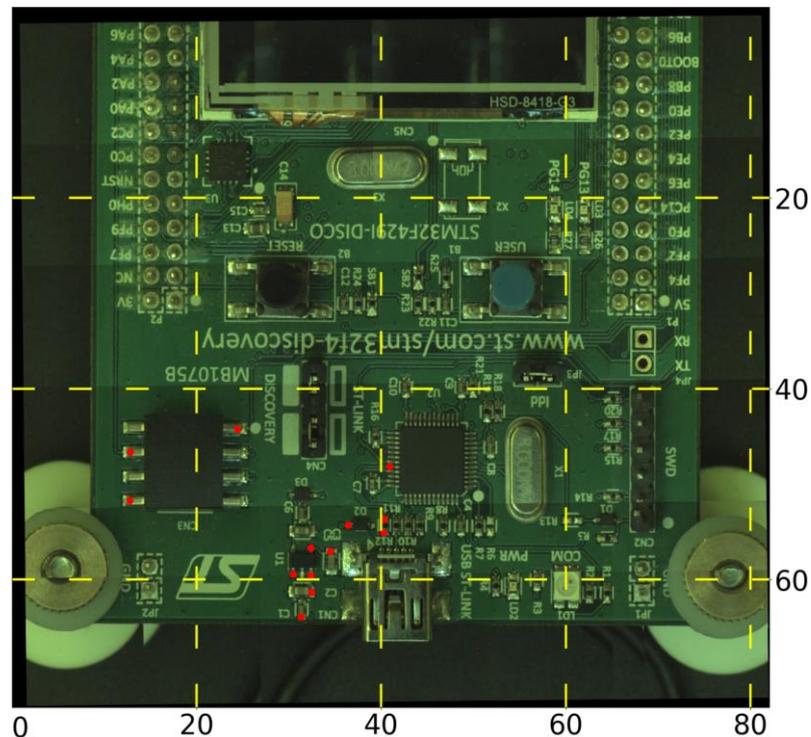
In this case, testing was done with test signal settings of 12V, 2.5mA and 100Hz. Only that part of the board that belonged to ST-Link was scanned. There were differences in the signatures of the conclusions, which are indicated by red dots in the photograph. Signature differences were 35% or more.

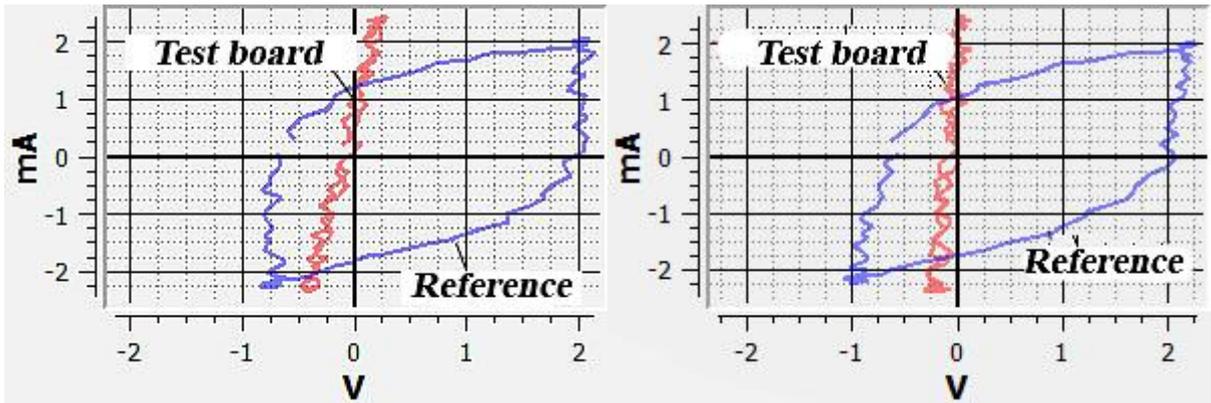
The following I - V characteristics were observed at pins 1 and 3.

According to the form of this I - V characteristic, we can say that the tested board has a short to ground through a small resistance, probably this is the resistance of the burned out microcircuit itself, and on the standard we see the I - V characteristic of the pn junction + large capacitor chain.

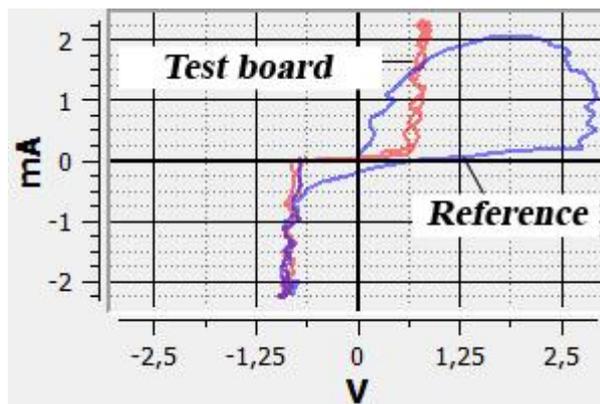
At pin 4, the following I - V characteristics were observed.

The resulting I - V characteristic indicates that there is an additional problem in the pn junction + capacitor circuit - there is no capacitance, which indicates a capacitor breakdown.

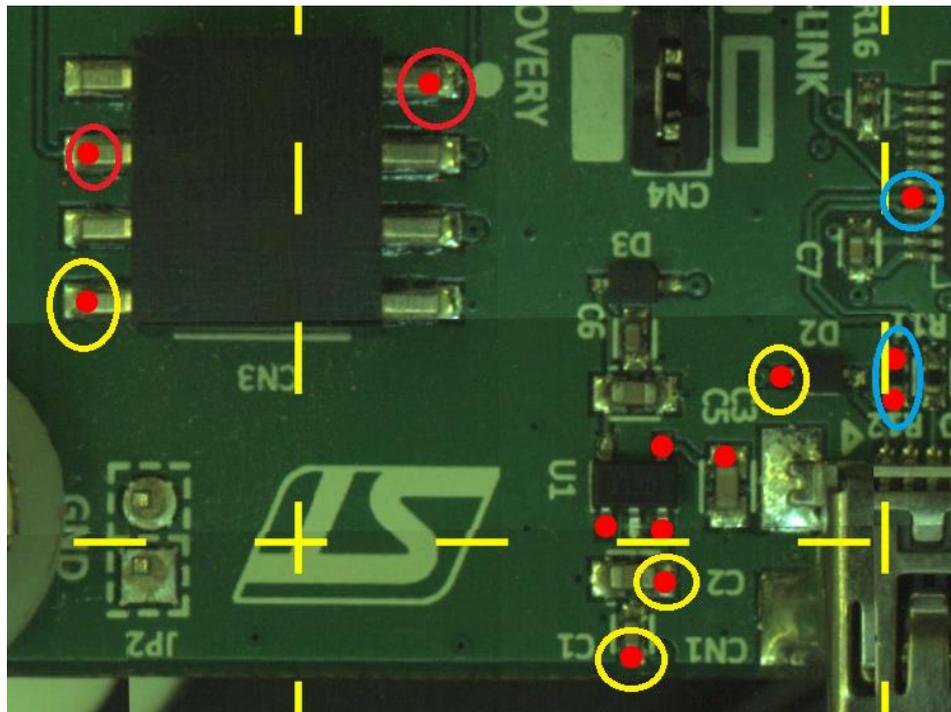
The points highlighted in yellow are connected to pin 3 of the U1 microcircuit as they have the same VAC.

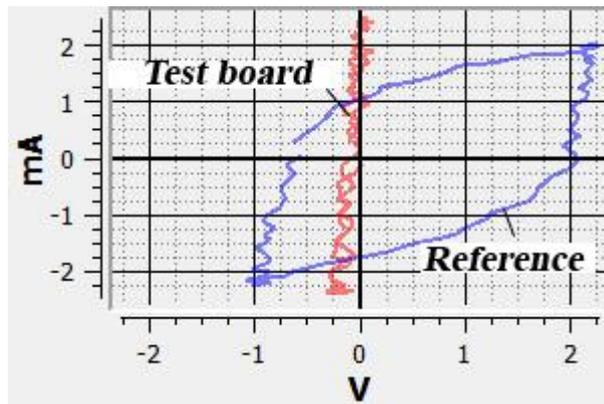
The difference between the I - V characteristic of the tested board and the reference one at the points marked in blue and red is most likely due to a problem in the U1 microcircuit. Therefore, we will try to determine what kind of microcircuit it is. To do this, you need to use the diagram or the list of components for the board.

According to the BOM on the board, U1 is an LD3985M33R chip, a 3.3V voltage converter with a maximum input voltage of 6V. Probably, a voltage higher than 6V was accidentally applied to the board, which led to the failure of the microcircuit.

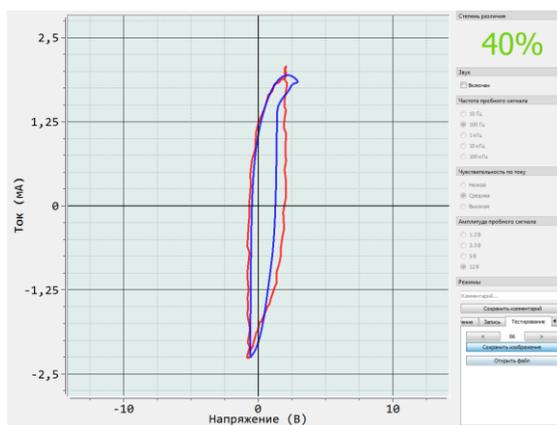
I - V characteristic at pin 1

After replacing the microcircuit, the I - V characteristics at the input 1 and output 5 of the microcircuit were checked, but **with the help of the EyePoint u22 desktop device** ([https://eyepoint.physlab.ru/ru/product/EyePoint\\_u2/](https://eyepoint.physlab.ru/ru/product/EyePoint_u2/)) and the epLab program. The resulting I – V characteristics are presented below.

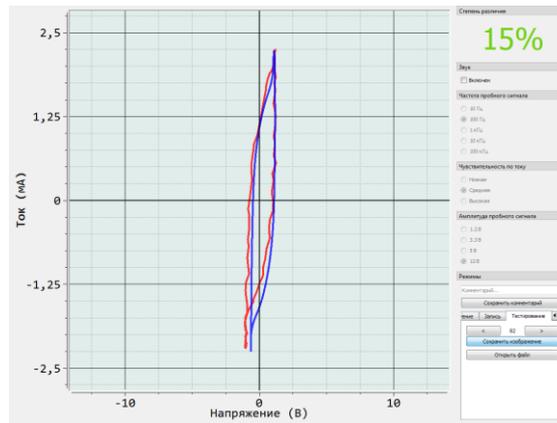
## VAC at pin 5

Checking the pins highlighted in red and yellow showed that the I - V characteristics at these points are the same. However, the I - V characteristics of the pins highlighted in blue are still different.

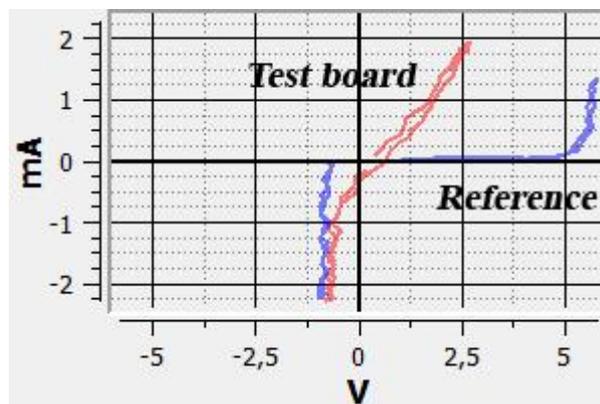
The following I - V characteristics were obtained:

This current-voltage characteristic indicates that the output responsible for one of the USB lines (according to the datasheet on the microcircuit, this is the USB\_D- line) behaves incorrectly. This is the cause of the observed error when the device is identified as ST-Link, but with a communication error. Replacing this microcircuit and its firmware will eliminate the error and return the board to correct functioning.
