Identification and Prevention of “Black Pad”

Paper type Case study

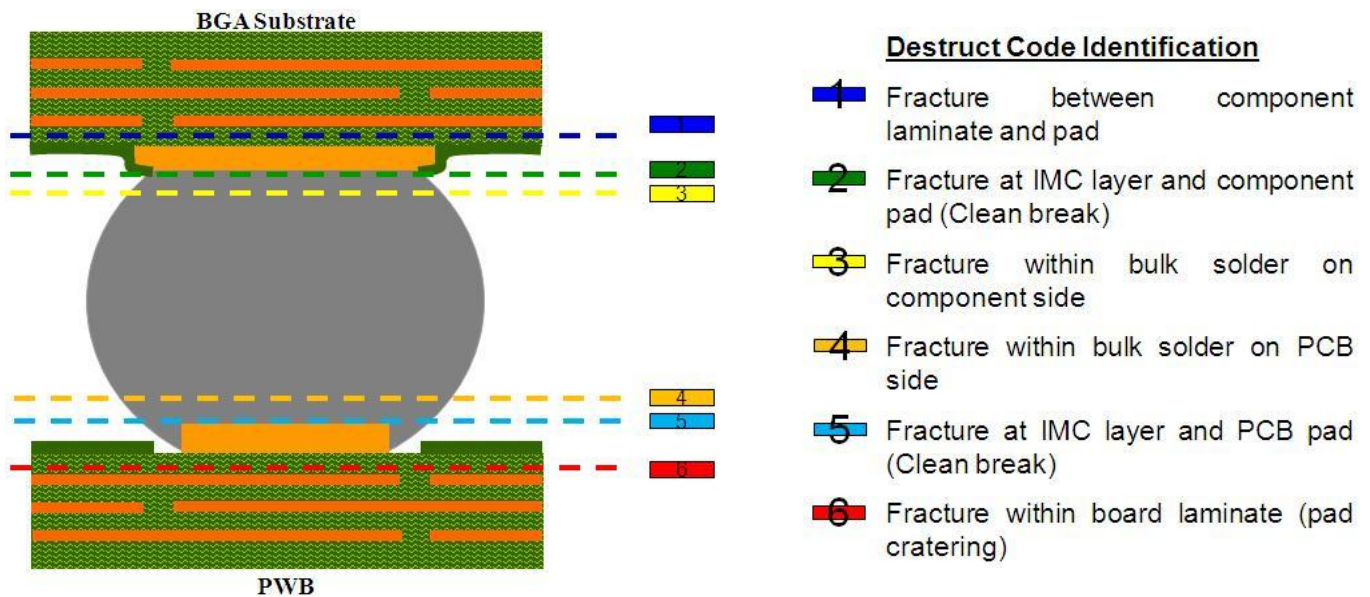
Figure 1: Destruct Code identification used as a guideline to check possible Black Pad failures side.

The authors had pre-identified six different destruct codes to be used as a guideline in our attempt to confirm the Black Pad failure mode. All of the six different destruct codes are shown in Figure 1. A direct

fracture between the inter-metallic compound (IMC) layer and BGA substrate under Destruct Code 2 is an early sign of possible Black Pad failures on BGA substrate. However, Destruct Code 5 will be indicating a possible open joint at the PCB side due to Black Pad failure. (Destruct Codes 1, 3, 4, and 6 are not of interest for the present case studies.)

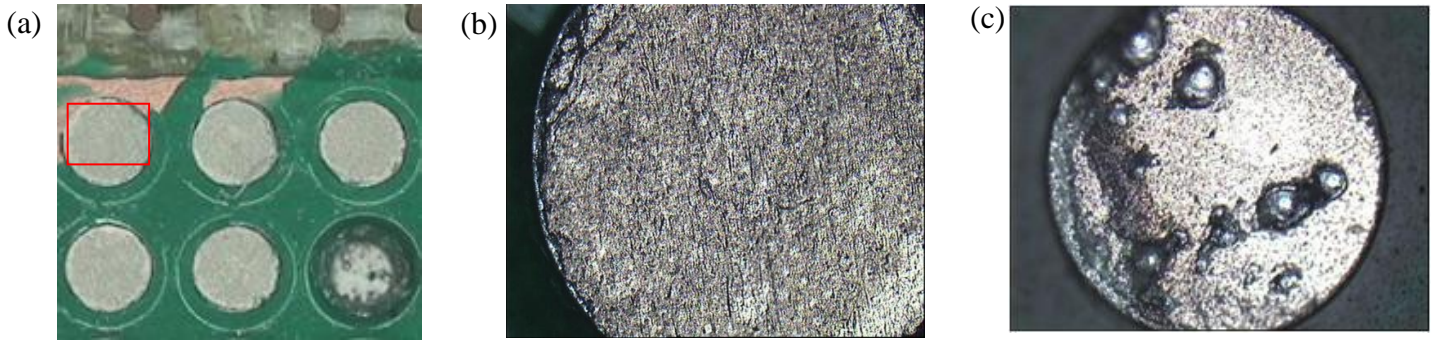
Figure 2: ‘Dye and Pry’ analysis on reflowed samples. (a) PCB BGA pad at 20X magnification. (b) PCB BGA pad at 200X magnification from (a). (c) PBGA package side substrate at 200X magnification.

Figure 2(a) and 2(b) present an ENIG-plated pad on a PCB where a reflowed BGA package site was ‘dyed and pried’ prior to 20X and 200X magnification visual inspections. Visual inspection at 200X magnification had shown that there were some bright areas indicating a small amount of fine IMC particles (grey) at the centre and the perimeter of the BGA pads, but, it is at a much smaller ratio as compared to the area observed with pink or black spot. The smaller ratio of IMC particles was evidence of a weaker PCB-BGA package bond. Although some solder joint formation still existed and Black Pad failures are not apparent upon

initial soldering, failures can be experienced at a later stage in the field when there are stresses induced by thermal and mechanical excursions. A similar phenomenon was observed on a PBGA package substrate as is evident from Figure 2(c). Visual inspection at 200X magnification had shown a pink or black coverage of more than half of the total substrate surface. Although partial IMC formation can be confirmed at random locations on the substrate surface, a much weaker BGA package-solder ball bond is expected.

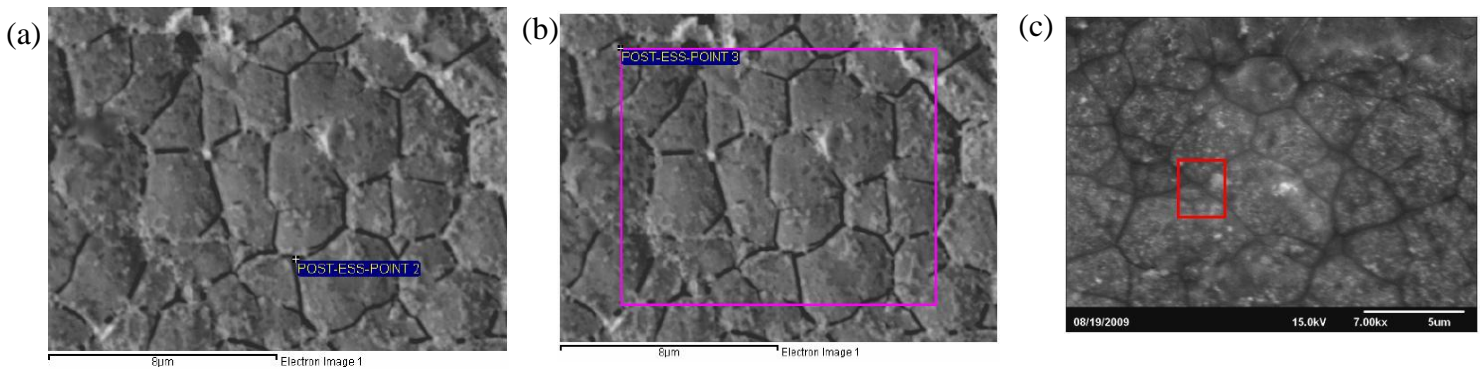
Figure 3: Top view inspection (a) Spot EDX analysis at PCB side, 8000X magnification. (b) Area EDX analysis at PCB side, 8000X magnification. (c) Area EDX analysis at PBGA package side substrate, 7000X magnification.

In a top view, further magnification at 7000X and 8000X had shown a feature that looked like the boundaries of the ENIG plating nodules, as can be seen from Figure 3(a) to 3(c). The boundary-like feature was the commonly called ‘mud-crack’ phenomenon related to Black Pad failure in the electronics industry. Both the spot and area EDX analyses had shown a close match of elemental composition, as indicated in Table 1. With the assumption that all the tin signals were detected from the few Ni₃Sn₄ particles (for the SnPb joint chemistry) and they were negligible on the BGA pad surface (for PCB) and substrate (for PBGA), the calculated atomic ratio of Ni:P was approximately 48.0:16.0 for the former and 14.4:4.0 for the latter, which was very close to the stoichiometry value of Ni₃P. The obtained value is in good agreement with Zeng *et al.*, 2006. Hence, the presented result had confirmed that the joint was fractured between the Ni₃P and Ni₃Sn₄ layers, while the mud-crack phenomenon observed was in the Ni₃P layer.

Table 1: EDX analysis results for locations identified in Figure 3(a) to 3(c)

Elements	Figure 3 (a)		Figure 3 (b)		Figure 3 (c)	
	Weight %	Atomic %	Weight %	Atomic %	Weight %	Atomic %
C	14.55	42.18	13.97	41.87	26.87	61.61
O	3.09	6.74	2.65	5.96	1.99	3.43
Si	0.58	0.71	0.50	0.64	N/D	N/D
P	10.44	11.74	9.96	11.58	8.13	7.23
Ni	59.02	35.01	57.53	35.28	55.30	25.94
Sn	12.33	3.62	15.39	4.67	7.72	1.79

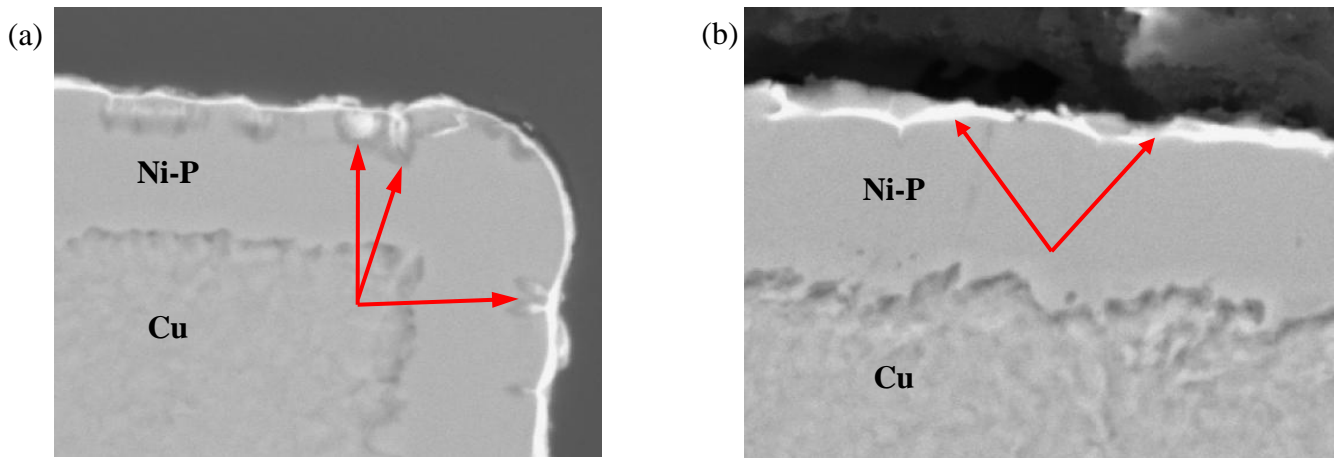
To obtain more conclusive evidence for Black Pad failures, two cross-sections were performed on the as-received PCB sample at two different locations on the same board. One of the cross-section locations was on the suspected known-bad pad. Figure 4(a) shows that corrosion spikes were clearly seen on the suspected sample at 5000X magnification. It can be seen that a feather-like structure around the spike or crack had spread into the nickel-phosphorous (Ni-P) plating, while only a hair line spike defect was observable on the good sample, as had been shown in Figure 4(b). As EN and immersion gold process will submerge the whole PCB in the solution bath, it is expected that the metallic coating defects and thicknesses should be consistent across all

areas of the surface. The only plausible explanation for the different observation may be due to the complexity of the PCB design at different locations or there may be an uneven movement in the solution bath, meaning that the solution bath was not maintained at a homogeneous concentration. On a separate note, cross sectional analysis was not performed on the failed PBGA when Black Pad failures happened, thus, comparative discussion of the two different destruct codes was not further explored in the present paper.

Figure 4: Cross section samples at PCB BGA pad. (a) Feather-like spikes or crack indicating the Black Pad phenomenon. (b) An acceptable good sample.
