USING X-RAY SYSTEMS TO DETECT COUNTERFEIT AND REWORKED ELECTRONIC COMPONENTS

Art Ogg
World Micro
Roswell, GA
aogg@worldmicro.com

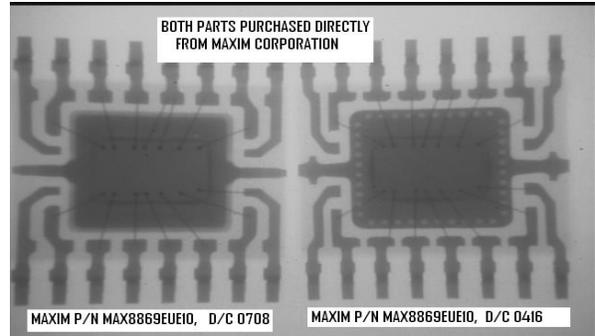
Figure-1 demonstrates how two components with the same part number but manufactured over two years apart can look so different yet will operate the same functionally.

The two photos shown in Figure-1 were sent to the OCM for verification, with the request to have them verify they were manufactured by that company. The OCM quickly verified the two components were authentic and the part numbers shown on the parts were correct.

Figure-1, X-ray sample of 2 parts that appear different but are the same functionally

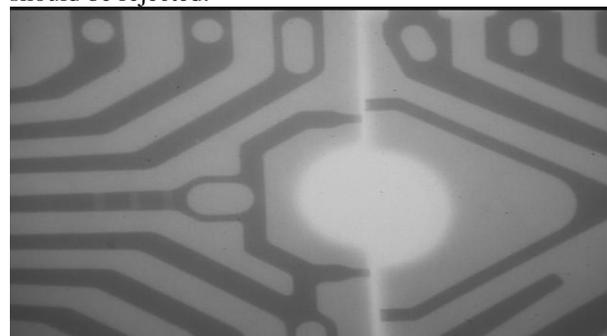
Components shipped in either tape or trays are easy to compare and detect issues. Figure-2 demonstrates two lead frame designs detected with an X-ray system. The two designs were side by side in the same tape and reel container.

In Figure-2, the two components are stamped with the same date code, same lot code and part number. The parts were suspected as having a false top coating during the initial visual inspection. A sample was then submitted to an X-ray examination and it was determined that even though the parts had the same markings and appeared to be the same size physically, they had a varying number of internal structures with different lead frames and dies. These parts should be rejected.

Figure-2, two different dies side by side in a tape

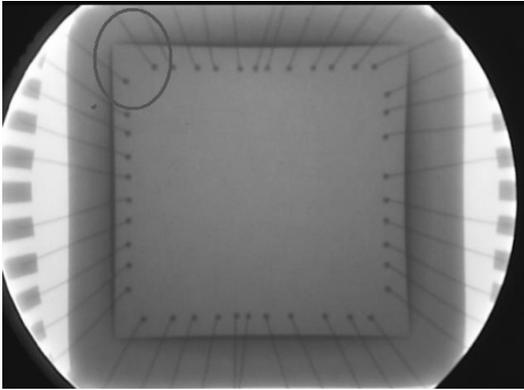
Note in Figure-3 that the bond wires are evenly spaced around the die perimeter. Without the use of an X-ray system, the diagnostician would be unable to determine the variances between Figure #3 & #4. The two components were found in the same reel of tape with exactly the same markings and country of origin.

Figure-3 is the good component

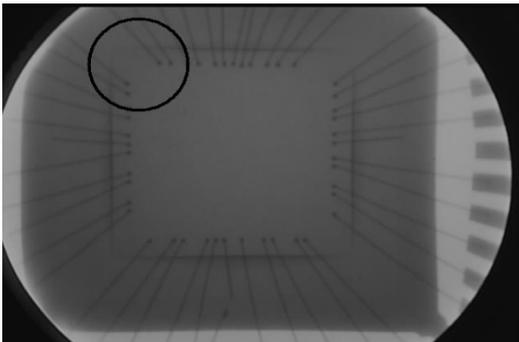
The bond wires attached to the die in Figure-4 are not evenly spaced around the die. Notice the gaps in each of the four corners of this die and the two different die sizes between the two parts.

Figure-4 is the incorrect die for this part

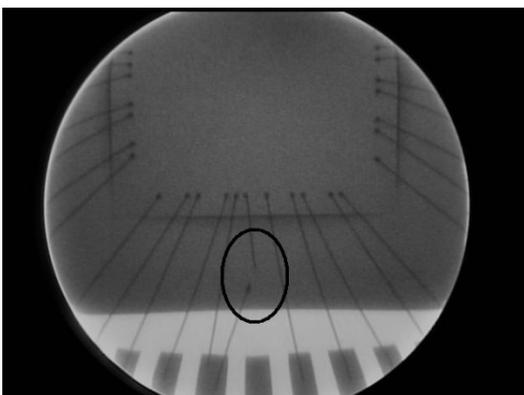
Figure-5 & 6 show broken bond wires that showed up during a routine check of the component internals with the X-ray system. The inspector would be unable to detect such a defect without an X-ray system. These photos were taken from a group of components that had a high fallout rate during a production run and were returned as being defective.

Figure-5, Broken wire in the center

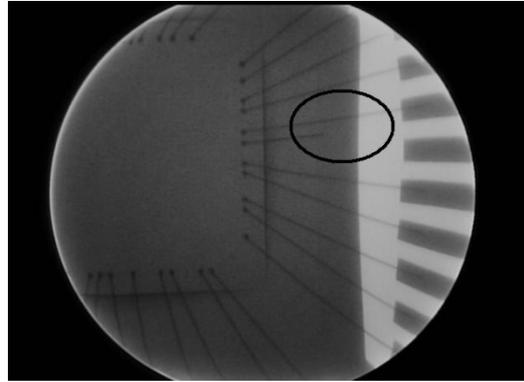
Figure-6, broken bond wire inside the circle

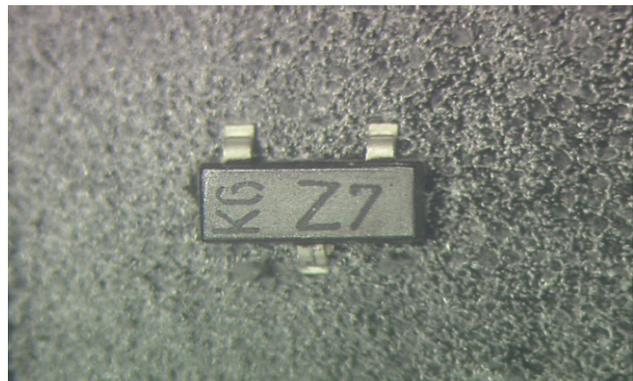
The component shown in Figure-7 should have the characters readable with the single lead facing up. This component has the markings upside down. This was the first clue that the parts were not genuine when they were compared with the markings shown on the data sheet.

Figure-7, shows the top surface of a fake part

In this series of photos the diagnostician has compared the component’s data sheet with the view shown in Figure-7. Notice the variance in lead layout versus the top surface markings, the decision was made to X-ray the parts.

When these components were compared against known good components the inspector was able to conclude they were most likely not the part number inscribed on the top surface. The parts were rejected and returned to the supplier.

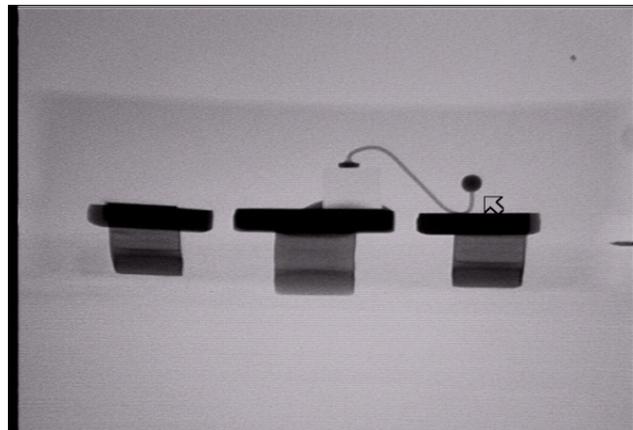
Figure-8 shows a non-standard “S” shaped wire bond connecting the two leads. Also notice the large bubble under the wire connection on the center lead. This is also non-standard and is of suspect.

Figure-8, fake part side view

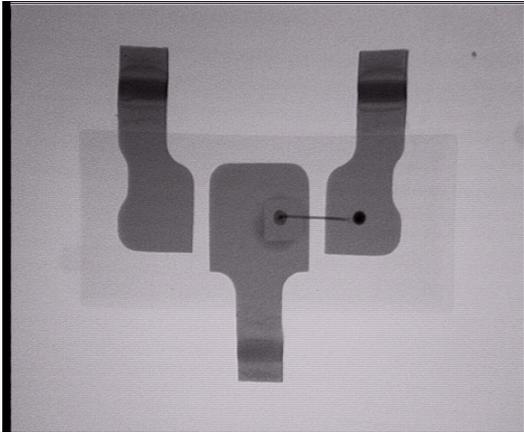
Figure-9 shows the suspected fake component. It looks properly spaced in this top down angle view. This could be a misleading view without also being compared to the other views.

Figure-9, fake part top view

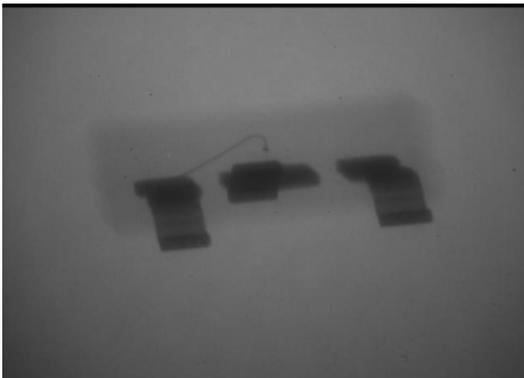
Figure-10 is the side view of a known good component. Notice the bond wire does not have the “S” shaped bond wire shown in the suspected fake component photo.

Figure-10, good part side view

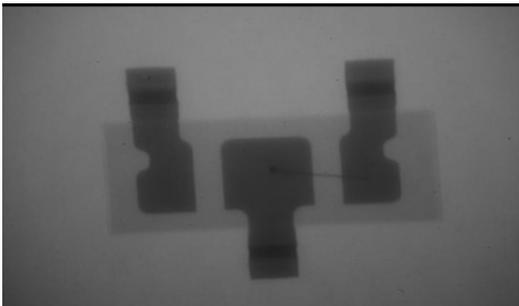
Figure-11 is the top down view of a known good component. This view compared to the suspected photo shows very little difference between these components.

Figure-11, good part top view

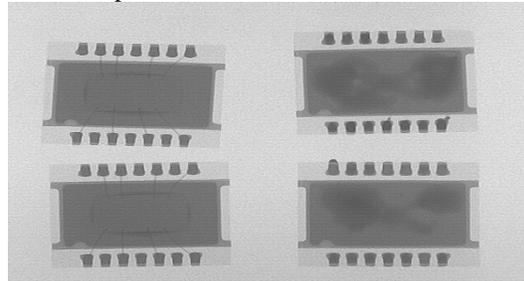
The two dies shown on the left are from known good components and the two on the right are taken of fake components that have no dies.

Notice in Figure-11 the dies on the right are missing from the components. The X-ray system has quickly established these components to be counterfeit.

Figure-11, fake parts on right with no die

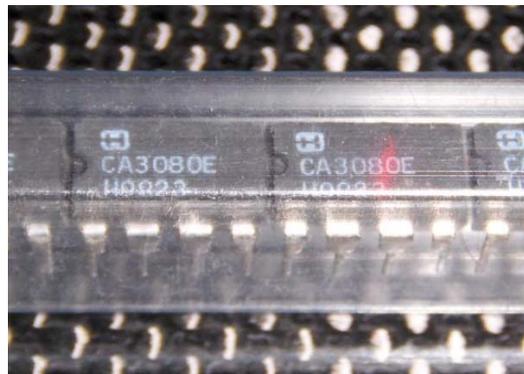
Figure-12 was taken to demonstrate that the components in this tube were correctly aligned in their tubes when the following X-ray photos were taken.

Figure-12, view of parts still in their tubes

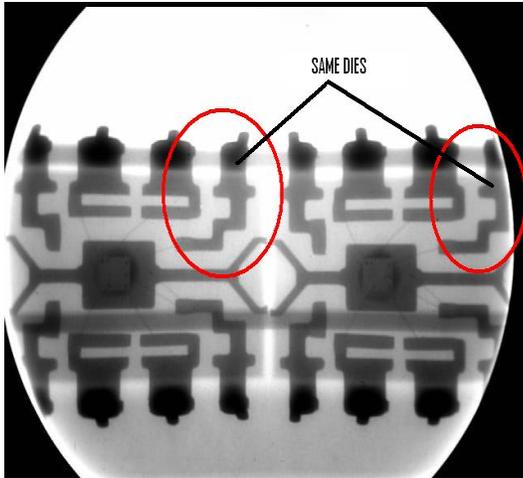
Figure-13 demonstrates two adjacent components have the same dies that are oriented in the same direction. This is the way they should appear in an X-ray photo.

Figure-13, lead designs compare

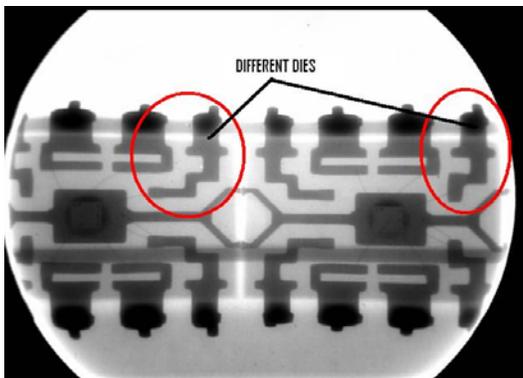
Figure-14 shows how two adjacent components in this reel of components have dies mounted differently within the component structure. Notice the comparison between the two red circles.

Figure-14, lead designs do not compare

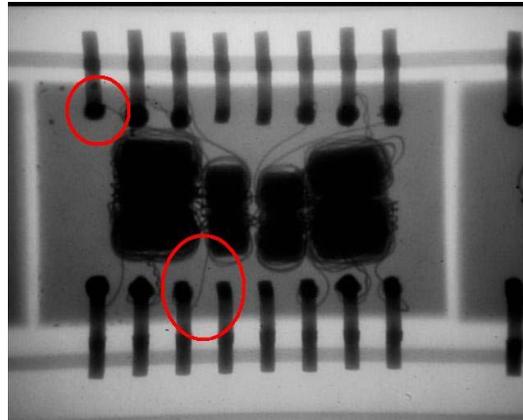
Figure-15 is a sample of a part in a single tube where there were four distinctly different internal component arrangements. Notice the red circle in the upper left corner showing the construction of the lead and how it compares with the hooked version in figure-16.

Also in figure-15 notice the bond wire leading from the third lead on the left connects with the smaller coil in the middle left. In figure-16 the wire coming from the same third lead is connected to the larger coil on the left. This is clear evidence the two components shown in figures 15 & 16 are not the same part number.

Figure-15, sample-1 lead design

- Each of the components shown in these four photos came from the same tube.
- Each component was marked identically with the same D/C, L/C, P/N and country of origin.
- There are four different lead frame designs represented in these four photos.
- Notice that figures-15 & 16 show the two small coils in the center between the two larger coils on the outside. While the other two photos show a staggered arrangement.
- This entire shipment should be rejected.

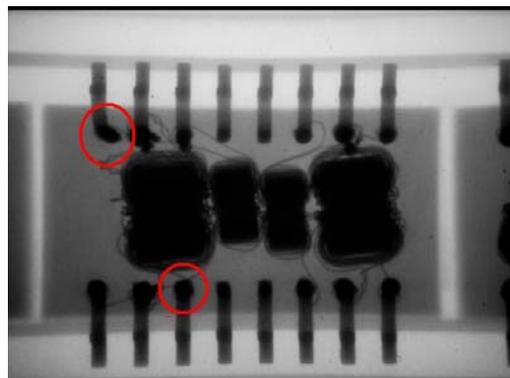
Figure-16, sample-2 lead design

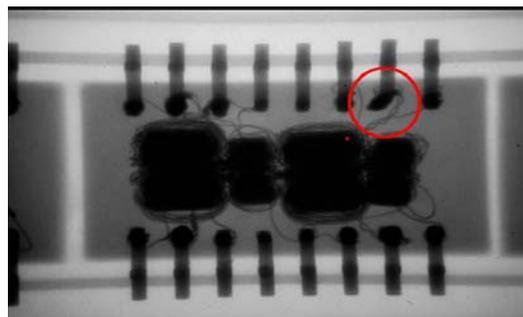
Figure-17 shows a lead that has a distinct hook to the left as shown in the red circle where this same lead shown in figure-18 does not have the hook.

Figure-17, sample-3 lead design

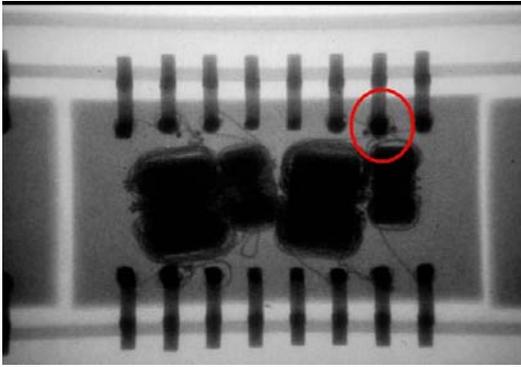
Figure-18, sample-4 lead design

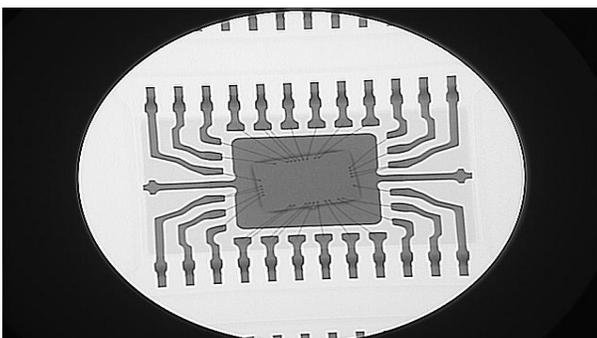
Figure-19 shows a component that has a die that is canted to one side. Do not presuppose it is a manufacturing defect. This component was verified by the OCM to be correct.

Figure-19, canted die, view-1

Always verify with all the means available including data sheets, archived photos, OCM contacts or other QA inspectors in a network of associates prior to assuming an unusual component like this is fake or is a manufacturing defect.
