Technical Bulletin

Common failure mechanisms in conformal coating: Delamination

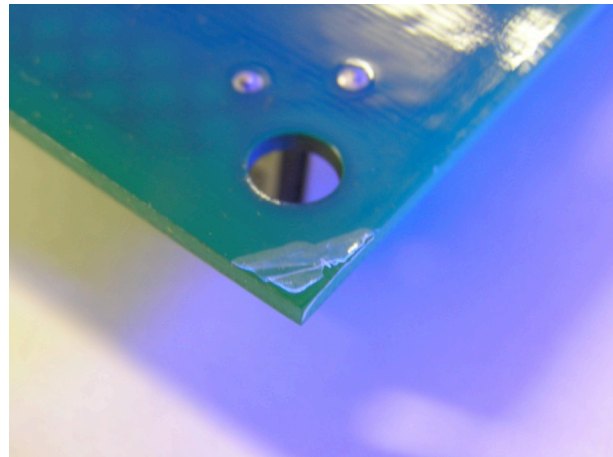
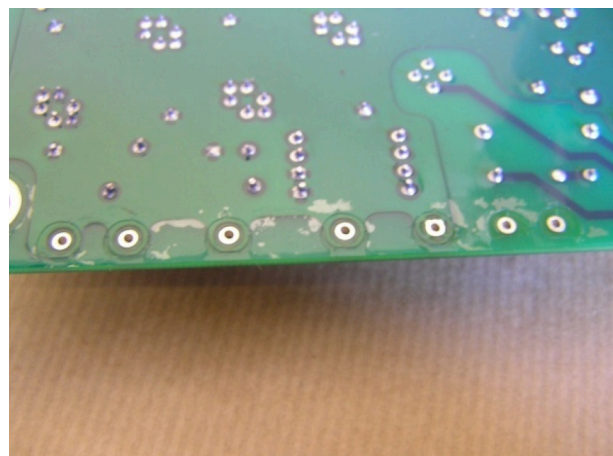
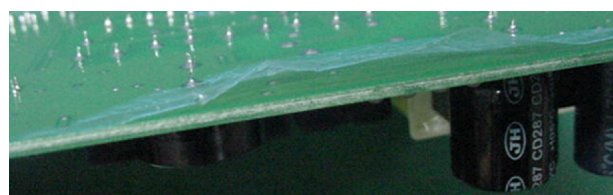
Examples of Conformal Coating Delamination

1. Cleanliness of the surface for adhesion
2. Compatibility between the coating and the surface adhered to due to surface energies mismatch
3. Permeability to moisture
4. Degree of coating cure

Examples are shown in the images throughout the bulletin where the conformal coating has lifted away from the surfaces, leaving torn and/or non adhered coating, producing a poor finish.

- Reducing the coating thickness
- Reduce force drying (thermal profile)
- Remove contamination such as mould release agents
- Apply a primer to treat the board surface
- Change the coating and / or surface finish so the surface energies are more favourable.
