# Head-on-Pillow Defect Detection – X-ray Inspection Limitations

Lars Bruno and Benny Gustafson  
Ericsson AB, Stockholm, Sweden

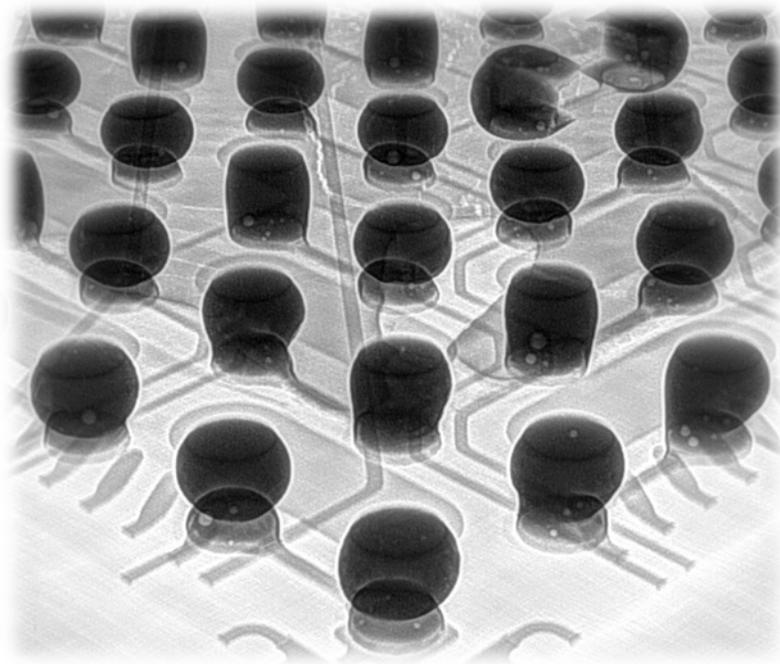
Figure 1 – X-ray image from HoP defect analysis<sup>1</sup>.

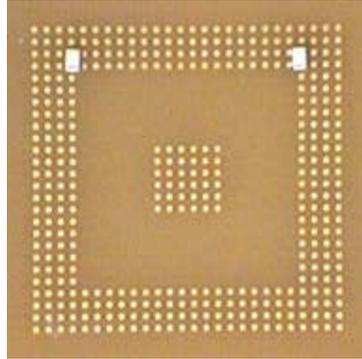
**Figure 2 – Example of chip components placed on a solder paste screen printed BGA pad site<sup>2</sup>.**

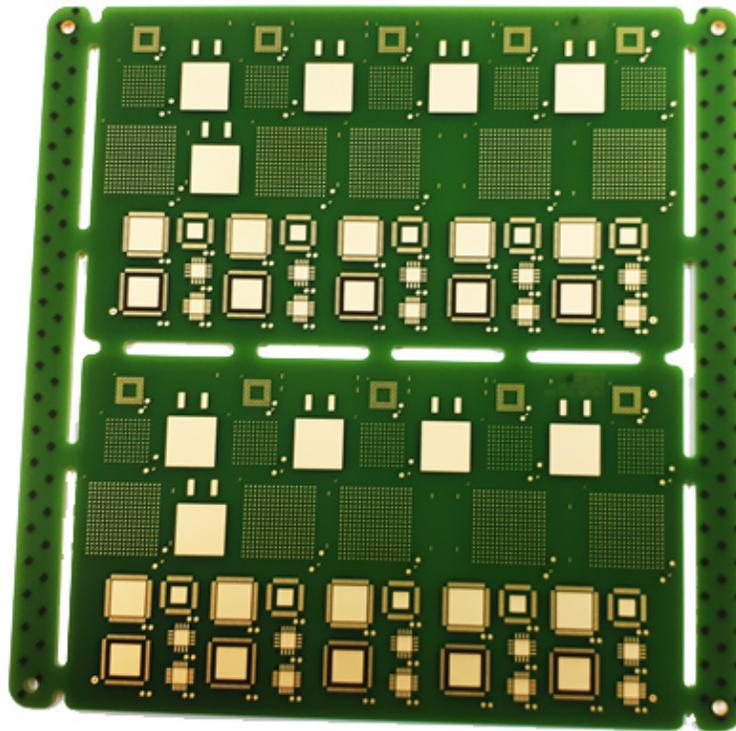
Figure 4 – Panel with two test PCB intended for solder paste void test and for HoP defect test.

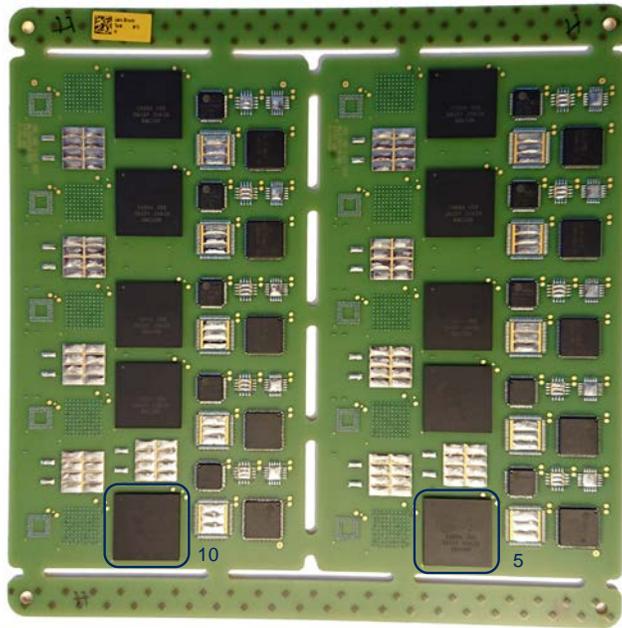
**Figure 11 – Test board panel with encircled HoP defect BGA test components.**

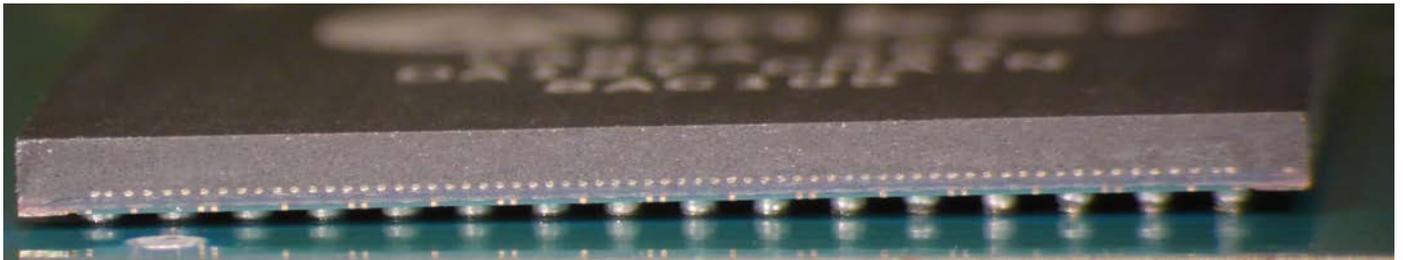
**Figure 12 – BGA256 package placed on printed site with two 0402 chip resistors underneath after soldering.**

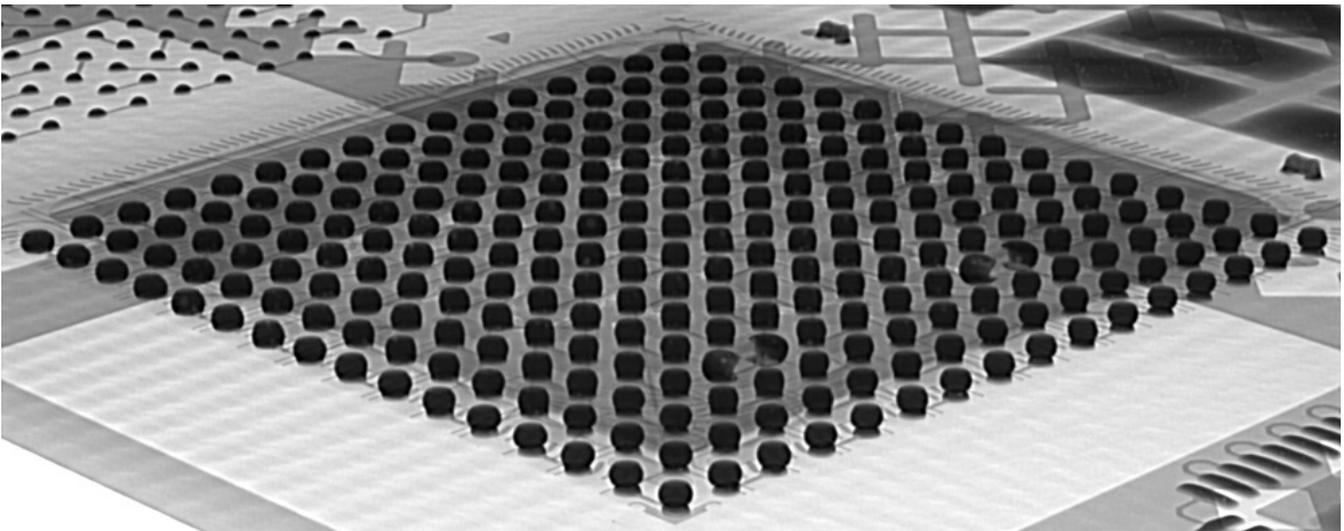
**Figure 14 – X-ray inspection – detector view angle 70°, sample rotation 45°.**

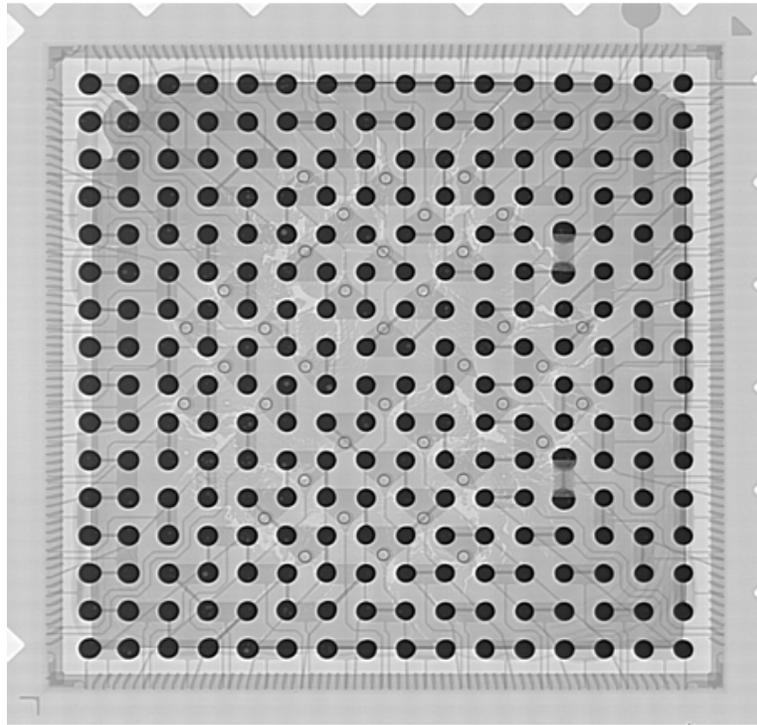
**Figure 15 – X-ray inspection – top view (0° tilt).**

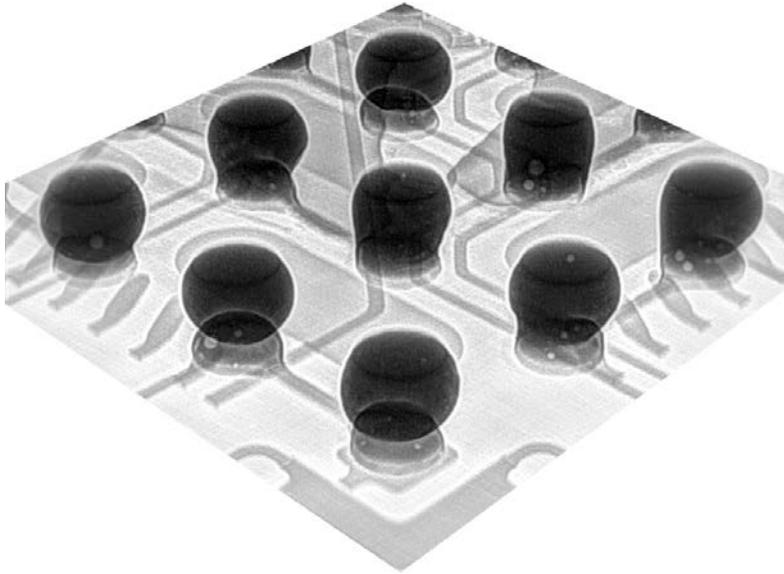
**Figure 16 – BGA solder joints - all regarded as HoP in this x-ray inspection.**

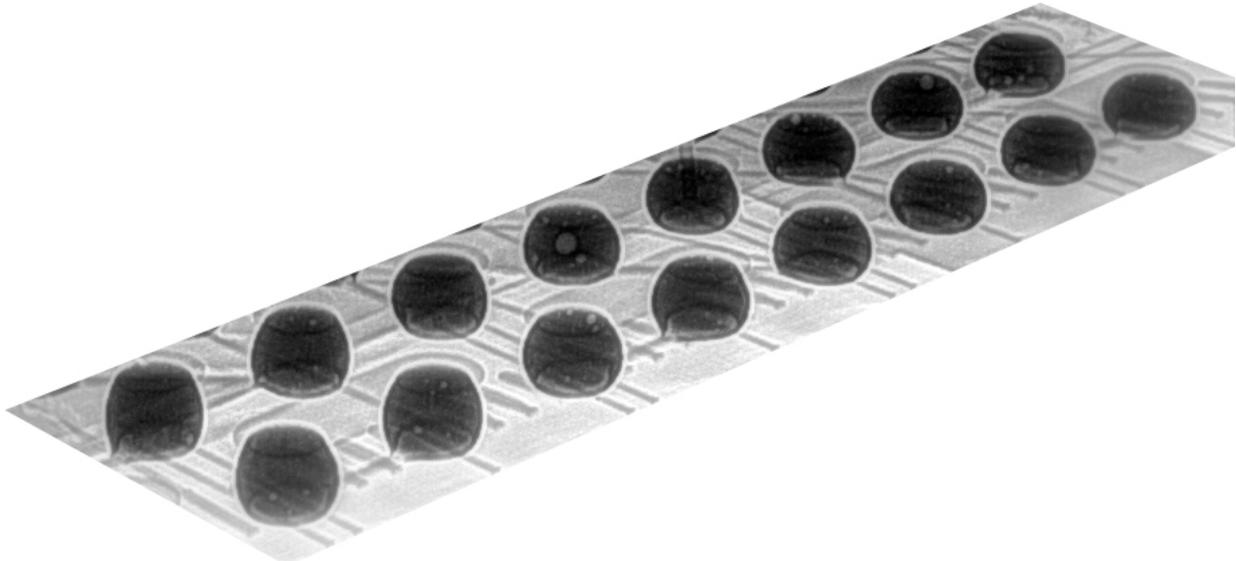
**Figure 17 – X-ray image of good solder joints - regarding HoP.**

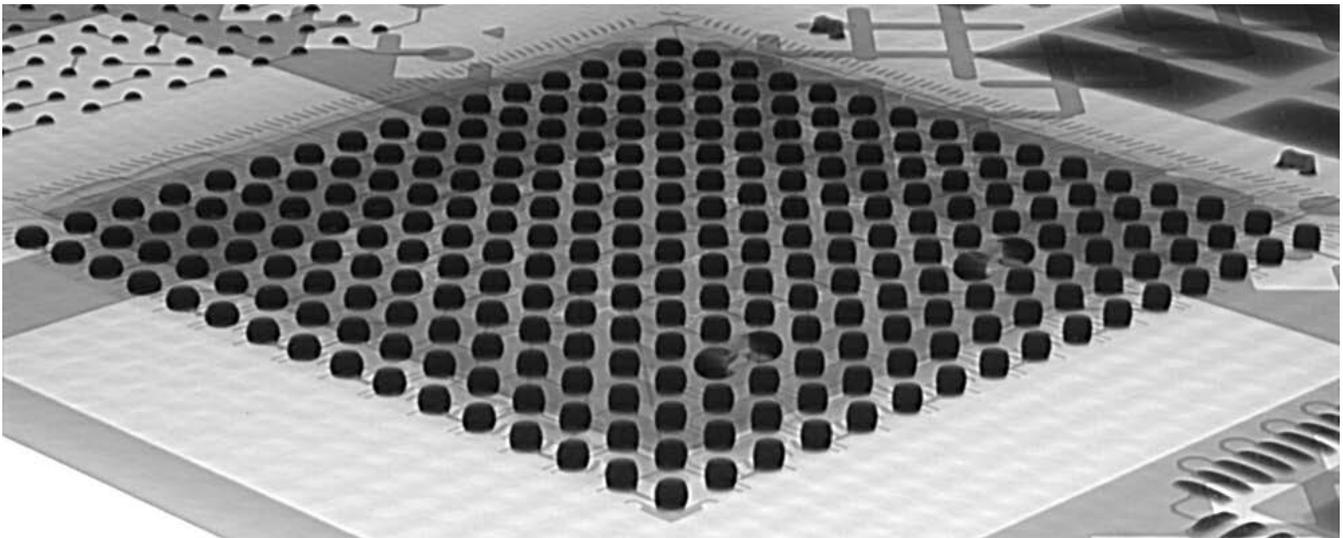
**Figure 18 – X-ray image of the best performing solder paste's solder joints.**

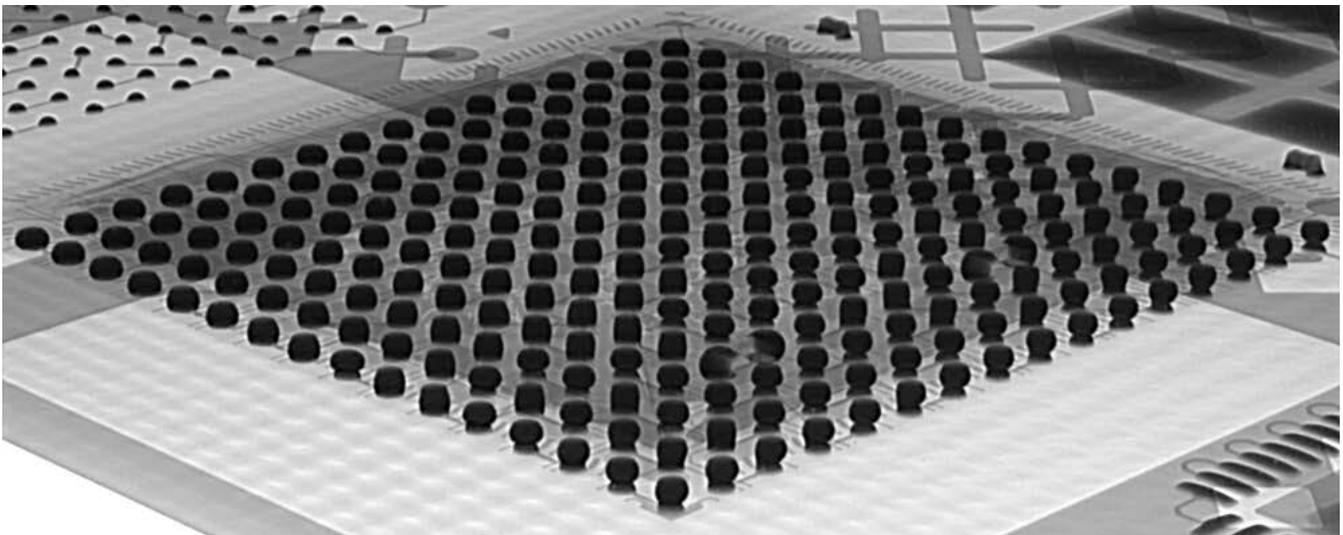
**Figure 19 – X-ray image of solder joints created with a solder paste with poor HoP mitigation properties.**

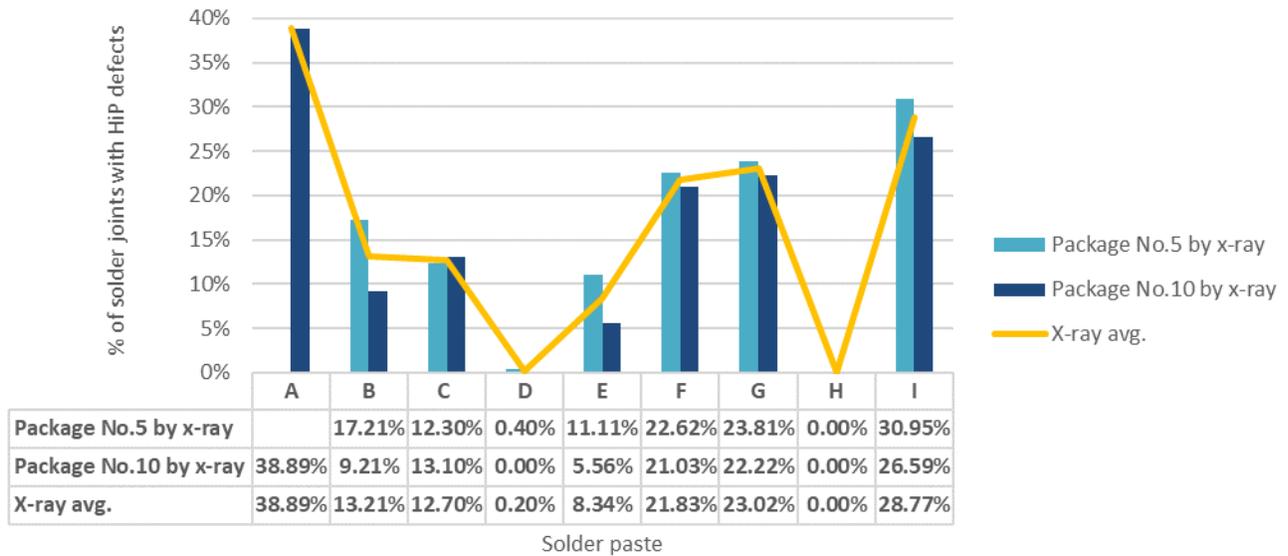
**Figure 20 – Solder paste HoP defect rates for nine different solder pastes – BGA256.**

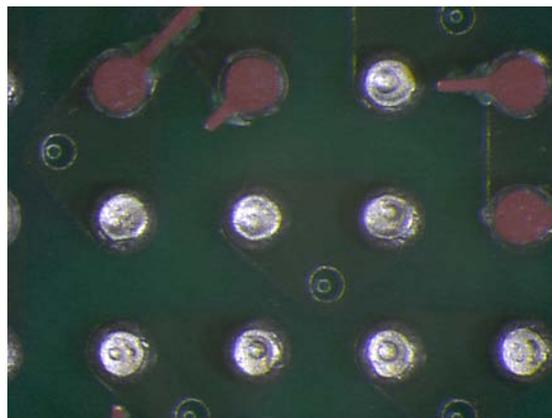
**Figure 21 – Eight HoP defects verified after prying-off a test BGA.**

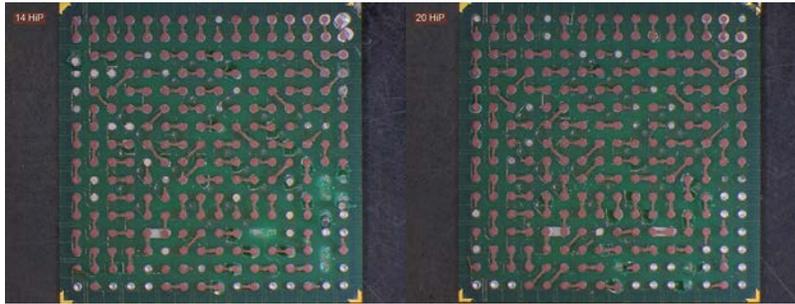
**Figure 22 – HoP defects verified after prying-off two test BGAs -solder paste I.**

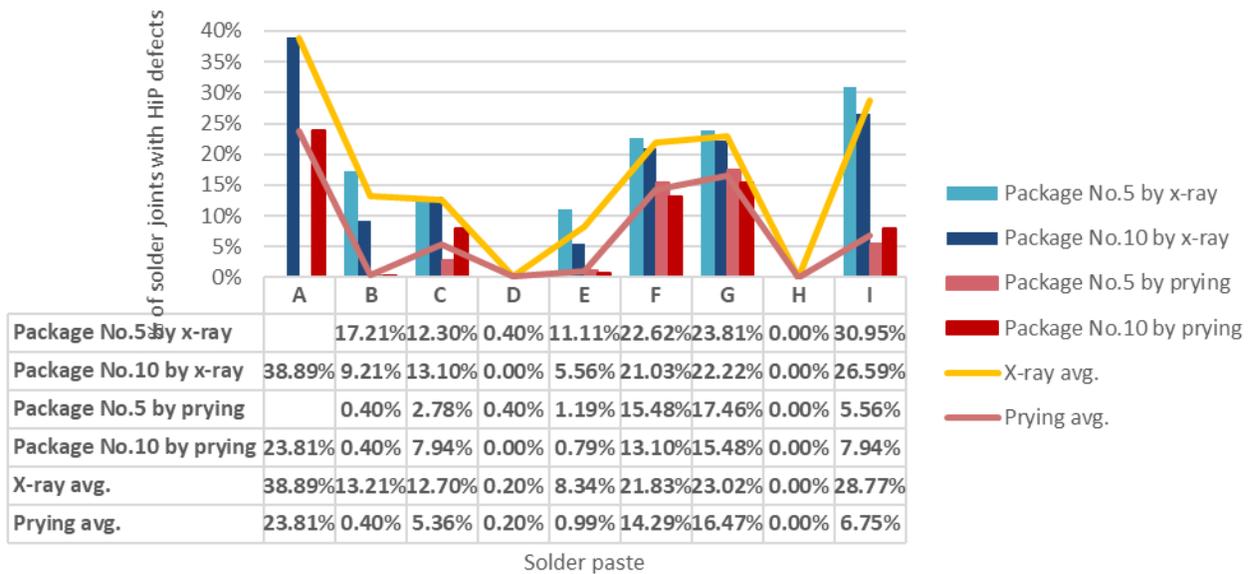
**Figure 23 – HoP defect rates – comparison of results between x-ray and prying off test BGAs.**

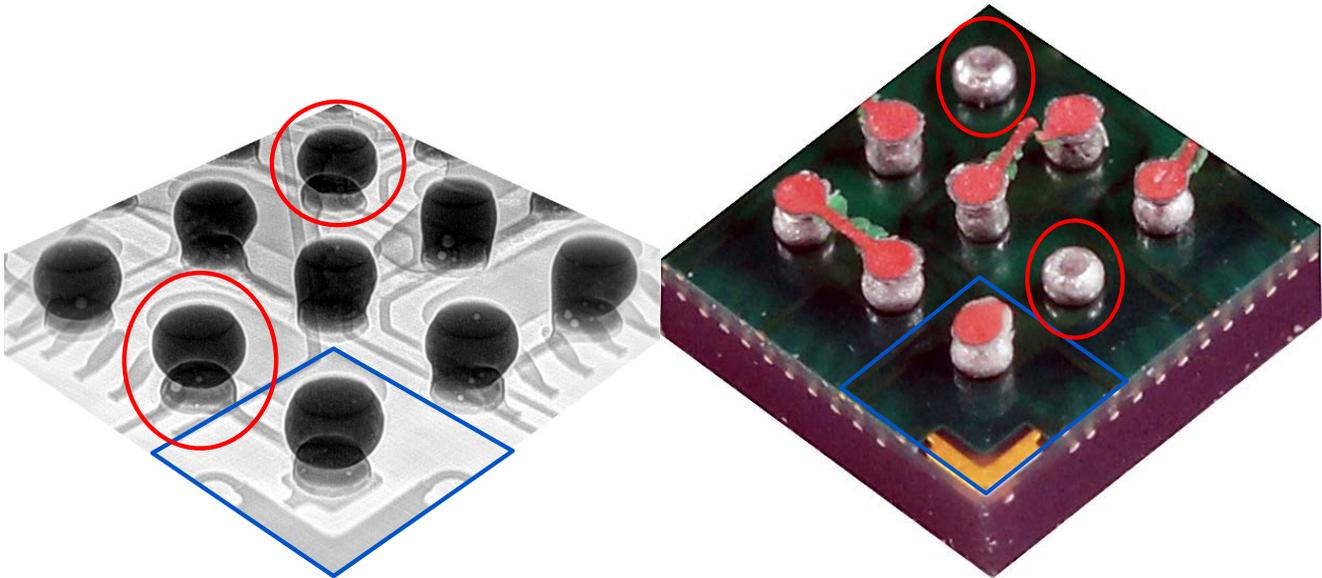
**Figure 24 – Comparison of x-ray image (left) and pried component (right) –red encircles show verified HoP defects.**

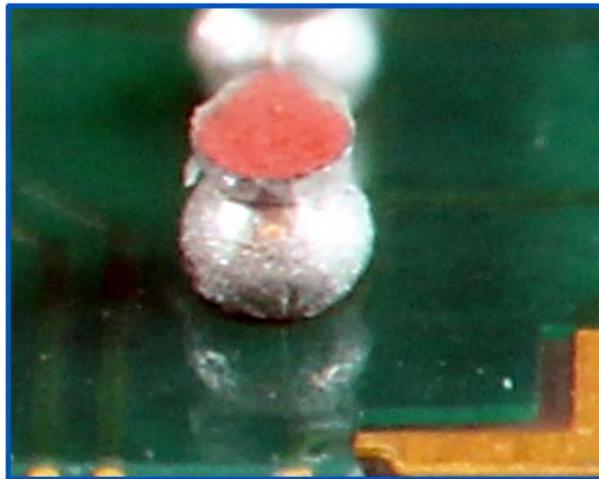
**Figure 25 – Enlargement of a component corner solder joint with clear “waist” that survived a pry off test.**

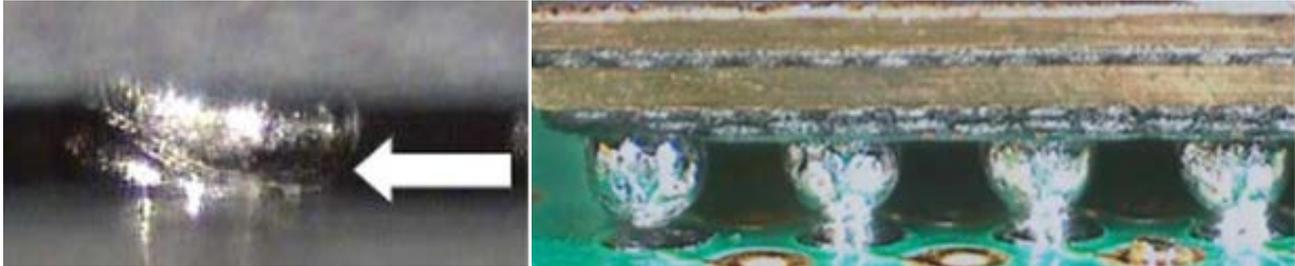
**Figure 26 – Defect criteria according to [2] – HoP (left) and “waist” in solder connection (right)<sup>11</sup>.**
