THE GREAT SAC DEBATE: COMPARING THE RELIABILITY OF SAC305 AND SAC405 SOLDERS IN A VARIETY OF APPLICATIONS

Heather McCormick, Polina Snugovsky, Craig Hamilton, Zohreh Bagheri, and Simin Bagheri
Celestica Inc.
Toronto, ON, Canada
hmccormi@celestica.com

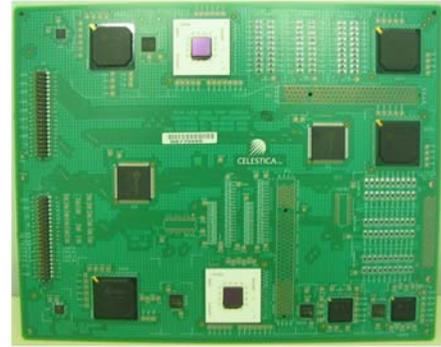
Figure 1: “RIA3” Test Vehicle

In order to assess the performance of SAC305 and SAC405, a test vehicle was designed which was representative of a typical mid-complexity telecom or server product. The test vehicle, known as RIA3, was 8” x 10” in size, and was 0.093” thick and is shown in Figure 1. It was sourced in a variety of surface finishes to determine if varying the finish had a significant effect on the reliability of the solder joints. The test vehicle included a wide range of components, including ceramic BGAs, plastic BGAs, LGAs, QFPs, MLFs and discrete resistors ranging in size from 1206s to 0201s. All of the area array components for this test vehicle were sourced in both SAC305 and SAC405 versions. This allowed for the assembly of test vehicles where the area array solder joints were composed of pure SAC305 or pure SAC405.

The RIA3 test vehicle was used to evaluate a number of different aspects of lead free manufacturing – the comparison of SAC305 to SAC405 involved data from 16 of the project’s cells. Each of the cells consisted of 17 boards – one for time zero analysis of the solder joints, and 16 for accelerated thermal cycling. Each test vehicle included two of each component type, making a total sample size of 32 components per cell. A summary of the cells referenced in this paper is shown in Table 1.

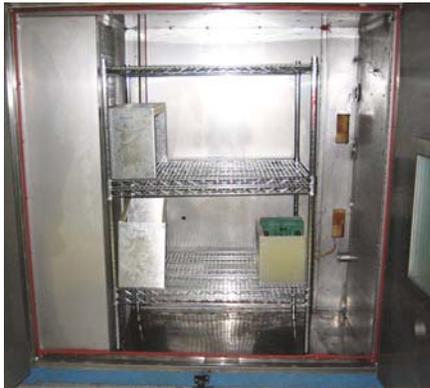
Figure 2: RIA3 Test Vehicles in Thermal Cycling Chamber

the harsh test, and 6000 cycles for the standard 0°C to 100°C test. The cards in all chambers were mounted into racks which maintained spacing between them to allow the air to circulate freely. Figure 2 shows the cards mounted inside one of the chambers.

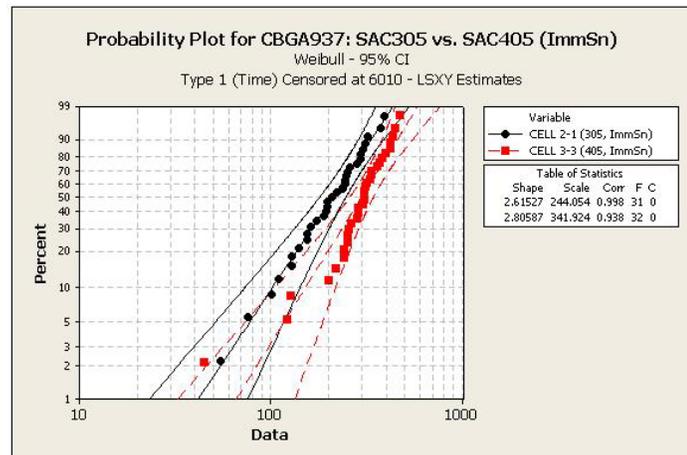
Figure 3: SAC305 vs. SAC405 CBGA on ImmSn in 0°C to 100°C Thermal Cycling

The difference between SAC305 and SAC405 was most pronounced on the ImmSn finish. On ImmSn, there was a difference in performance between SAC305 and SAC405 at N63%, with the SAC405 outperforming the SAC305. However, at lower failure levels, the difference is no longer statistically significant. On ENIG and Electrolytic NiAu, there was no significant difference in performance between the two alloys.

Though the 0°C to 100°C cells contained a wide variety of component types, not all of them had accumulated a sufficient number of failures by the time of writing to allow a Weibull plots to be generated. One component which did have a sufficient number of failures was the CBGA component. The CBGA on the RIA3 test vehicle was a 937 I/O, 1mm pitch CBGA. The cells using SAC305 paste were assembled using CBGAs balled with SAC305, and the cells using SAC405 paste were assembled using CBGAs balled with SAC405. Weibull plots comparing the performance of the CBGA on ImmSn, ENIG and Electrolytic Ni/Immersion Au are shown in Figures 3 through 5. For the remaining finishes, OSP and ImmAg, there was no SAC405 cell assembled, making comparison impossible.

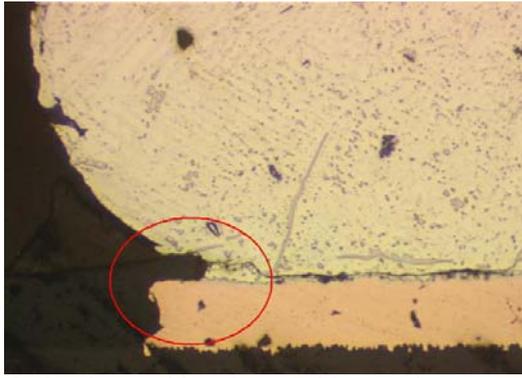
Figure 6: Crack Resulting from Solder Mask Encroaching on Pad

In each case, a small number of early failures were observed. These were attributable to premature second level solder joint cracks caused by poor solder mask registration. In some cases, this resulted in solder mask encroaching on the surface of the pad, resulting in pads which were, in effect, partially solder mask defined. The pads had been intended to be fully non-solder mask defined. The solder mask encroachment changed the shape of the solder joint and formed an area of concentrated stress. Cracks initiating from the solder mask contact propagated across the joints and caused failures, some of them very early. A typical crack showing solder mask encroaching on the pad is shown in Figure 6.

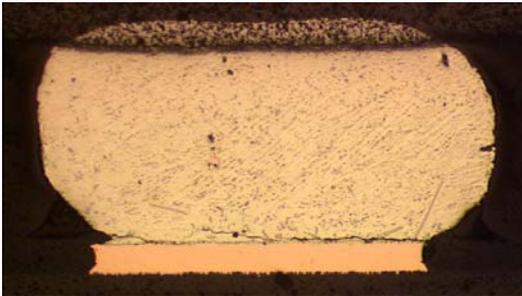
Figure 7: Typical Board Side Solder Joint Crack

Three crack paths were observed for both the SAC305 and SAC405 components. The first, the board side solder joint crack, was found to be responsible for many of the early failures observed. It was also found on some joints with more normal numbers of cycles to failure, and in many cases was associated with some encroachment of the solder mask onto the component pad. The crack propagates through the bulk solder above the pad. A typical example of this failure mode is shown in Figure 7.

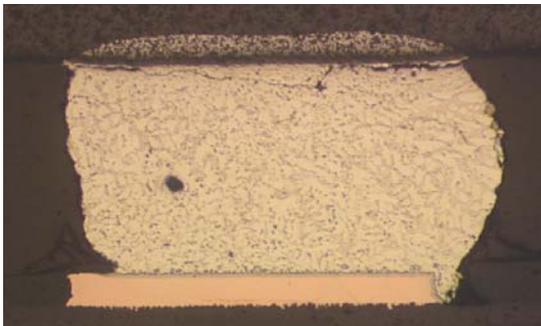
Figure 8: Typical Component Side Solder Joint Crack

The second crack path was the component side solder joint crack. This is the commonly expected failure mode for these components when the solder mask is not partially encroaching on the board side pad. As with the board side failure mode, the crack propagates through the bulk solder. A typical example is shown in Figure 8.

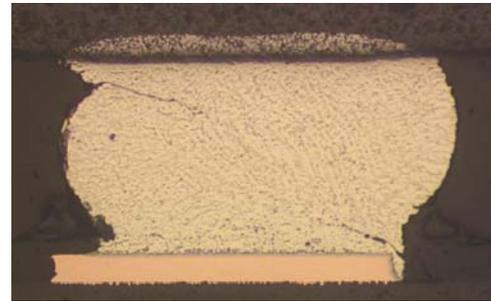
Figure 9: Diagonal Crack Path

Although the vast majority of the components had either board side or solder joint cracks, a small number had a diagonal crack path. These cracks did not result in complete failures of the solder joint. In this crack path, one crack grows diagonally towards the centre of the joint from the component side, and a second crack grows diagonally towards the centre of the joint

from the opposite end of the board side pad. Figure 9 shows an example of this crack path.

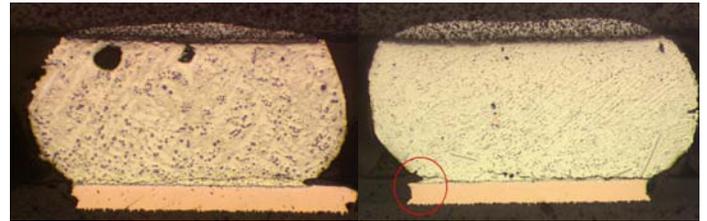
Figure 10: SAC305 Joint (Left) and SAC405 Joint (Right) on ImmSn

Comparison of the joint structures was also carried out. Figure 10 shows a SAC305 joint and a SAC405 joint side by side. In general, the SAC305 joints were found to have larger tin dendrites than the SAC405 joints. No Ag_3Sn needles were observed in the SAC305 joints, but did appear in the SAC405 joints – this was expected due to the higher silver content of the SAC405 paste (check ref.4 in Polina's paper).

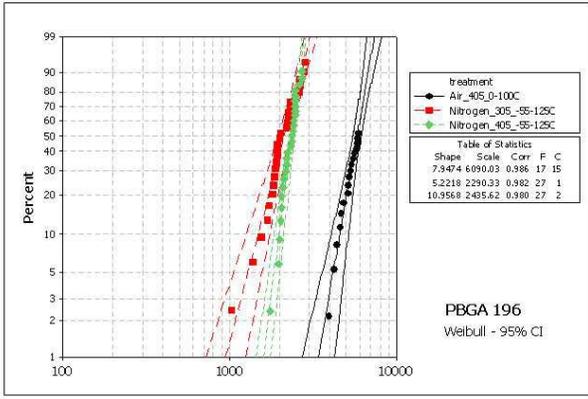
Figure 11: Weibull Plot, SAC305 vs. SAC405 for PBGA196 in -55°C to 125°C Thermal Cycling

Though many components were included in the harsh environment testing, the discussion will focus on the PBGA196, as this was one of the few component types to generate sufficient numbers of failures to allow a comparison of the performance of the SAC305 and SAC405 joints to be made. The Weibull plot for the PBGA196 is shown in Figure 11. The SAC405 joints can be seen to outperform the SAC305 joints, with a statistically significant difference in the performance at the critical N1% level. At higher levels of failure (including at N63%, the characteristic life) the difference is no longer visible. However, in field applications, the difference in performance at low levels of failure is of critical importance. Figure 12 shows the number of cycles to 1% failure (N1%). At this level, the performance of SAC405 is approximately 1.7X better than SAC305.

Failure analysis reveals that the failure mode for both the SAC305 and SAC405 PBGA196 joints was the same – cracks through the bulk solder on the component side of the joints. These cracks occurred most frequently at the balls under the die corners – E5, E10, K5 and K10 – for both SAC305 and SAC405.

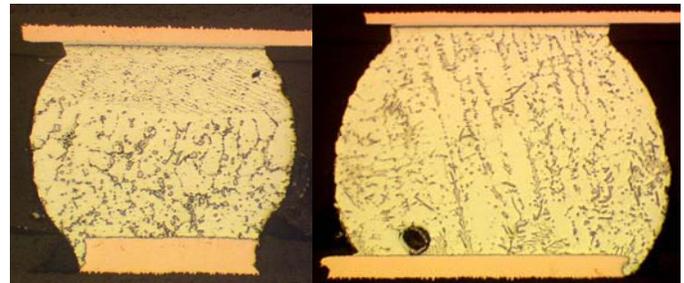
Figure XX: Partially Mixed CSP64 Joint (Left) and Fully Mixed PBGA256 Joint (Right)

Time zero analysis of the SAC305 and SAC405 assemblies showed differences in the degree of mixing of the PBGA196 joints between the SAC ball and the SnPb paste. This was done by performing a cross section along the component’s diagonal axis and visually assessing the degree of mixing obtained. Figure XX shows examples of partially mixed and fully mixed joints from two of the other component types on the board – a CSP64 and a PBGA256. Table 2 summarizes the results for degree of mixing. Generally, it is expected that the degree of mixing would increase with increasing reflow profile peak temperature. However, this trend did not show clearly in this data. Upon review of the reflow profile, it was discovered that the profile with a target peak temperature of 210°C used for Cells 1-3 and 1-4 was actually somewhat colder than the profile used for Cells 1-1 and 1-2, which was intended to have a peak temperature of 205°C . This profiling error accounts for the lower degree of mixing observed for Cells 1-3 and 1-4 when compared to Cells 1-1 and 1-2.

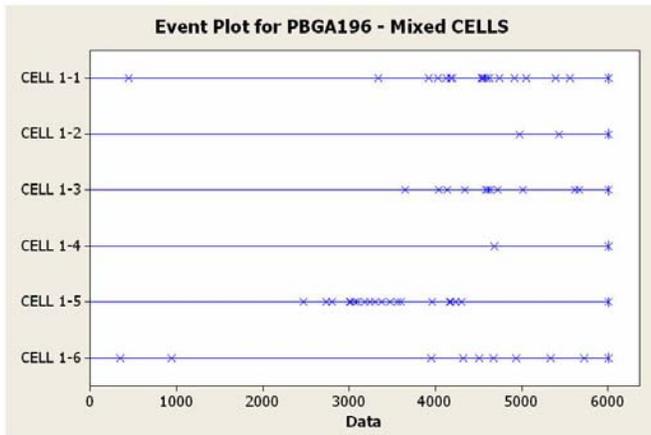
Figure XX: Event Plot for Mixed PBGA196 Joints after Thermal Cycling

Following the completion of thermal cycling, which used the standard 0°C to 100°C profile, an event plot was generated to show the relative performance of the mixed assembly cells. As there were insufficient failures in some cells, meaningful Weibull plots could not be generated for comparison. The event plot is shown in Figure XX.

Two main trends were uncovered in analyzing the data. The first trend is a decrease in reliability with increasing peak temperature. Full mixing was not required to create reliable solder joints – in fact, the partially mixed joints created with the two cooler profiles actually produced joints that outperformed the fully mixed joints. Intermetallic thickness measurements were performed on the time zero cross section samples, and these confirmed that the intermetallic layer thickness increased with increasing profile temperature (it must be recalled that the 210°C profile was, in fact, the coolest due to a profiling error). The intermetallic layer thickness measurements are shown in Table 3.

The second trend relates directly to the difference in performance of SAC305 and SAC405. It was observed that the joints formed from components with SAC405 balls (Cells 1-2, 1-4 and 1-6) outperformed those formed from components with SAC305 balls (Cells 1-1, 1-3 and 1-5) using each of the three reflow profiles. Though it is not possible to determine whether the difference is statistically significant due to the inability to generate proper Weibulls for the cells with low numbers of failures, the difference in performance between joints formed from the two alloys at a given temperature is marked.

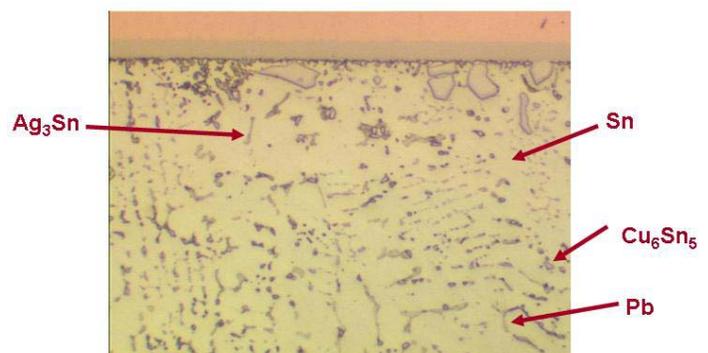
Figure XX: Detail of the microstructure of a fully mixed PBGA196 solder joint

At time zero, the fully mixed microstructure consists of primary Sn dendrites, with ternary Sn-Pb-Ag₃Sn eutectic and quaternary Sn-Pb-Ag₃Sn-Cu₆Sn₅ eutectic. This structure may be seen in Figure XX. The partially mixed time zero microstructure shows a fully mixed region in the lower portion of the joint with the same microstructure as the fully mixed joints, and a region of pure SAC305 or SAC405 remaining at the top of the joint.

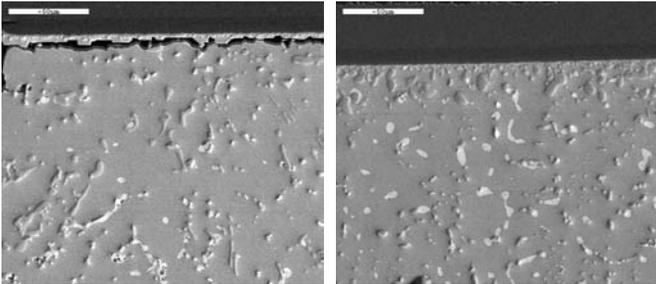
Figure XX: Microstructure of fully mixed solder joints based on SAC305 (left) and SAC405 (right), 600X Magnifications

Detailed analysis of the fully mixed microstructure following the completion of ATC shows a slight difference in the microstructure of mixed joints formed from components balled with SAC305 and components balled with SAC405. The mixed joints formed from SAC305 generally had larger grains than those formed from SAC405. In addition, the SAC305-based mixed joints had fewer intermetallic particles than the SAC405-based joints, and the intermetallics that were present in the SAC305-based joints were spaced further apart. Figure XX shows the microstructure of fully mixed joints created from SAC305 and SAC405.

Though the exact failure mechanism for the fully mixed solder joints is not known, it is thought that the finer grain size of the SAC405 based mixed joint microstructure could explain why it outperforms SAC305 based joints, as the finer structure of the SAC405 based joints would coarsen more slowly under stressed imposed by thermal cycling. The reinforcing effects of the additional intermetallic particles in the SAC405 based joints could also contribute to their improved performance.
