## **Tin Whiskering on PCBA Capacitors in Storage (Inside ESD Bag, Inside a Sealed Cardboard Box)**

Terry Munson  
Foresite Inc.  
Kokomo, IN, USA  
terrym@residues.com

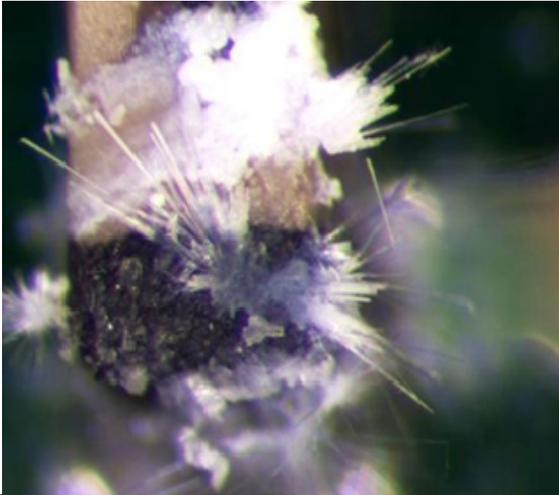
Figure 3 – Capacitor #1 with tin whiskers on power input side

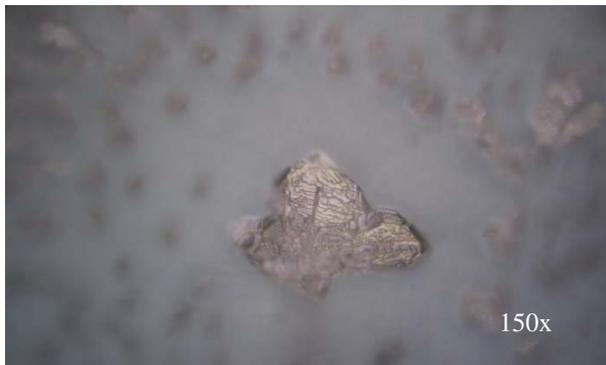
Figure 5 – Inside ESD bag surface above capacitor #2

Inside the ESD bag we see surface differences only above the direct contact points of the capacitor. It appears that the inside waxy chemical dissipation material was heated and cooled only over the capacitor.

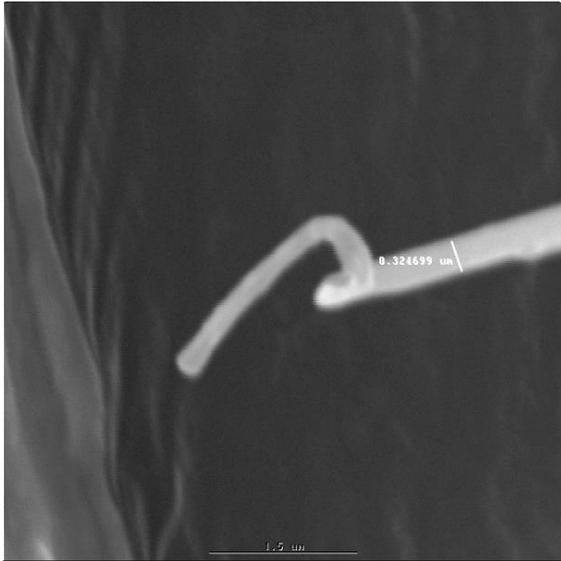
Figure 9 – SEM of whiskers removed from capacitor

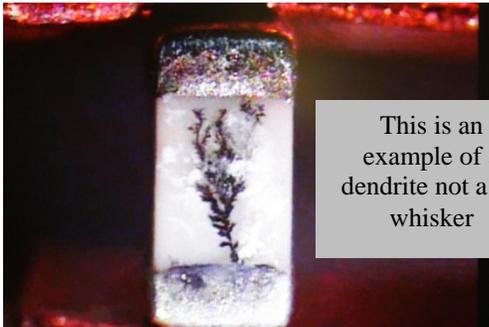
This is an example of a dendrite not a tin whisker

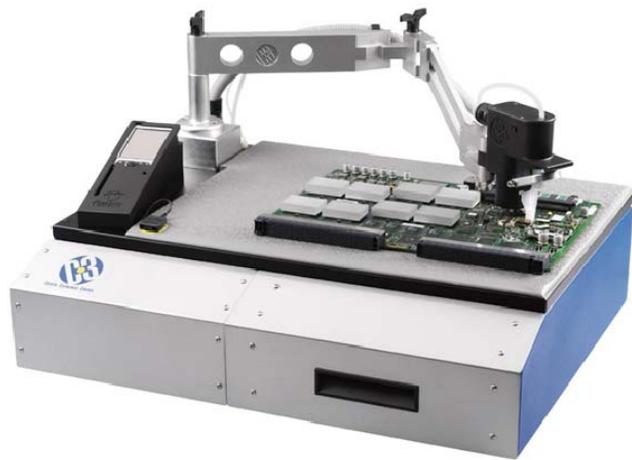
Figure 12 – C3 test system for localized extractions

To isolate the areas of the circuit board and ESD bag we used the C3 extraction and test system to determine the specific area cleanliness and electrical effect on the test electrode in solution after the extraction. Due to the small area configuration of the 0402 components we choose the smaller C3 test cell (the extraction area is the size of an 0805 chip component) which extracts a 0.02 in<sup>2</sup> area of the board surface and has an extraction volume of 2.0 mls of extraction solution.
