Materials Compatibility and Aging for Flux and Cleaner Combinations

Sandia National Laboratories

Abstract

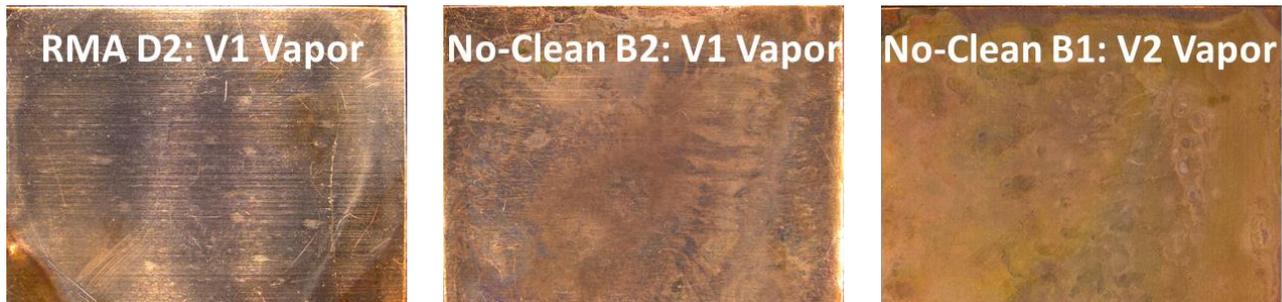
Figure 6. Best of High Temperature, no-clean flux B1 & B2 or RMA Flux D2.

In Phase 1 the least amount of damage to the metal coupons was seen when using RMA flux with added vapor degreaser fluid, which typically resulted in minor staining or residue. A slight increase in staining was noted for the higher temperature tests (Figures 5 – 6).

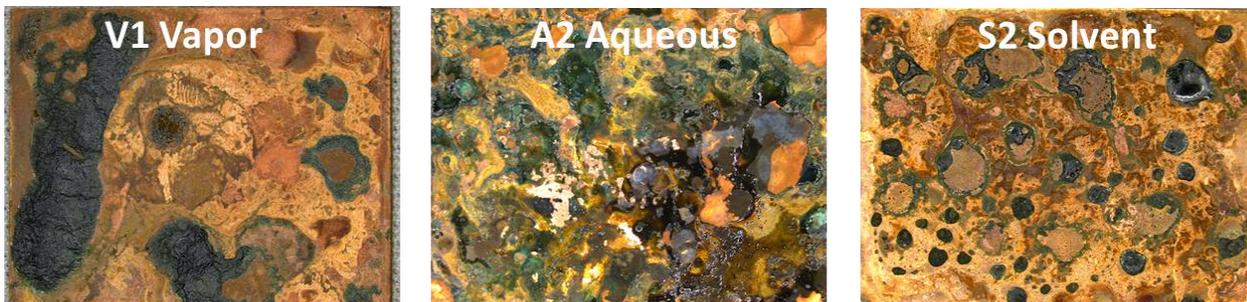
Figure 7. Worst of Low Temperature, C1 water soluble ORH1 flux.

The greatest amount of damage was seen with the ORH1 flux and, in general, the aqueous defluxers. However, solvents and vapor defluxers (as well as no cleaning) created substantial corrosion as well (Figures 7 – 9). It is noted that all coupons in Phase 1 were in aging solution stacked on one another, thus it is possible that galvanic corrosion accelerated or decelerated coupon damage. The flux C, water-soluble ORH1, and Cleaner A1 rating as seen in Figure 9-a is higher due to staining on other coupon materials. Fluxes B1 & B2, no-clean, are most dependent on cleaner for the Low Temperature tests, as seen in Figure 9-b.

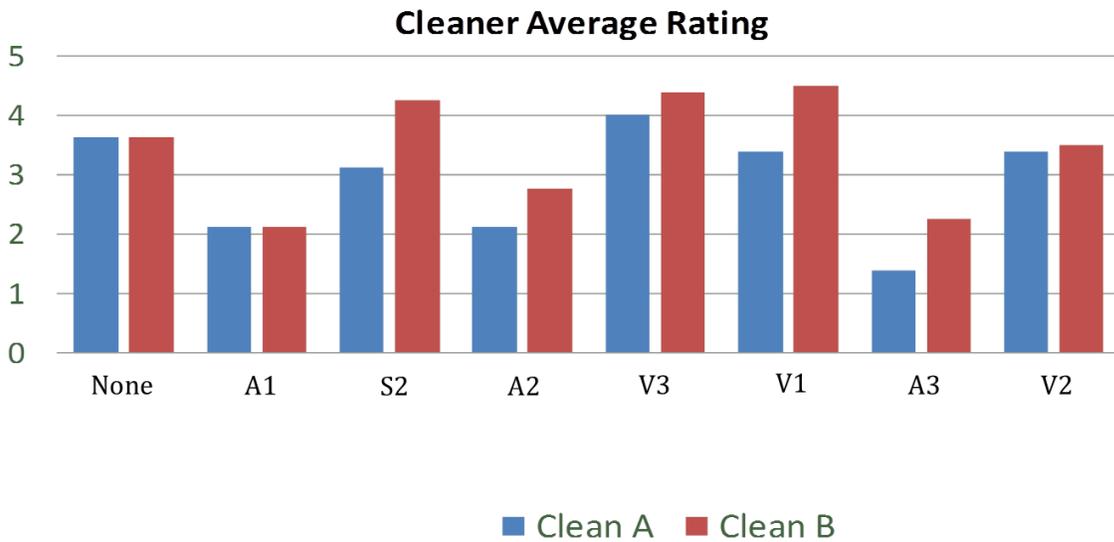
Figure 13. Average of ratings for all cleaner and flux combinations for Phase 2.

Averaging the rating values for like combinations of cleaning agents and fluxes in Phase 2, shown in Figure 13, resulted in generally best clean and least damage for the aqueous cleaning agents, with measurable increase between Clean A and Clean B for A2 and A3, but not A1.

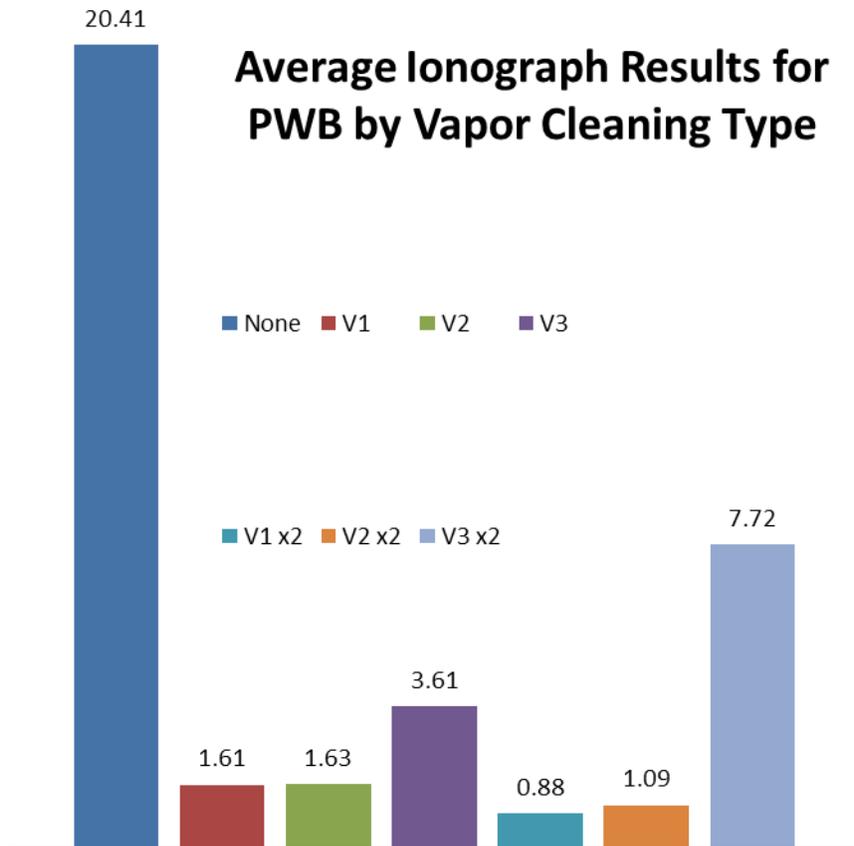
Figure 14. Printed wiring board ionic residue, in micrograms/square inch.

One set of boards was cleaned by a typical vapor cleaning, the second set cleaned with a double amount of cleaning cycles, but as seen in Figure 14, all fell below 10 micrograms per square inch of sodium chloride equivalent. The PWB double cleaned in V3 defluxer appears to have increased residue in comparison to the same cleaning done with a single cycle, which indicates the variation in the soldering and cleaning is probably on the order of the amount of residue measured. However, it is likely that as V3 showed results worse than V1 and V2 in both single and double cleaning cycles, and left visible residue on the boards (see Figure 15) that it fares least well in this comparison.

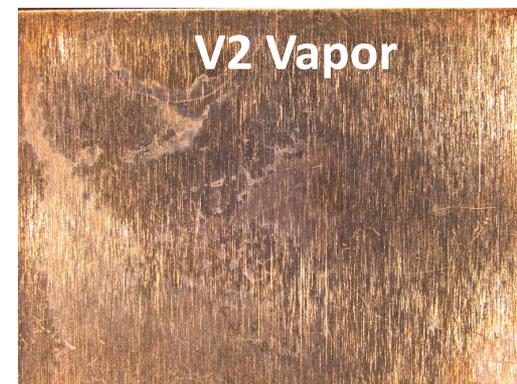
Figure 1: Best of Low Temperature; RMA flux D2 with vapor defluxers

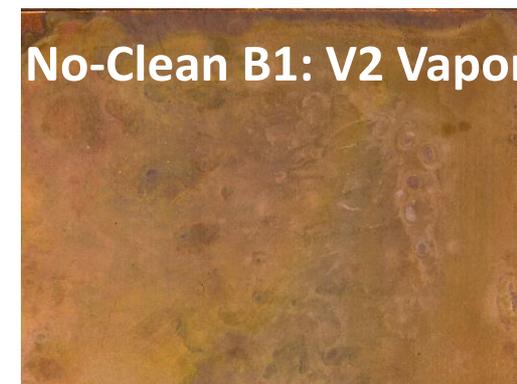
Figure 2: Best of High Temperature, no-clean flux B1 & B2 or RMA Flux D2

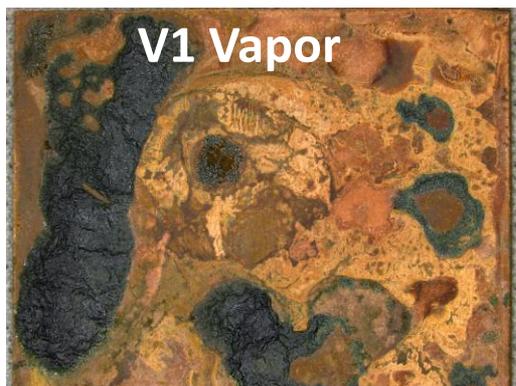
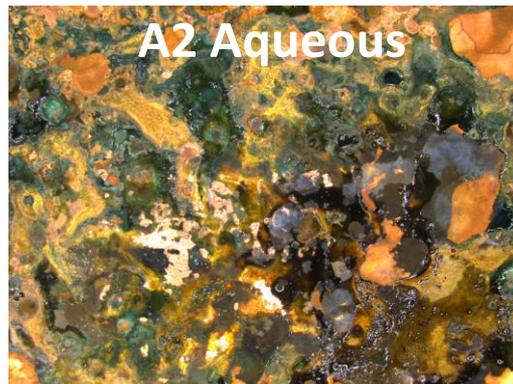
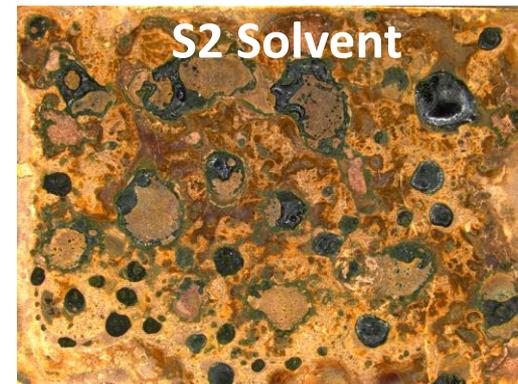
Figure 3: Worst of Low Temperature, C1 water soluble ORL1 flux

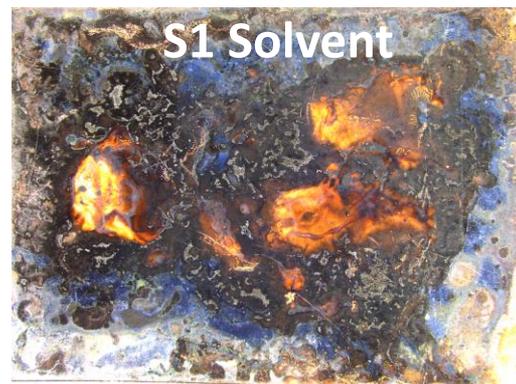
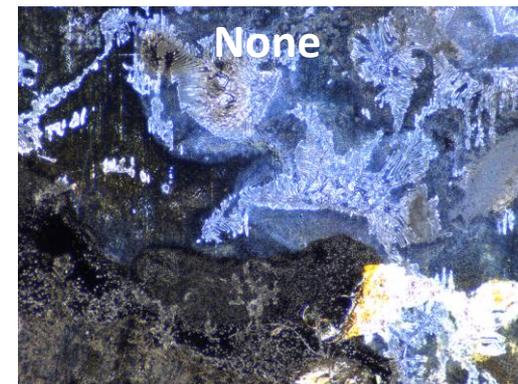
Figure 4: Worst of High Temperature, C1 water soluble ORL1 flux

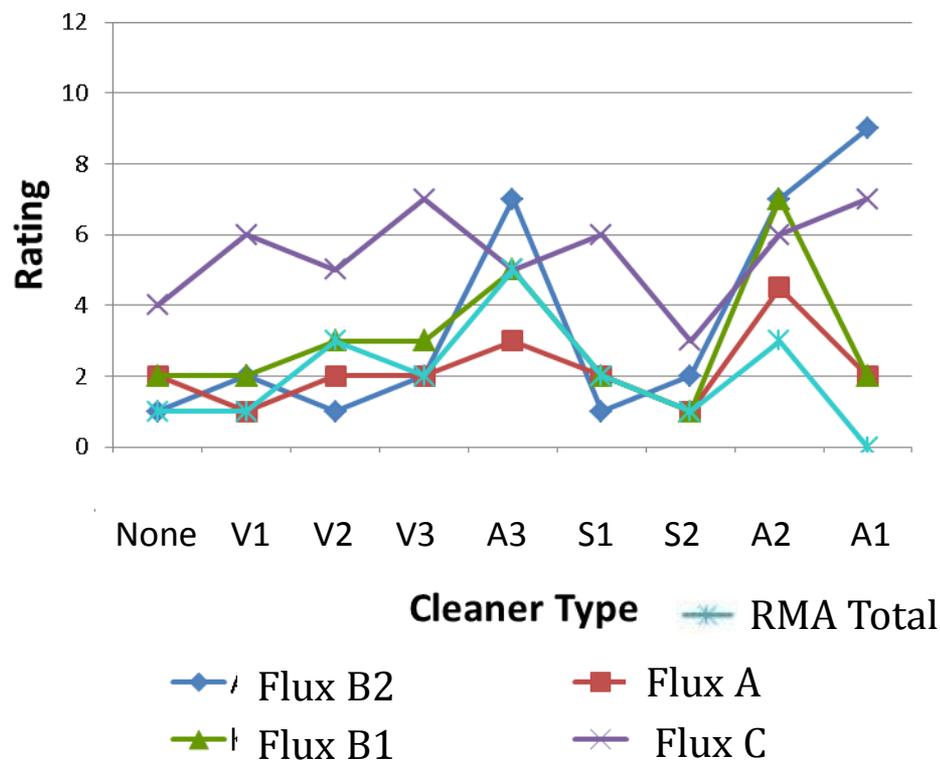
Figure 9: High Temperature

Figure 10: Low Temperature

Note: Flux C, water-sol ORH1, and Cleaner A1 rating is higher due to staining on other coupon materials

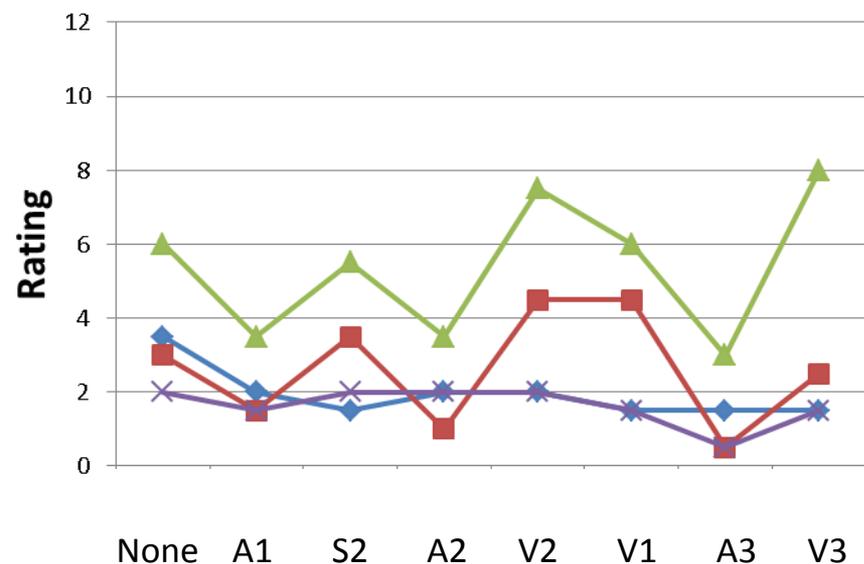
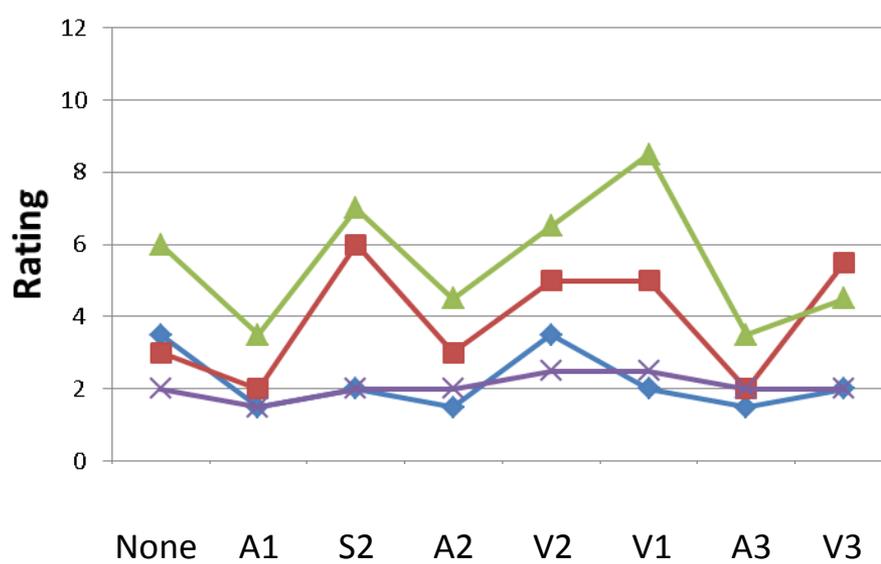
Figure 11: Clean A

Figure 12: Clean B

Note: A very minimal clean and rinse was little different from a more thorough clean and rinse, when little physical cleaning action is present (no impingement spray, etc.)

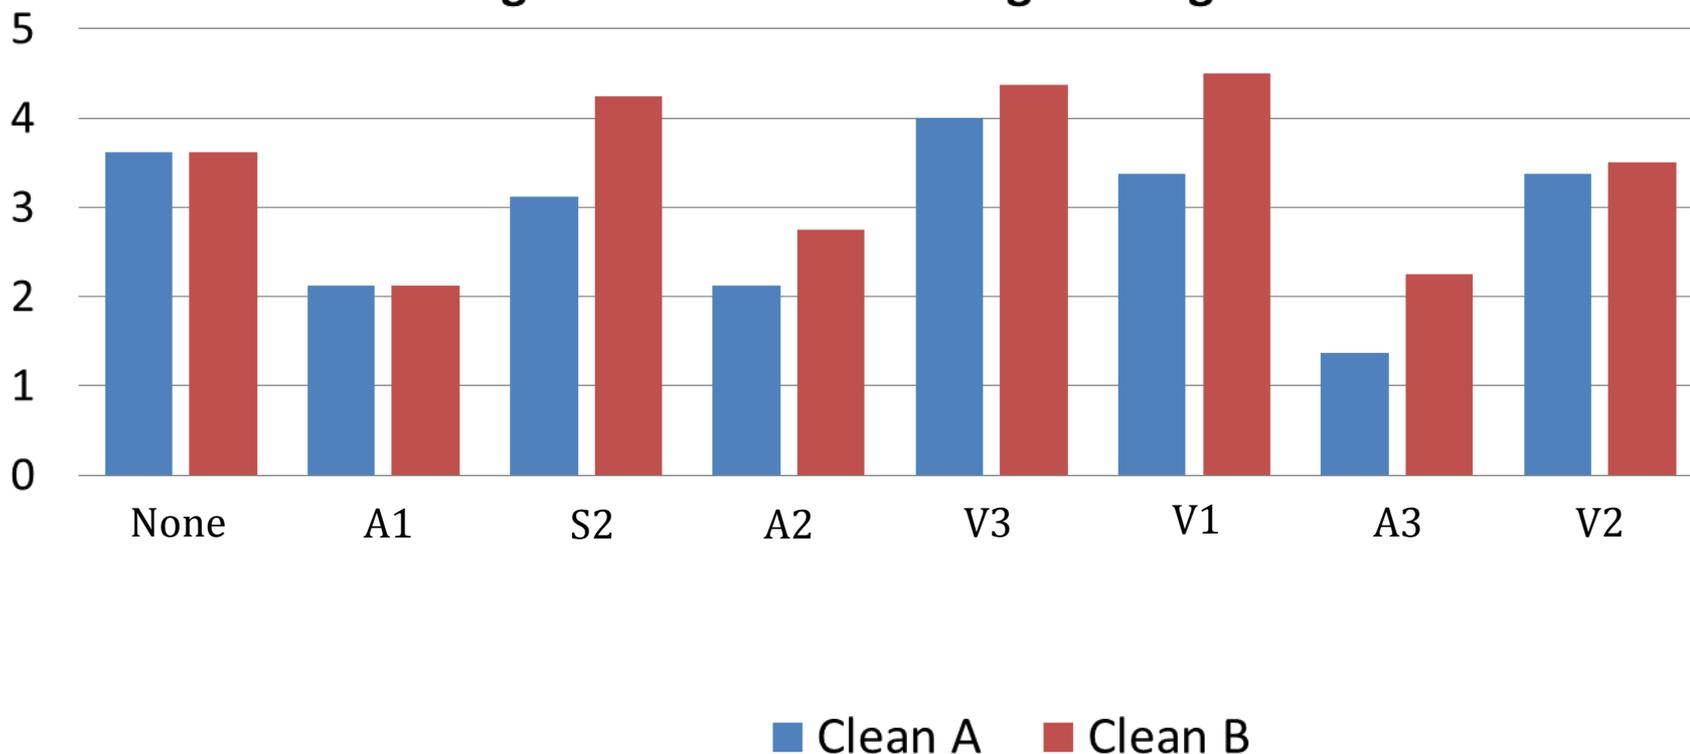
Figure 13: Cleaner Average Rating
