Interconnect Reliability Correlation with System Design and Transportation Stress

Dr. Paul Wang, Vincent Weng, and Dr. Kim Sang Chim
MiTAC International Inc.
ShunDe, China

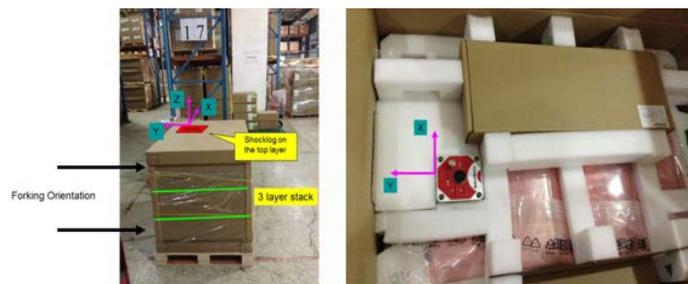
Figure 10 – A shock gravitational force measurement device is embedded in the shipping box

After the implementation of the three changes in design variables, the effect to the failure rate would need to be verified in terms of whether the system can survive during the severe shock in the transportation and handling processes. Two transportation routes from Fushan China to Sezimovo Czech Republic through China and Russia border by train then return sea trip through Mediterranean, Arabic and South China Sea. As shown in Figure 10, a shock gravitational force measurement device is embedded in the shipping box of the computer server to record the acceleration and direction of shock in real-time in large stationary or moving systems in transportation and transferring process. The data collected can be used to calculate the shock energy level ΔV . The comparison between the value of ΔV and the criterion can be used to judge whether the shock can cause poor contact problems in transportation and transferring process. At the same time the maximum temperature and humidity were measured by temperature sticker and humidity sticker as compared to the reading from the shock measuring device.

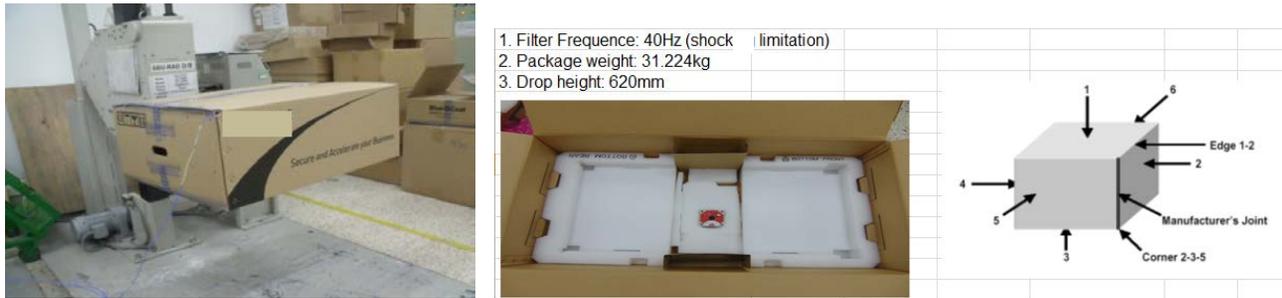
Figure 11 – Lab ten corner-edge-face multiple drop tests to emulate transportation stress

Lab drop testing with extreme condition was performed on a boxed computer server system to emulate the harsh transportation process as shown in Figure 11. Test settings are 250Hz filter frequency and drop height 610mm for the packaged weight of 16.42Kg. In the test, the accelerometer is installed in the box and used to record the acceleration and duration along X, Y and Z axis when the system is going through 10 multiple corner-edge-faces drop tests. After the lab test

The maximum shock force level along X, Y and Z in the drop test is recorded in Table 5. The maximum ΔV calculated from equation (1) is 17.09 along the Z-axis which can be used as the criteria to judge whether the shock energy level for the packaged system is out of limits in transportation and transferring processes. The data maximum g force from those two routes by train and sea are retrieved from the shock measurement device then the same computation was done as above for maximum energy levels ΔV . The maximum acceleration recorded by device from the railroad route along the horizontal xy-direction is 20g and vertical z-direction is 35g which convert to 5.46 total energy. On the other hand the maximum acceleration recorded by the device from the sea cargo route along the horizontal xy-direction is 13g and vertical z-direction is 11g which converts to 2.03 total energy. Comparing the total shock energy of railway and sea cargo to the maximum energy from the lab test indicate the package design and three design improvements are able to eliminate the contact interconnect problem and reduce the failure rate to zero.
