The Relationship between Backward Compatible Assembly and Microstructure on the Thermal Fatigue Reliability of an Extremely Large Ball Grid Array

Richard Coyle, Richard Popowich, Peter Read, and Debra Fleming Alcatel-Lucent, Murray Hill, NJ
Raiyo Aspandiar, Alan Donaldson, and Vasu Vasudevan, Intel, Corporation, Hillsboro, OR
Iulia Muntele, Sanmina-SCI Corporation, Huntsville, AL
Stephen Tisdale, Intel, Corporation, Chandler, AZ
Robert Kinyanjui, formerly of Sanmina-SCI Corporation, Huntsville, AL

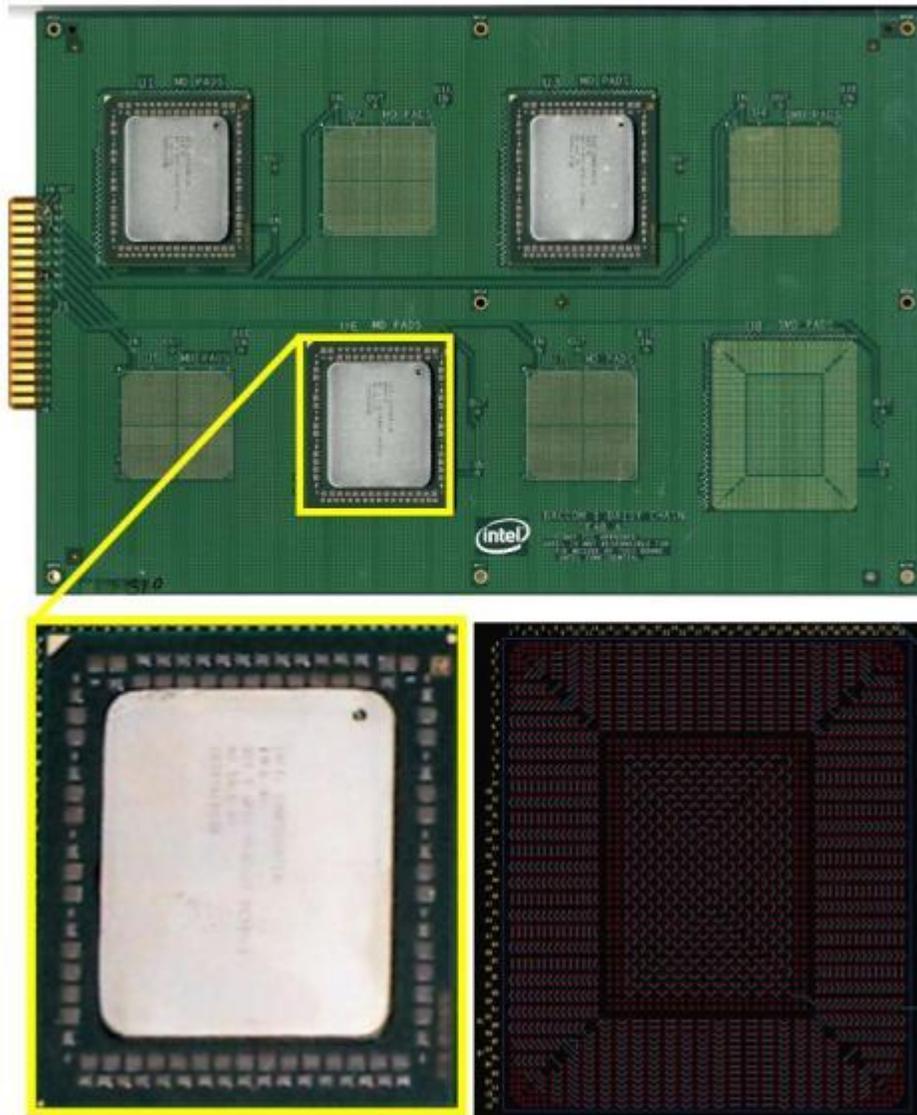
Figure 1: Populated daisy chained test board, top view of large body-BGA and BGA pin diagram.

The detailed package test vehicle attributes for the large-body BGA test vehicle are listed in Table 1. The populated printed circuit board test vehicle and the BGA pin diagram are shown in Figure 1. This is an 8 layer test board with dimensions 12 inches x 8 inches x 0.093 inches (305 mm x 203 mm x 2.36 mm). The board contains two different component footprints but only the larger one (51.0 mm x 59.5 mm, 3162 ball count) is used in this study. The test board contains component sites with either metal defined (MD) or soldermask defined land patterns (SMD) but only the sites with MD lands are used in this study. The MD lands are 17 mils in diameter and the surface finish on the test vehicle is organic solderability preservative (OSP). There is one daisy chain net for each land pattern. A number of lands on and near the corner areas as well as similar corner sites at the die shadow of the land patterns are not connected within the daisy chain. Typically these corner ball locations are not electrically functional on comparable product packages that use this design and are termed non critical to function (NCTF). Daisy chain nets from each of the components patterns are routed out to a card edge connector and soldered connections are used to monitor the resistances of the daisy chain nets during temperature cycling.

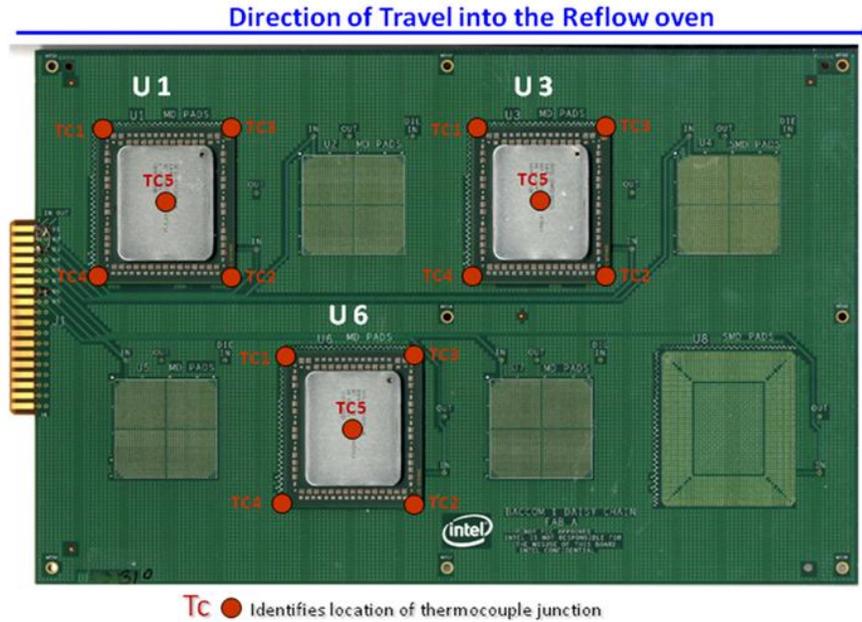
Figure 2: A schematic of the reflow profile development board showing the thermocouple locations.

As mentioned above, the experimental strategy for this work entailed three legs, a partial Pb mixing leg, a full Pb mixing leg and a lead-free leg that acts as the control leg. A thermocouple board was prepared to develop the reflow profiles that can enable these levels of Pb mixing. The schematic of this thermocouple board is shown in Figure 2. Thermocouples were attached to all three BGA sites (U1, U3, and U6) populated with the package TV. Each package TV had five thermocouples attached, one at each of the four corners (TC1, TC2, TC3, and TC4) and one at the center (TC5). Each of these thermocouples had fine tips (diameter = 0.005 inches) and were placed at the center of solder joint by drilling from the bottom side of the test board. The direction of travel of the test board through the reflow oven is also shown in Figure 2.

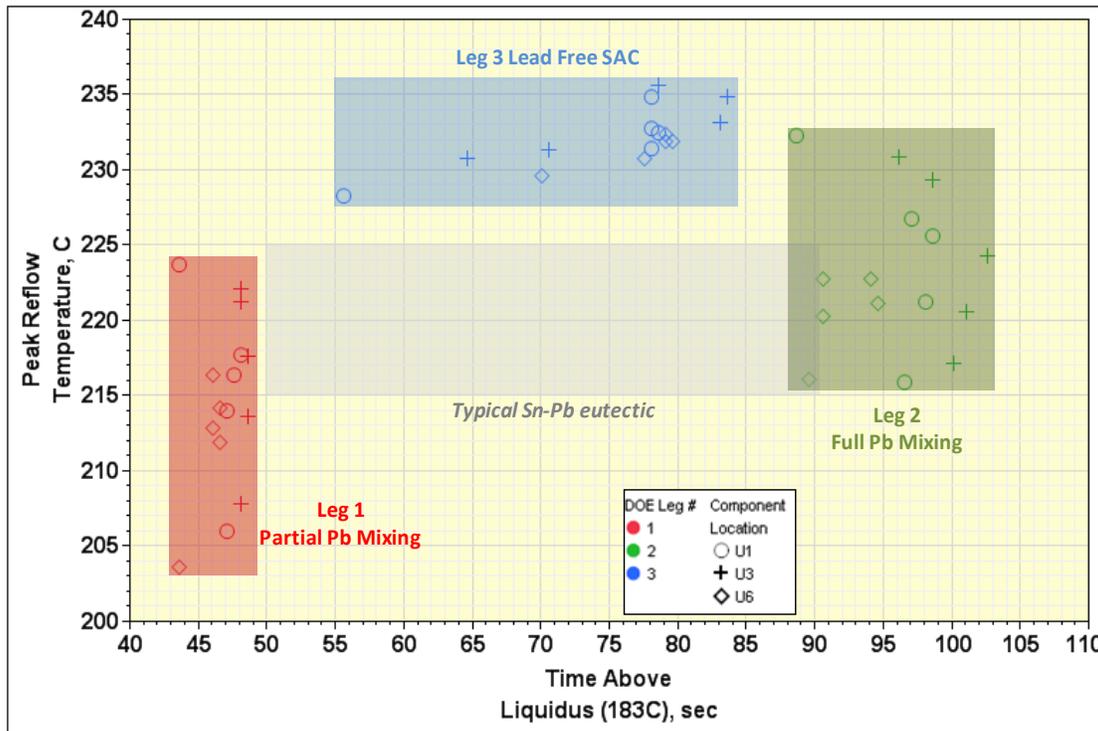
Figure 3: Reflow profile windows for the three Legs of the DOE using three package test vehicles on the test board

from Figure 3 that both the Leg 1 and Leg 2 reflow profile windows are outside the typical Sn-Pb eutectic soldering reflow window used in the industry.

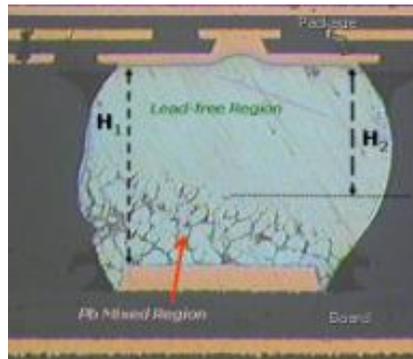
Figure 4: Photomicrograph of a partially mixed alloy solder joint illustrating the Pb mixing level calculation.

Figure 4 defines H1 and H2. H1 is the distance from the top of the package land to the top of the board land and is essentially the solder joint height or standoff. H2 height is calculated by measuring the distance from the top of the package land to the average height location of the Pb-mixed region.

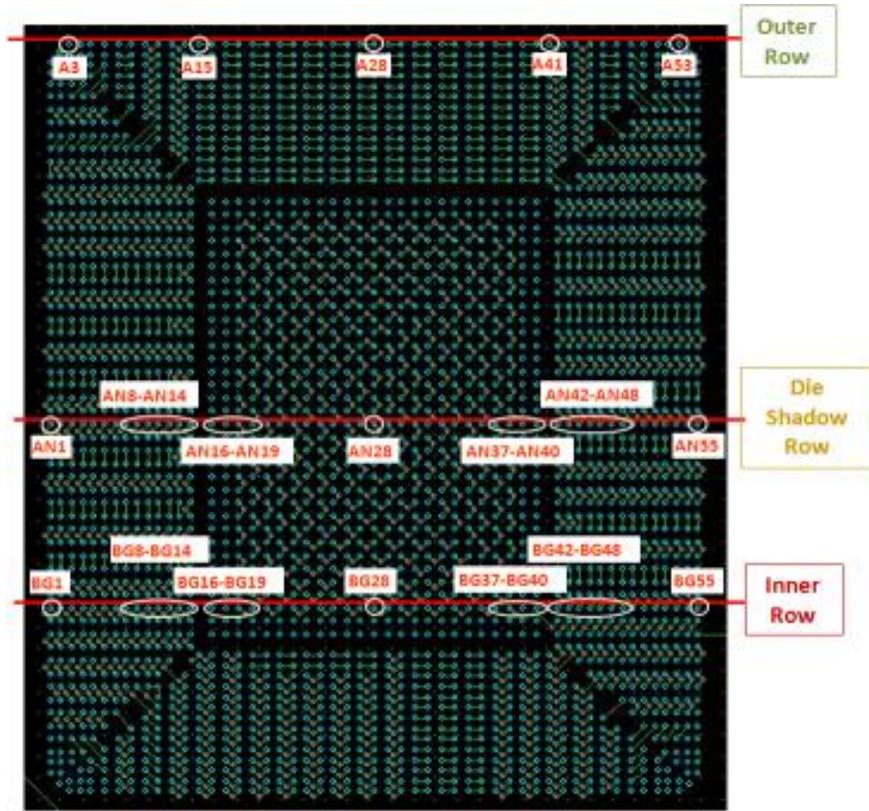
Figure 5: Ball map of the BGA package test vehicle showing the location of the three cross-section cuts as well as the ball numbers of the solder joints whose %Pb mixing levels were measured after polishing the cross-sections

To determine the Pb mixing in the solder joints of the assembled board test vehicle, solder joints of the BGA package test vehicle assembled on all three locations (U1, U3, and U6) on the board test vehicle were cross-sectioned. Figure 5 indicates the locations of the three cross-section cuts on the ball map of the BGA package. These three cuts, which were performed on each assembled package on reflow profile validation boards, are identified as the a) outer row, b) the die shadow row, and c) the inner row in this figure. After polishing, specific solder joints in each cross-section, as indicated by the ball numbers in Figure 5, were inspected using an optical microscope and the %Pb mixing measured as explained in Figure 4.

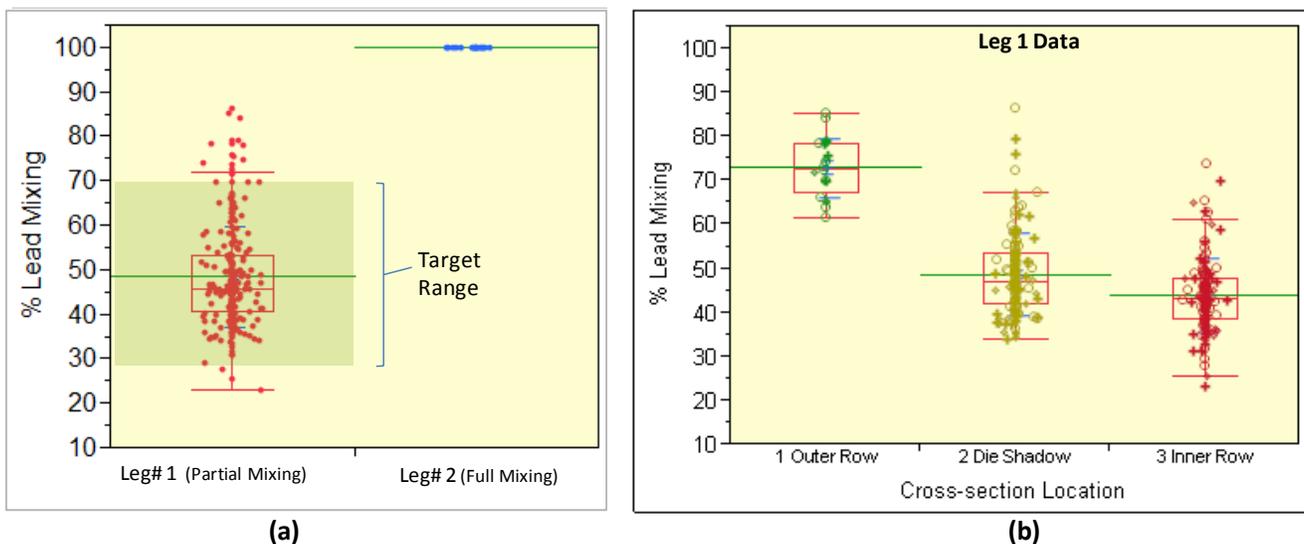
Figure 6: (a) Comparison of % Pb mixing in the solder joints for Leg 1 and Leg 2; (b) comparison of % Pb mixing in Leg 1 solder joints at outer row, die shadow row and inner row cross-section cut locations

The wide range in %Pb mixing in Leg 1 requires further investigation. Figure 6b shows the box plots for %Pb mixing in the solder joints with the location within the package where the cross-section cut was made. As is apparent in this figure from the box plots, the levels of %Pb mixing decrease and their range of values increases as the location of the cross-section cuts moves from the outer row towards the interior of the package, i.e., first the die shadow row and then the inner row. A closer look at the profile of the %Pb mixing values across these rows indicates the reason for these trends.

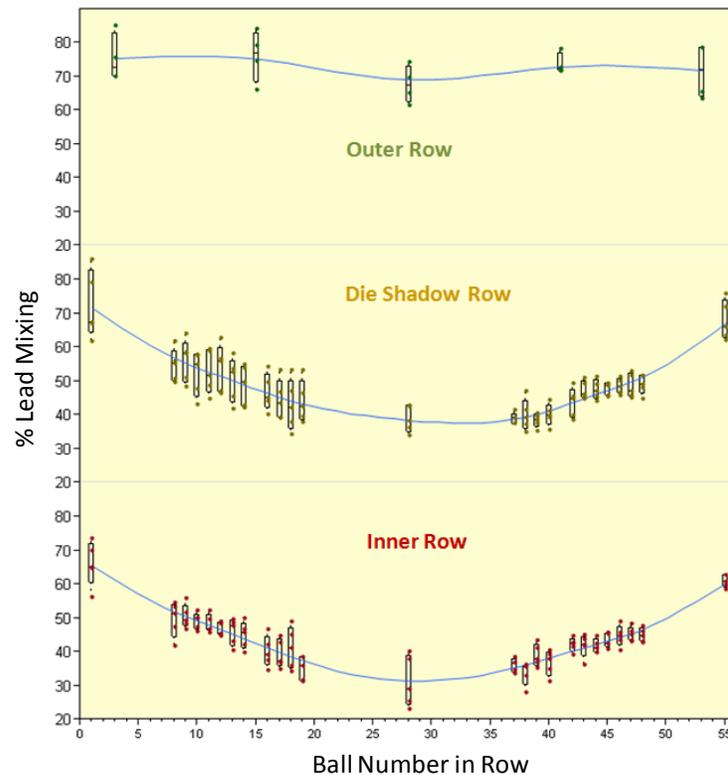
Figure 7: Plots showing the variation of the %Pb mixing in the BGA solder joints across the solder balls in the three cross-section cuts made at various locations on a total of six package test vehicles assembled for Leg 1.

Figure 7 shows the variation in % Pb mixing within BGA solder joints that was measured across solder balls in three cross-section cuts made at various location on 6 package test vehicles which were assembled using Leg 1 reflow profile parameters. The upper plot is for the cross-section cut on the outer row, the middle plot is for the cross-section row on the die shadow row and the lower plot is for cross-section on the inner row. The locations of these three rows with respect to the ball map of the BGA package can be seen in Figure 5 above.

Figure 7 clearly illustrates the wide variation in the %Pb mixing across the solder joints of the large BGA package test vehicle under evaluation. The outer row has a fairly uniform distribution of the %Pb mixing in the solder joints across its entire length. The die shadow row and inner row have, in contrast, a non-uniform distribution of the %Pb mixing across the solder joints in those rows. The solder joints in the middle of the rows, those that are under the die or close to the central location of the package body, have a significantly lower %Pb mixing (in the 25-50% range) than those on the edges of the rows, close to the edge of the package body. As expected, the %Pb mixing levels in the inner row towards the central part of the package are slightly lower than those in the die shadow row.

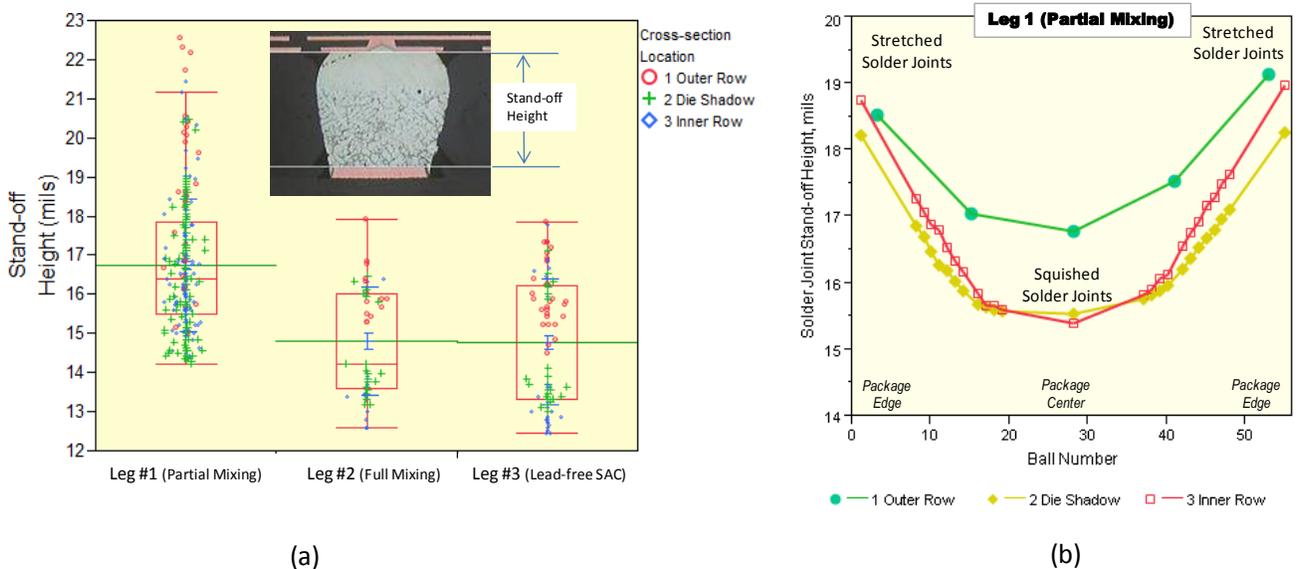
Figure 8: (a) Stand-off heights of the BGA solder joints for all three Legs of the experiment; the inset micrograph depicts the measurement of the stand-off height. (b) Variation of the stand-off heights of the BGA solder joints for Leg 1 (Partial Pb mixing) assemblies across the outer, die shadow and inner rows.

Figure 8b shows the variation of the solder joint stand-off heights across the three cross-sectioned rows, an outer row, an inner row and a die shadow row, indicated on the ball map of the package test vehicle in Figure 5. This plot is for Leg 1 (partial mixing) assemblies only. Each data point in this graph is a mean of the stand-off height for the same ball numbers from six packages across two assemblies. The reason for the wide range in the stand-off heights is apparent from this plot. Due to the dynamic warpage characteristics of the package test vehicle the solder joints on the outer rows are stretched with tall stand-off heights, whereas those in the inner rows, particularly within the center of the package are compressed (squashed) with short stand-off heights.

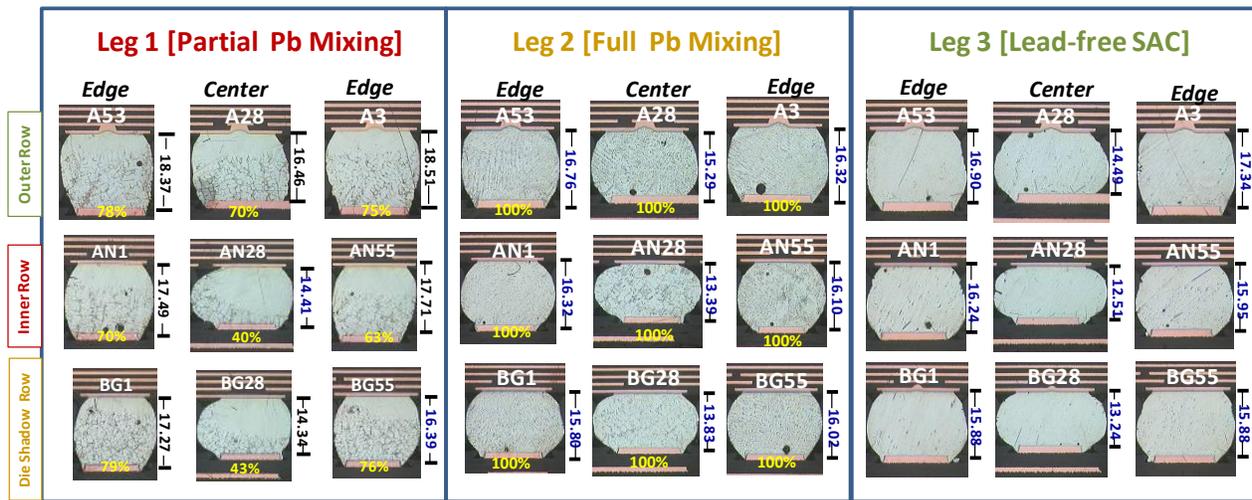
Figure 9: A collection of typical single solder joint micrographs for from each of the three legs, and for each of the three cross-section cut locations. Ball numbers, %Pb mixing levels and stand-off height in mils for each solder joint are also listed.

Figure 9 is a compendium of single solder joint micrographs from each of the three legs, for each of the three cross-section cut locations (outer row, inner row, die shadow row). The variation of the solder joint stand-off heights are apparent with the center solder joints compressed whereas the edge solder joints are stretched, especially in the inner and die shadow rows. The variations in the leg mixing levels are also apparent, with Leg 1 having partial Pb mixing with this level varying from edge to center and from row to row. Leg 2 has full Pb mixing for all solder joint locations on all rows.

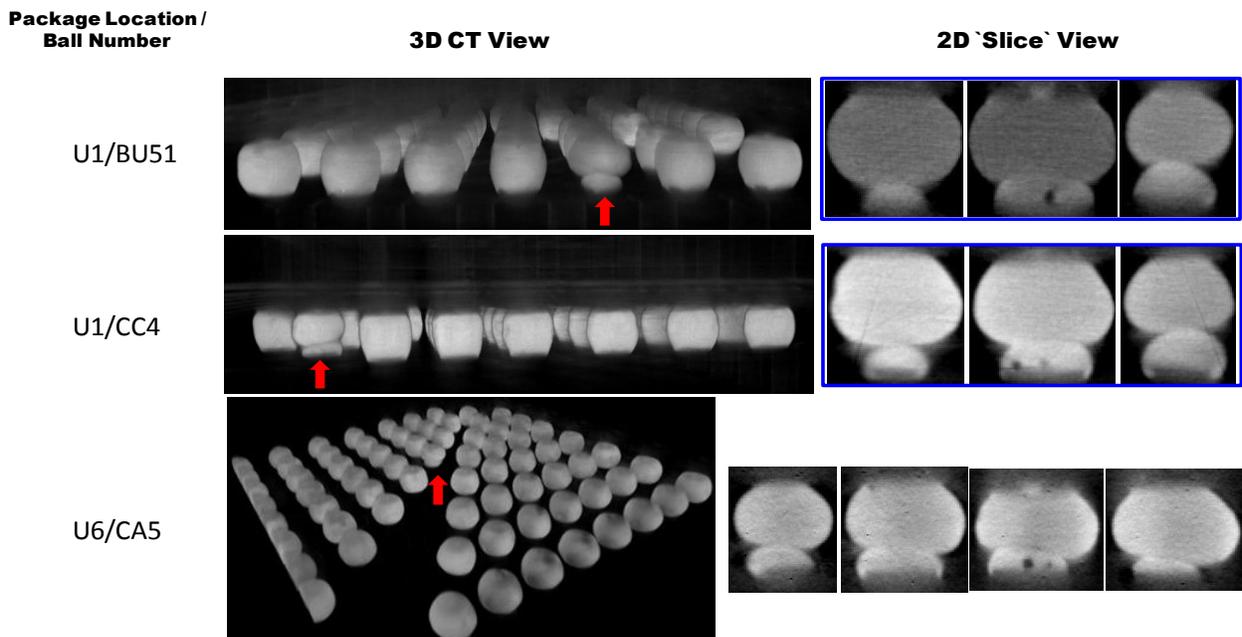
Figure 10: 3D CT and 2D slice X-ray images depicting Head-on-Pillow (HoP) defects at three solder joint locations for one Leg 3 (Lead-free SAC) board.

To confirm this, two package locations on a single board that exhibited the early failures were analyzed using 3D Computer Tomography (CT) X-ray technique. This technique enables detection of solder joint quality issues without destructive cross-sectioning of the sample. Figure 10 shows the X-ray images obtained from two assembled packages on a Leg 3 (Lead-Free SAC) board that had early failures. The images in the top two rows are for two different solder joints from the same package location on the board. The bottom row images are from another package location on the same board. In all three cases, the head-on-pillow defect signature is clearly visible. The left images are in 3D view with multiple solder joints visible. The right images are various slices of the single solder joint that had the defect. This analysis confirmed that the HoP defect was the root cause of the early failures during the accelerated thermal cycling tests for these boards.

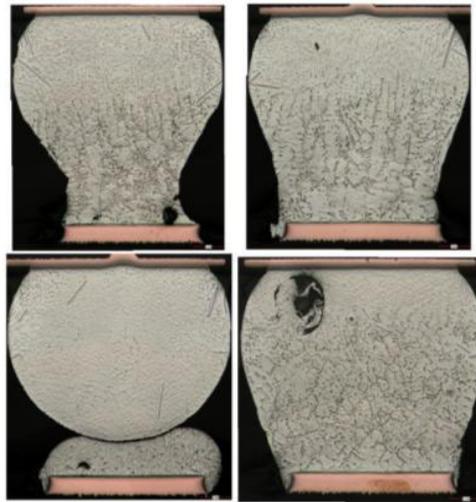
Figure 11: Optical photomicrographs of a temperature cycled Leg 1 BGA test vehicle showing examples of necked-down and stretched solder joints and a head-on-pillow defect that resulted in an early failure condition.

The data for Pb mixing solder standoff, and warpage presented previously in the process characterization section exemplify the assembly challenges inherent to this large BGA package. These assembly challenges are reflected in the thermal cycling results shown in Table 2. A total of 15 early failures were reported and in most cases, the failures occurred within the initial five cycles of the testing. A comparison of censored vs. uncensored sample sizes in Table 2 shows that a number of early failures occurred in each of the three test cells (Legs 1, 2, and 3). The root cause of the early failures was determined through metallographic cross sectional failure analysis. The optical photomicrographs in Figure 11 show the source of the open circuit failure, a head-on-pillow (HoP) defect [52], as well as stretched solder joints resulting from dynamic warpage of the BGA package. These failures are not surprising given the wide range of assembly quality shown in Figures 8-10.

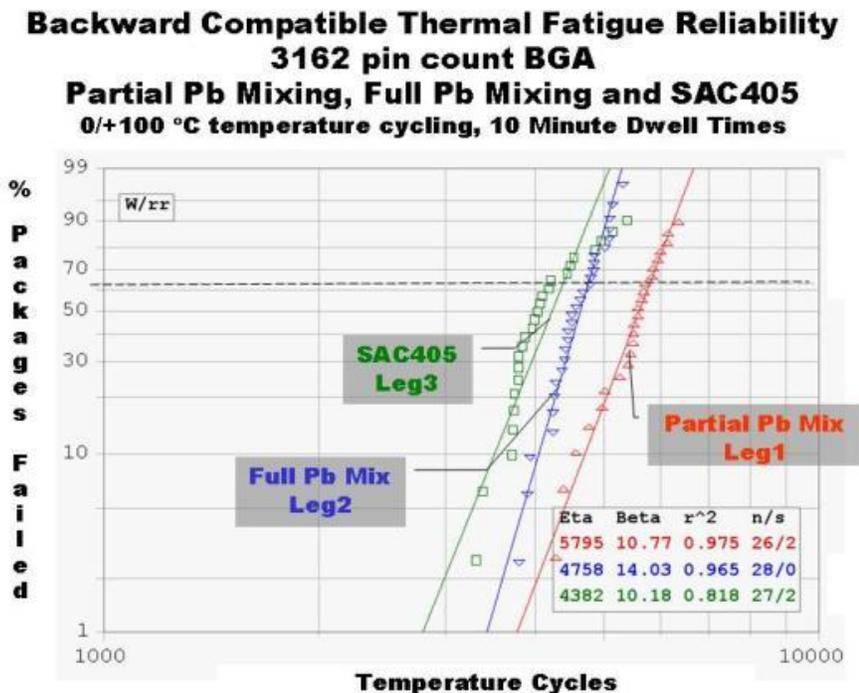
Figure 12: Weibull plot comparing the temperature cycling performance of mixed alloy Leg 1 (partial Pb mixing) and Leg 2 (full Pb mixing) and the Pb-free Leg 3 (SAC405, no Pb mixing).

The temperature cycling data for the 3162 ball count BGA test cells are summarized in Table 2 and presented in the Weibull plot in Figure 12. The Weibull plot presents only censored data, with the early, non-fatigue failures removed. The parameter used to assess the reliability or thermal fatigue performance is the Weibull characteristic fatigue lifetime (η). For these three test cells, the Leg 1 Partial % Pb Mixing cell has better reliability than either the Leg 2 Full Pb Mixing cell or the completely Pb-free SAC405 cell. Additionally, the full Pb mixed cell (Leg 2) has approximately 10% better reliability than the SAC405 Pb-free cell (Leg 3).

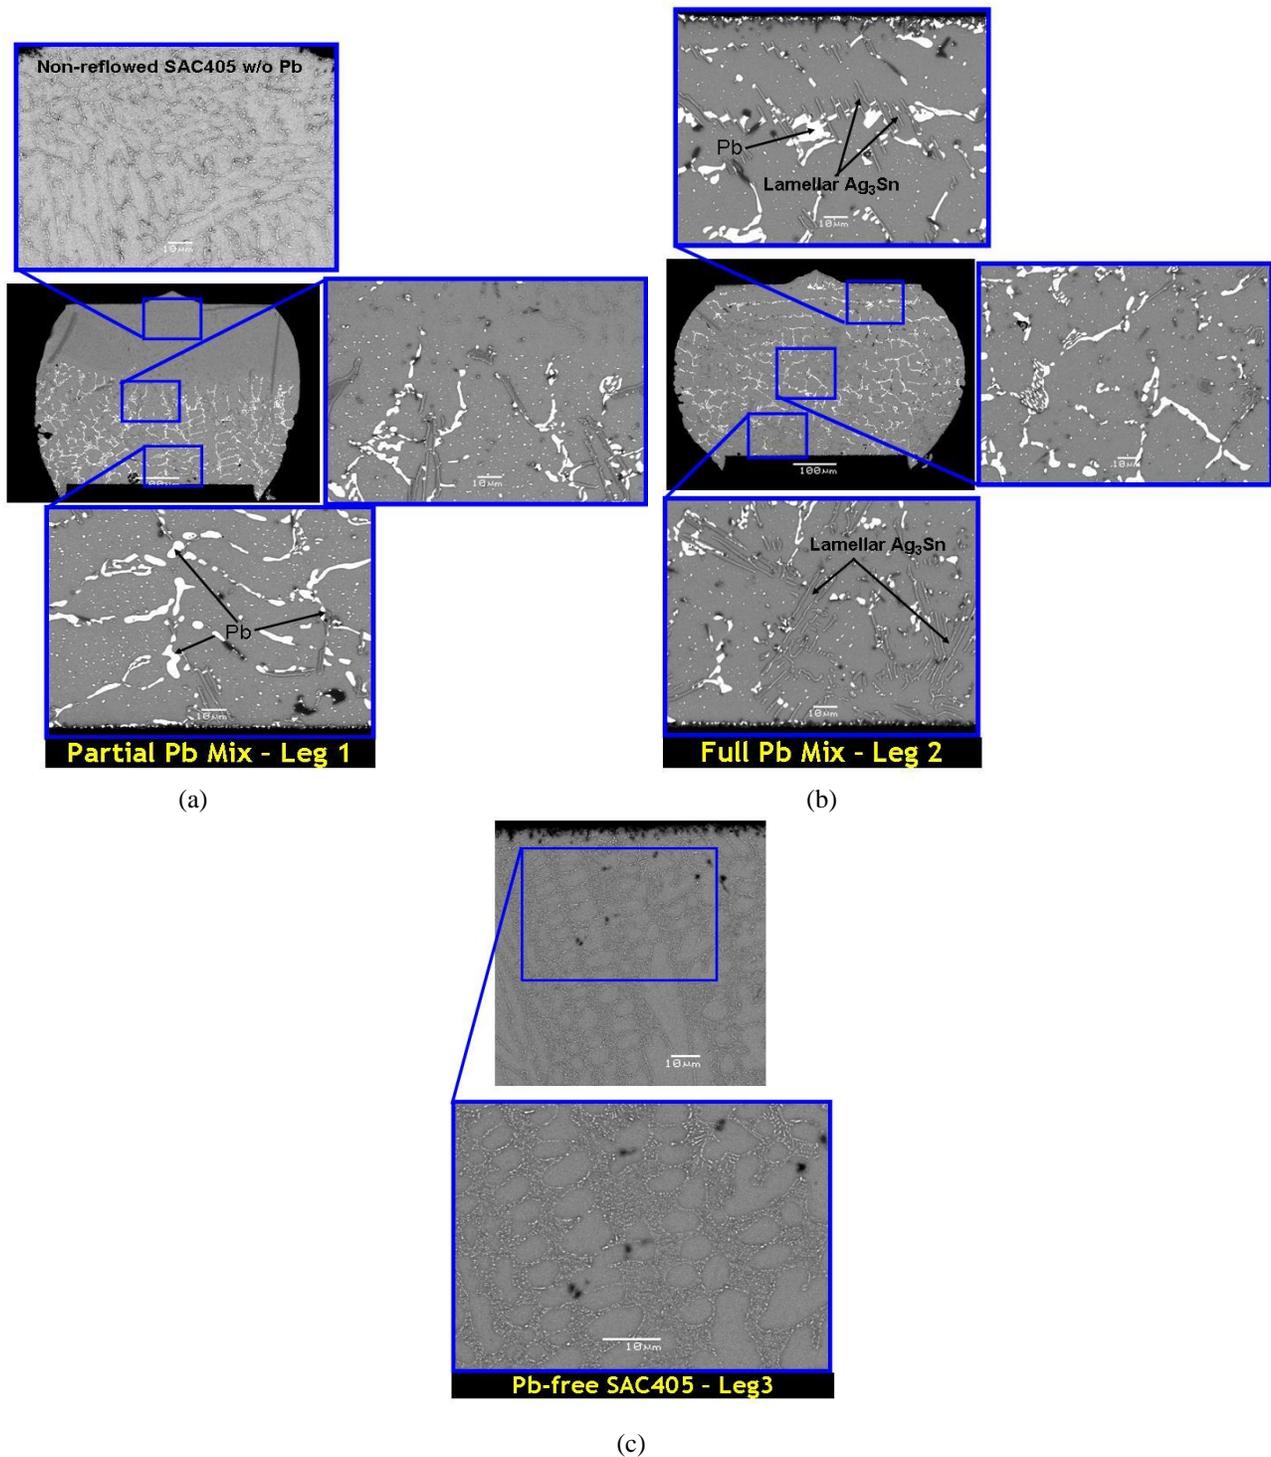
Figure 13: Backscattered electron (BEI) images of the baseline microstructures for typical BGA samples from each of the test cells used in the mixed alloy accelerated temperature cycling study.

Figure 13 shows a number of backscattered electron images (BEI) of the baseline microstructures for typical BGA samples from each of the test cells used in the mixed alloy accelerated temperature cycling study. In the backscattered mode, the dense, Pb-rich phase has a bright white appearance. Figure 13a shows details of the partially mixed microstructure (Leg 1) that results from assembly using a SnPb soldering profile with a short TAL and a peak temperature slightly below the Pb-free solder melting point. The Pb has mixed upward through approximately 25-80% of the height of the solder ball, depending on its location in the package (see details in Figures 7 and 9). In the upper region of the solder ball (package side) where the fatigue cracks tend to propagate, the SAC microstructure (without Pb) is more typical of the microstructure found in an as-received BGA before surface mount assembly. The SAC solder in this region did not melt during the surface mount reflow process. The microstructure consists of small primary Sn cells surrounded by regions where the binary Sn-Ag eutectic decomposition has produced dense networks of very fine Ag_3Sn intermetallic particles.

Figure 13b shows the full Pb mixed microstructure (Leg 2) that results from assembly with a SnPb solder profile using longer TAL and temperature slightly above the Pb-free soldering melting point. The Pb from the solder paste is distributed throughout the SAC solder ball during reflow, extending upwards from the PCB pad to BGA pad side of the solder joint. This is characterized as a fully mixed condition but the Pb-bearing constituents are not distributed homogeneously throughout the solder joint. The SAC microstructure again consists of primary Sn grains with Ag_3Sn intermetallic particles at the cell boundaries. However, in this case the Ag_3Sn intermetallic particles have a lamellar, rather than equiaxed morphology. This intermetallic morphology is also found in the reflowed region of Leg 1 and appears to result from using a SnPb assembly profile.

Figure 13c shows the microstructure of the pure Pb-free SAC405 (Leg 3) test cell created with a Pb-free soldering profile using a peak temperature of approximately 240 °C. The pure Pb-free Leg 3 microstructure qualitatively is similar to the microstructure of Leg 1 shown in Figure 13a with primary Sn cells with Sn-Ag eutectic decomposition at the boundaries. The major microstructural difference is that Leg 3 has a lower the density of Ag_3Sn intermetallic particles and the intermetallic particle size is larger.

In these samples, unlike some of the non-optimum solder joints cited in Figure 9-11, the extent of solder melting and mixing has resulted in reasonable solder joint quality. The mixed alloy solder ball collapse is comparable to the pure Pb-free collapse, the solder joints are well-formed, and there is no excessive segregation of Pb in the mixed regions.

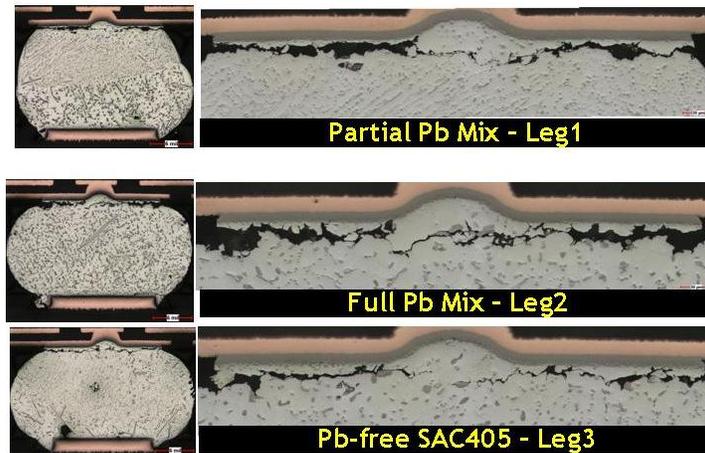
Figure 14: Optical photomicrographs of BGA solder joints from Legs 1, 2, and 3 that have failed by thermal fatigue during accelerated temperature cycling.

Figure 14 shows optical photomicrographs of failed solder joints from the ATC testing. All failures have the characteristic intergranular fracture along Sn boundaries that is seen routinely in SAC fatigue failures and is consistent with those reported much earlier by workers such as Dunford [53]. The fractures in both the partially mixed (Leg 1) and full mixed (Leg 2) samples also resemble SAC fractures because the cracks propagate along Sn boundaries, regardless of the presence of Pb, in the same manner as in the Pb-free sample (Leg 3) [49].

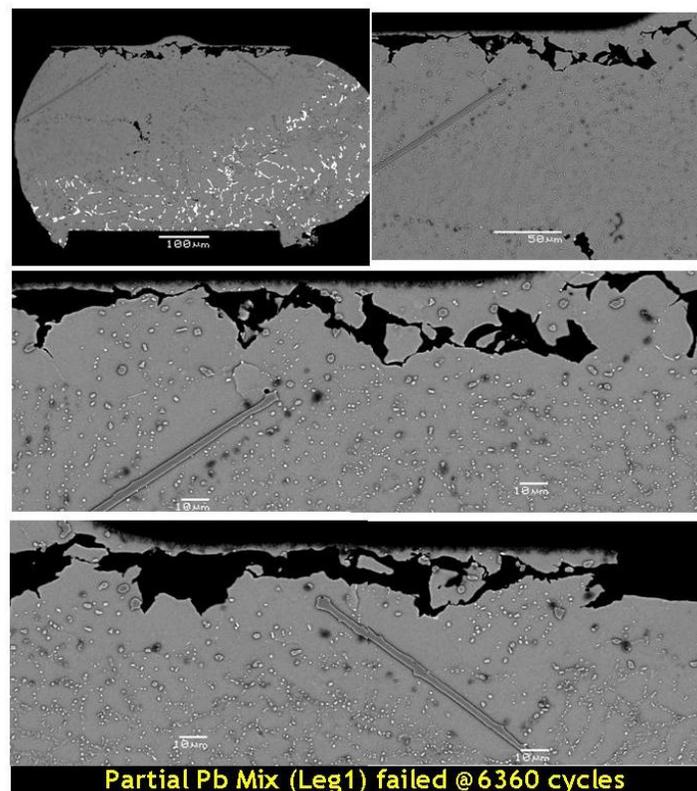
Figure 15: Backscattered electron (BEI) images of a Partial Pb Mix, Leg 1 sample that failed in ATC at 6360 cycles. The fatigue failure occurred at the package side of the solder joint at a significant distance from the region of Pb mixing.

Figure 15 shows backscattered electron images of a Leg 1 sample that failed in thermal cycling. Although the initial microstructure had approximately 50% Pb mixing, Pb did not influence the failure because cracking occurred in the upper, Pb-free region (see baseline microstructure in Figure 13a). The higher magnification images show accelerated coarsening of the Ag_3Sn intermetallic particles in the strain-localized region of the solder joint where crack propagation occurs. This pattern of microstructural evolution is characteristic of the thermal fatigue failure process in these Pb-free alloys [54] and was first reported by Dunford in 2004 [53]. The coarsening process is slower in the region below the fatigue crack because it is only driven thermally with a minimal contribution due to strain.

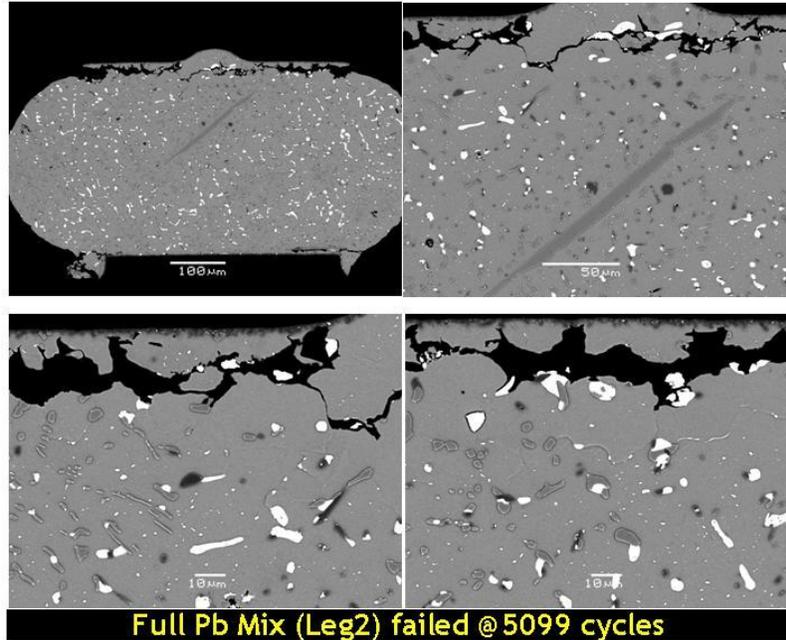
Figure 16: Backscattered electron (BEI) images of a Full Pb Mix, Leg 2 sample that failed in ATC at 5099 cycles.

Figure 16 shows backscattered electron images of a Leg 2 sample that failed in thermal cycling. The higher magnification images show coarsening of the lamellar Ag_3Sn intermetallic particles in the strain-localized region of the solder joint where crack propagation occurs. The lamellar morphology remains intact outside the strain-localized region. The crack propagation

path is intergranular along Sn boundaries, as seen routinely in SAC fatigue failures. There are some Pb particles along the crack path but it is difficult to ascribe a negative affect to the presence of Pb since Leg 2 outperformed the Leg 3, Pb-free SAC405 test cell (Figure 12).

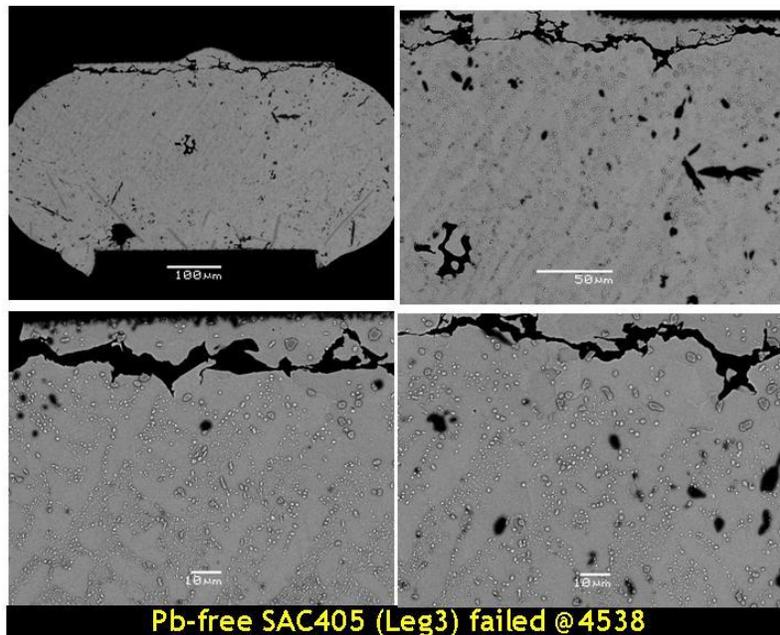
Figure 17: Backscattered electron (BEI) images of a Pb-free SAC405, Leg 3 sample that failed in ATC at 4538 cycles.

Figure 17 shows backscattered electron images of a Leg 3 sample that failed in thermal cycling. As expected, the higher magnification images show Ag_3Sn intermetallic particle coarsening in the strain-localized region of the solder joint and intergranular crack propagation along Sn boundaries.

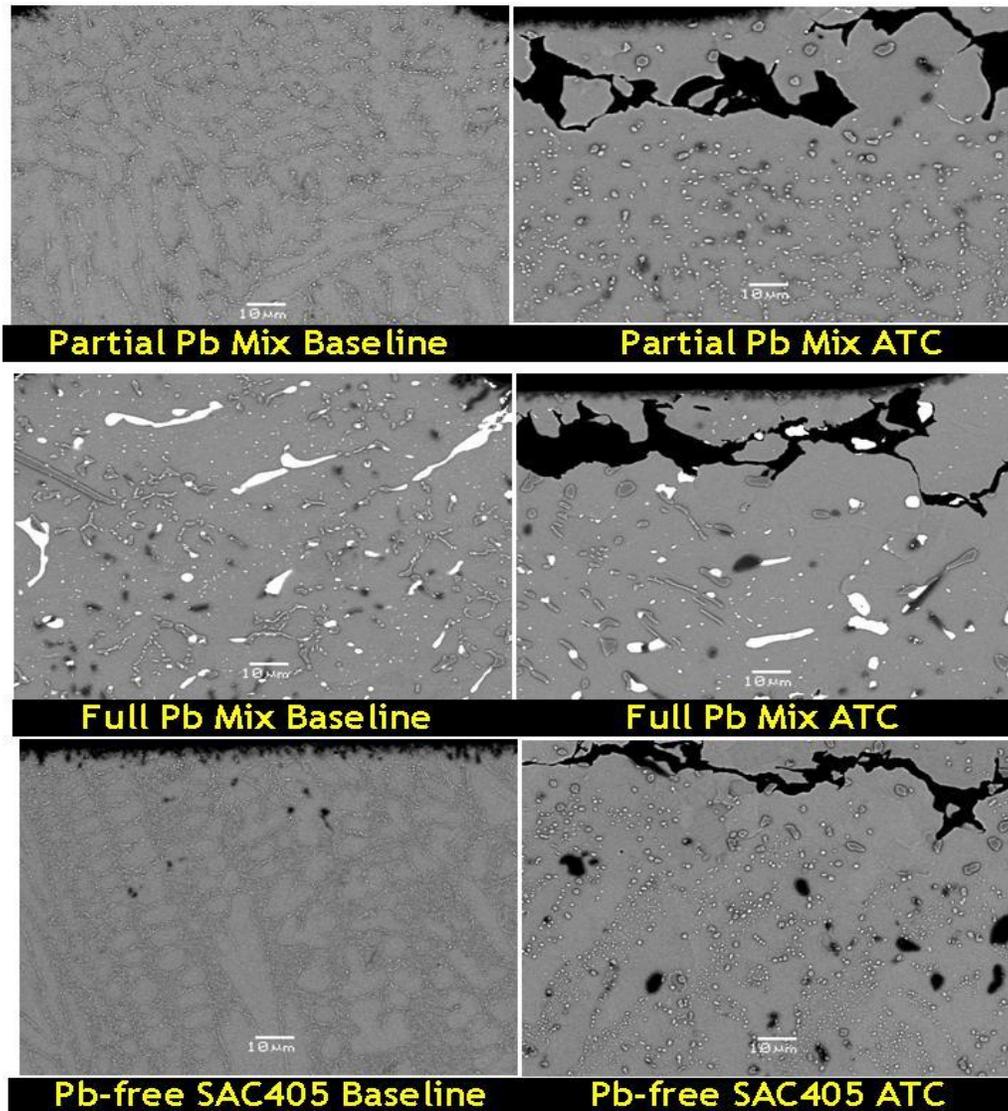
Figure 18: Backscattered electron (BEI) images comparing the baseline SAC microstructures and the microstructures after thermal cycling (ATC) for each of the three test cells.

controlled more by the characteristics and properties of the underlying Pb-free (SAC) microstructure than by the Pb content added during assembly [49]. Figure 18 shows the underlying baseline SAC microstructures and the microstructures after thermal cycling for the three test cells. Since Legs 1 and 3 both failed in a Pb-free region of their solder joints, a comparison of these two samples is of high interest.

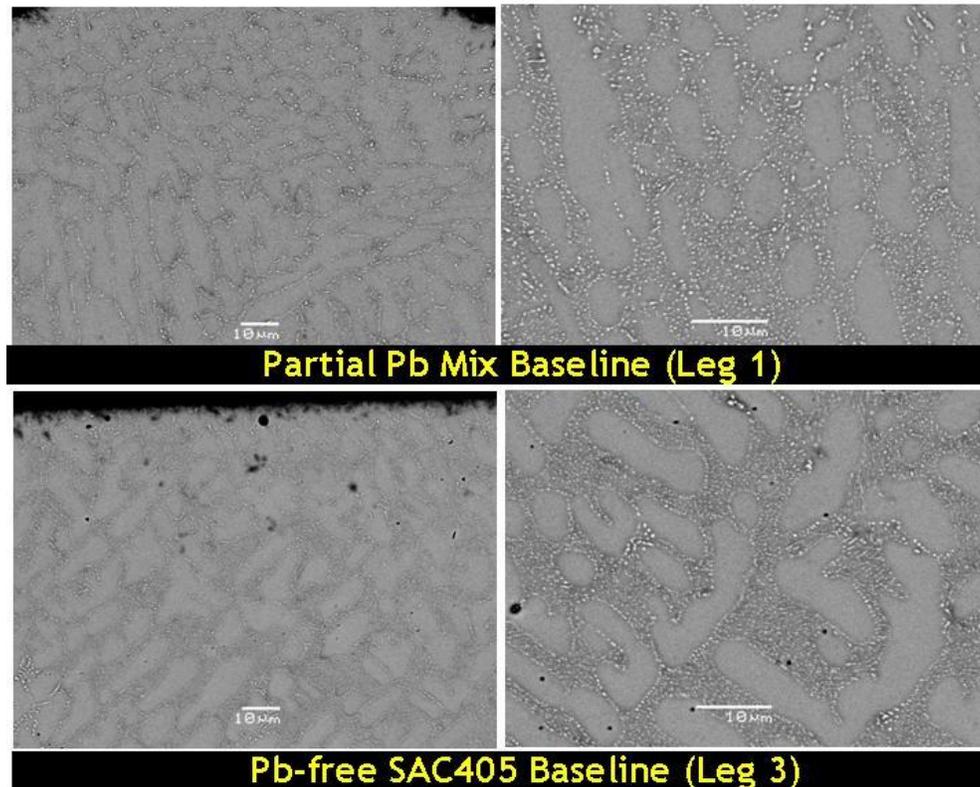
Figure 19: Higher magnification backscattered electron (BEI) images comparing the baseline SAC microstructures of the Leg 1 partial %Pb Mix Leg 3 Pb-free test cells.

The higher magnification images in Figure 19 reveal no startling baseline microstructural differences between Leg 1 and Leg 3. The microstructures of both test cells have a high density of the Ag_3Sn intermetallic particles, which is a characteristic of the SAC405 alloy. The quantity and size of the Ag_3Sn intermetallic particles is similar in both samples, although the Leg 1 sample may contain a slightly higher volume fraction of Ag_3Sn particles. A higher volume fraction of Ag_3Sn particles could account for the better fatigue resistance in Leg 1 [55, 56, 57]. The Leg 3 sample appears to contain larger primary Sn dendrites, and there is one paper that suggests fatigue resistance increases with increasing Sn dendrite size [58]. The Sn dendrite effect however, remains only a hypothesis and has not been supported by other research. A definitive determination of Sn dendrite and intermetallic particle size and distribution would require extensive quantitative metallography, which is beyond the scope of this study.

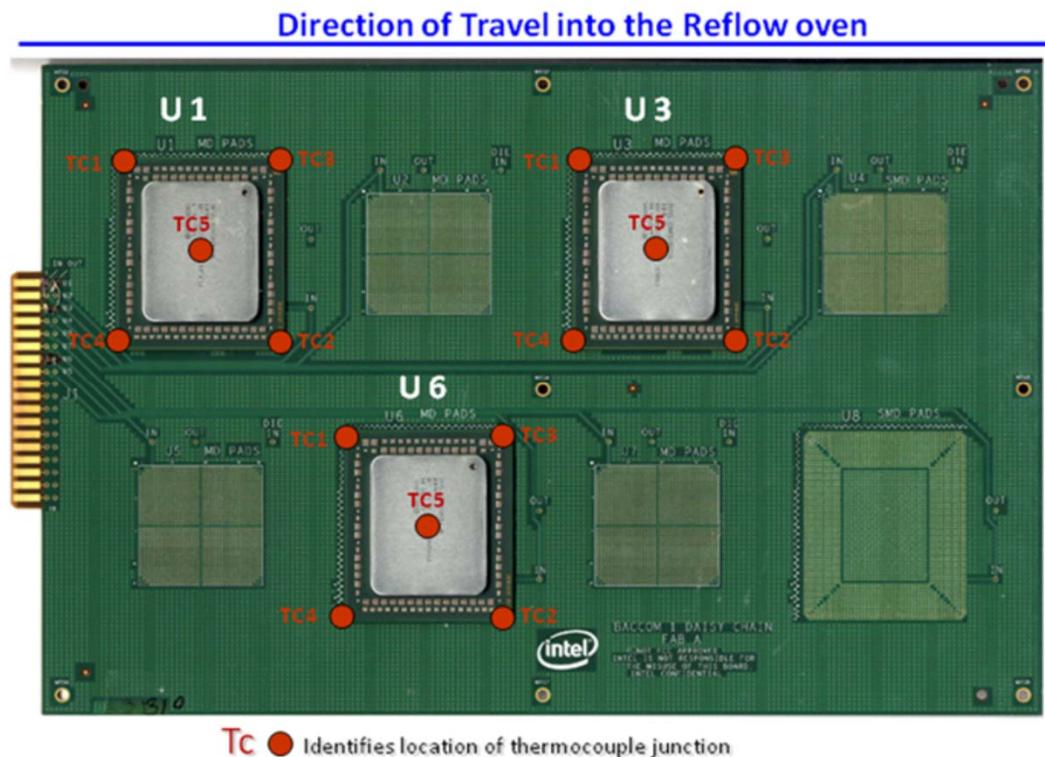
Thermocouple Locations for Reflow Profiling

- ✓ Thermocouples placed at the center of joints by drilling from bottom side of the board

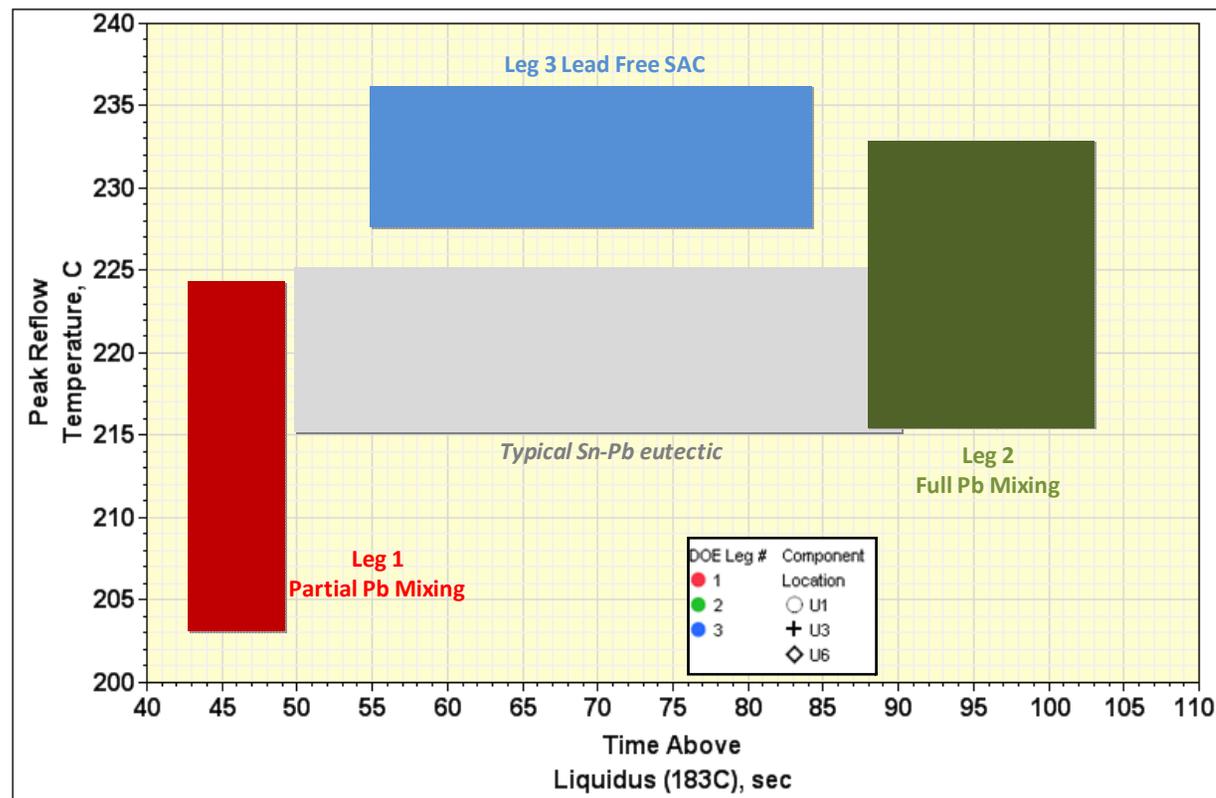
- Reflow Profiles for the 3 Legs compared by plotting the Windows on a Peak Reflow Temperature – Time above Liquidus (183C) Graph

- Wide range for Peak Reflow Temperature for all three legs
- Large body of the BGA and its high thermal mass require assembly profiles outside the typical industry SnPb reflow profile windows

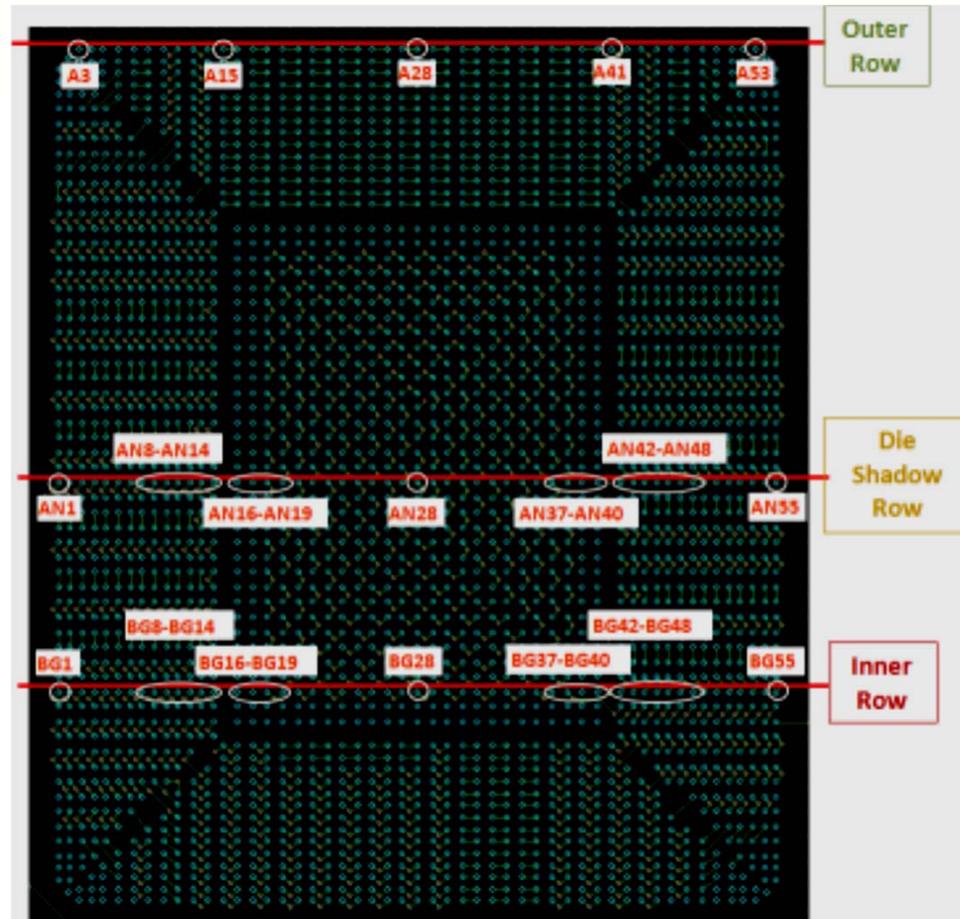
Cross-section Locations for Pb Mixing Measurements

- For assessment of %Pb mixing, three separate rows of balls were measured for a package

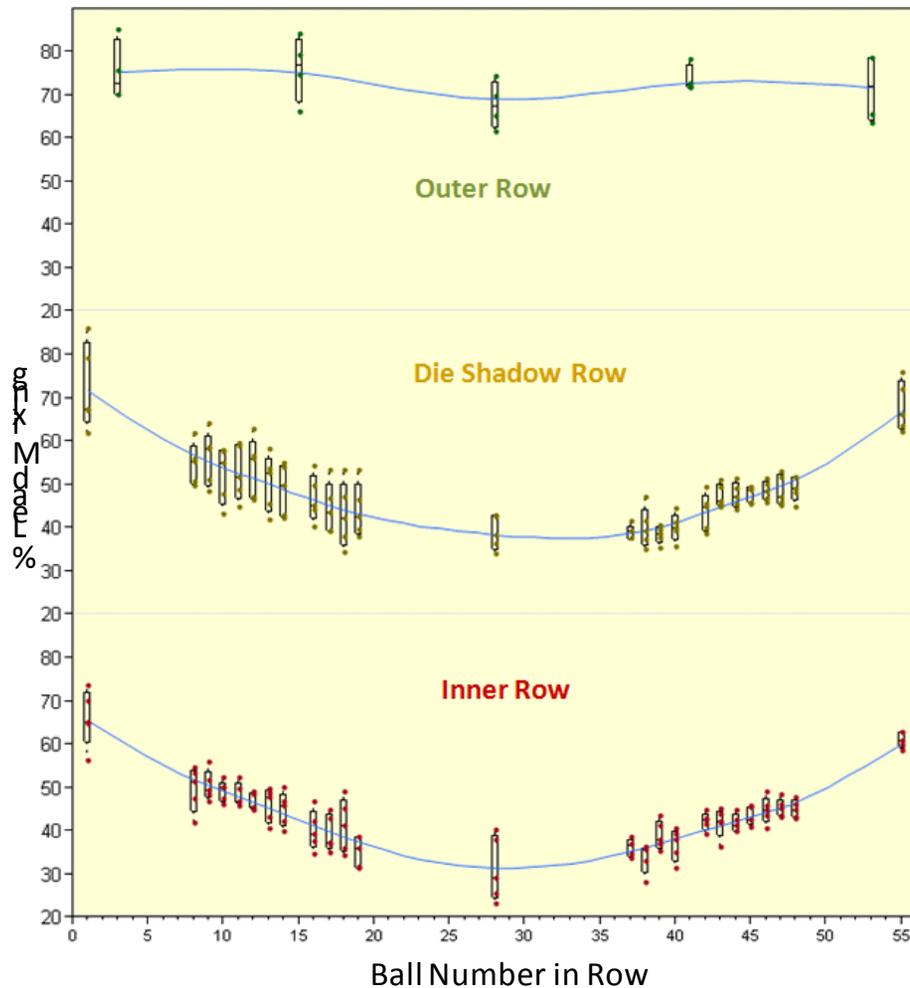
Pb Mixing Results Across Each Measured BGA Row

➤ **Fairly uniform %Pb Mixing within the outer row**
