The Relationship between Backward Compatible Assembly and Microstructure on the Thermal Fatigue Reliability of an Extremely Large Ball Grid Array

Richard Coyle, Richard Popowich, Peter Read, and Debra Fleming Alcatel-Lucent, Murray Hill, NJ
Raiyo Aspandiar, Alan Donaldson, and Vasu Vasudevan, Intel, Corporation, Hillsboro, OR
Iulia Muntele, Sanmina-SCI Corporation, Huntsville, AL
Stephen Tisdale, Intel, Corporation, Chandler, AZ
Robert Kinyanjui, formerly of Sanmina-SCI Corporation, Huntsville, AL

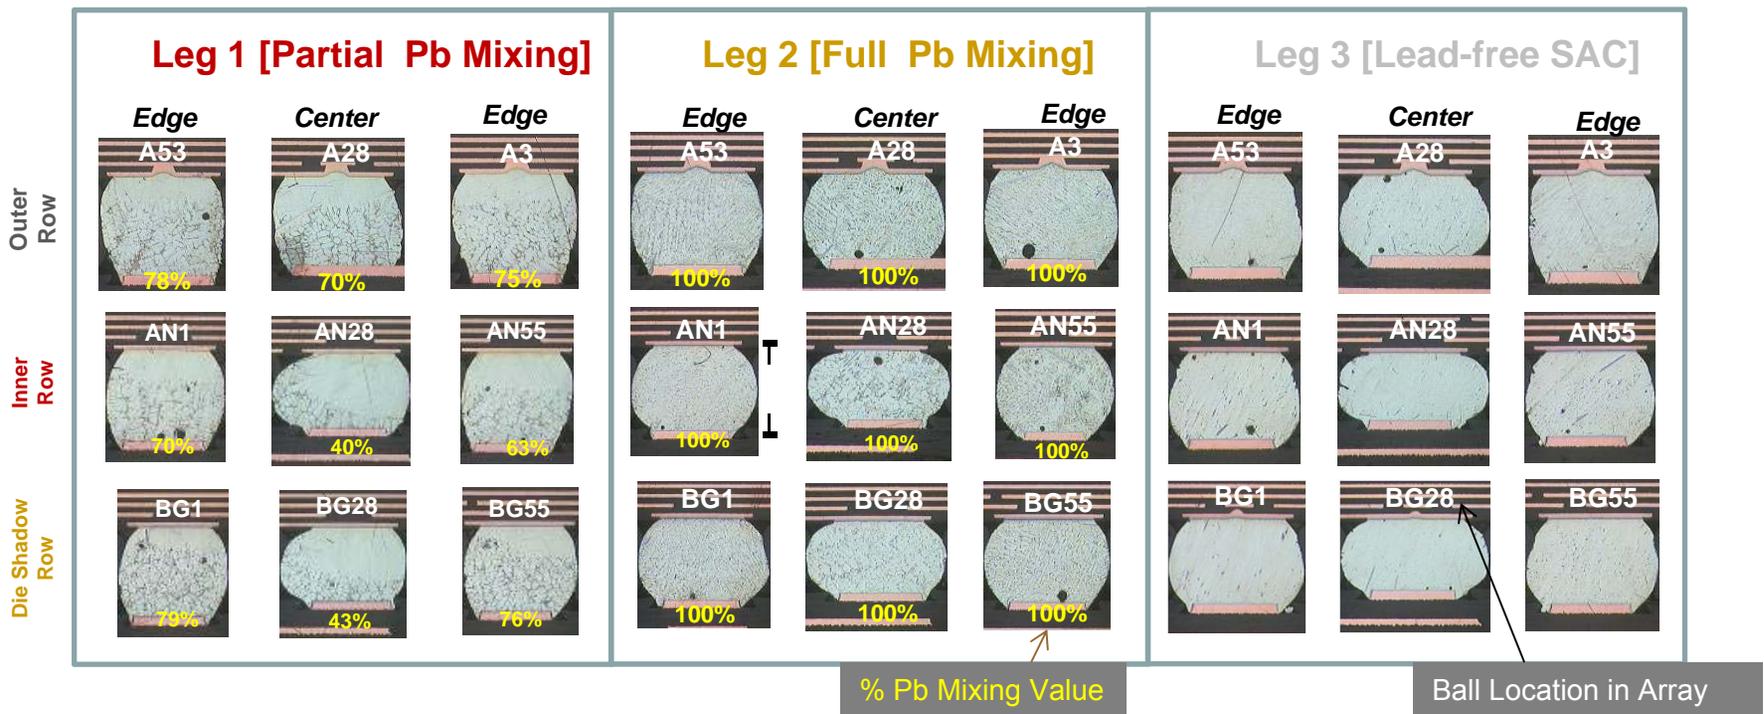
Typical Solder Joint Photomicrographs for Legs 1, 2, and 3

➤ Significant Variation in %Pb Mixing and Standoff Height, across Legs, Rows and Ball locations

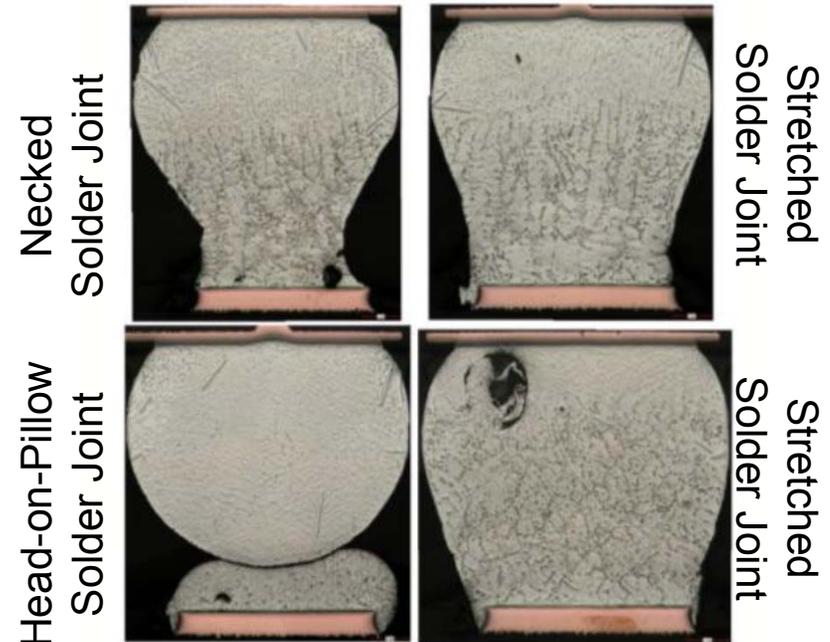
Optical Micrographs for Leg 1
Early Failures

➤ Analysis of Optical Micrographs showed strong correlation between early failures and solder joint quality

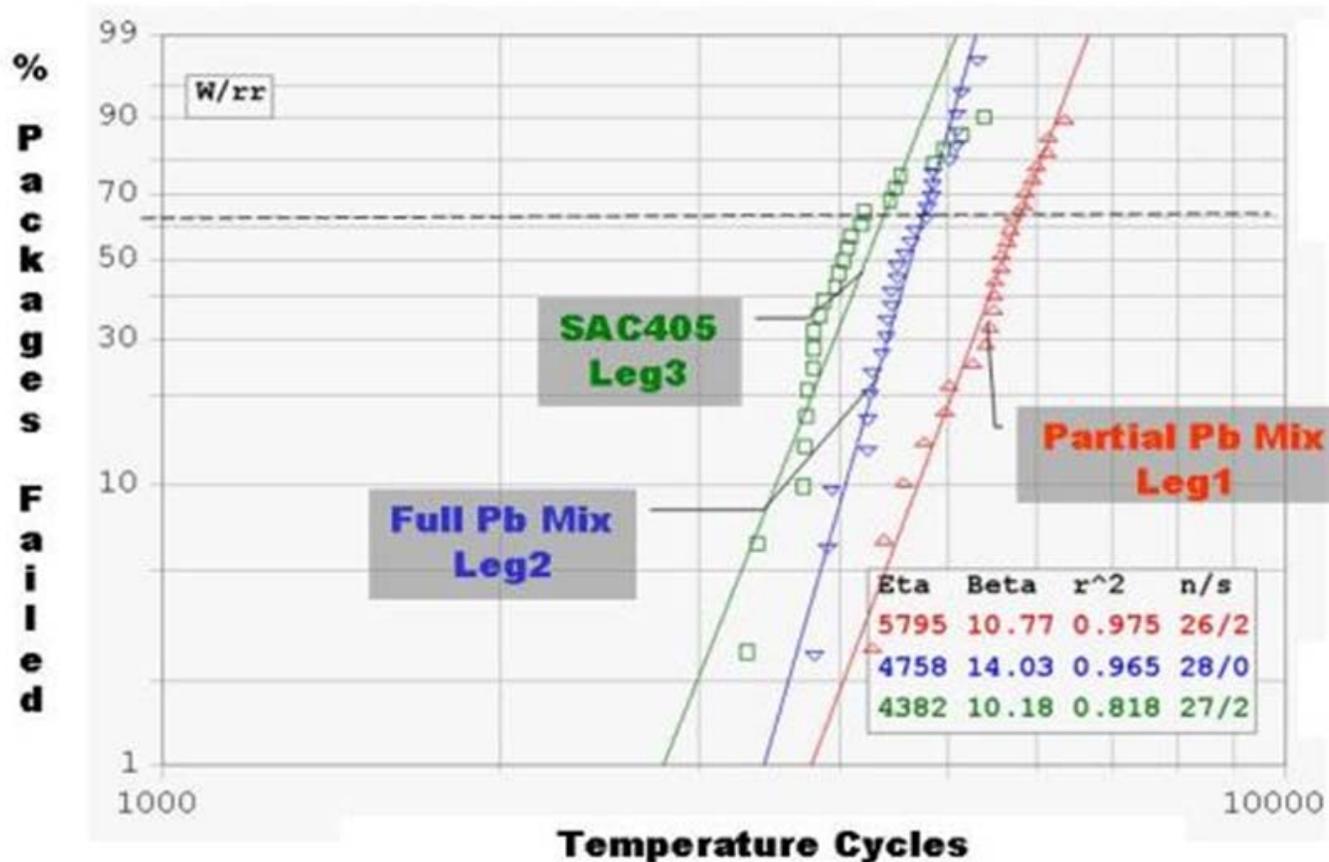
3162 Pin Count BGA with 51.0 mm x 59.5 mm Pkg Body
0/+100C Temp Cycling, 10 minute Dwell Times

- Thermal Fatigue Reliability Trend.....
- Leg 1 (Partial Mixing) > Leg 2(Full Mixing) > Leg 3 (Pb Free SAC)
- ✓ *Contrary to published data in the literature for smaller BGA packages*

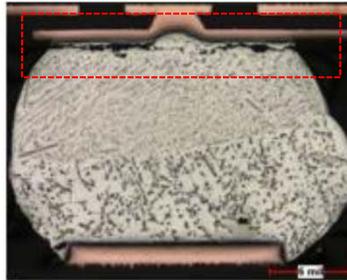
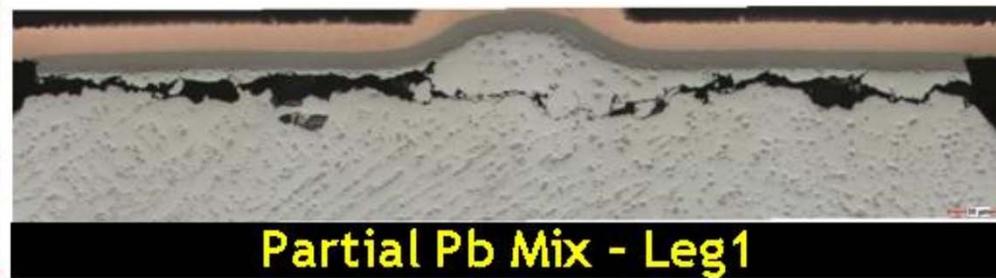
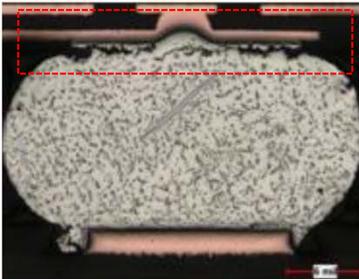
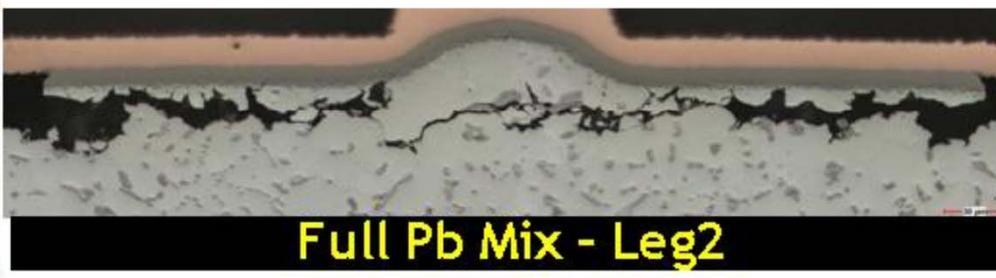
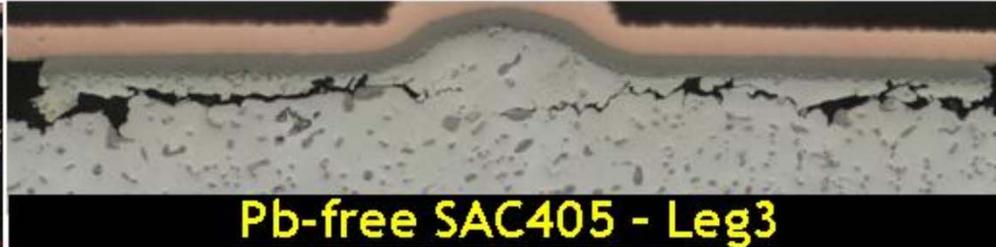
Optical Photomicrographs of Solder Joint Fatigue Cracking

- **Inter-granular fatigue fracture observed within the solder joint near the package land**
