# An Investigation of Whisker Growth on Tin Coated Wire and Braid

Dave Hillman and Tim Pearson  
Rockwell Collins  
Cedar Rapids IA USA  
[ddhillma@rockwellcollins.com](mailto:ddhillma@rockwellcollins.com)

Thomas Lesniewski  
Northrop Grumman Corporation  
San Diego CA USA  
[tom.lesniewski@ngc.com](mailto:tom.lesniewski@ngc.com)

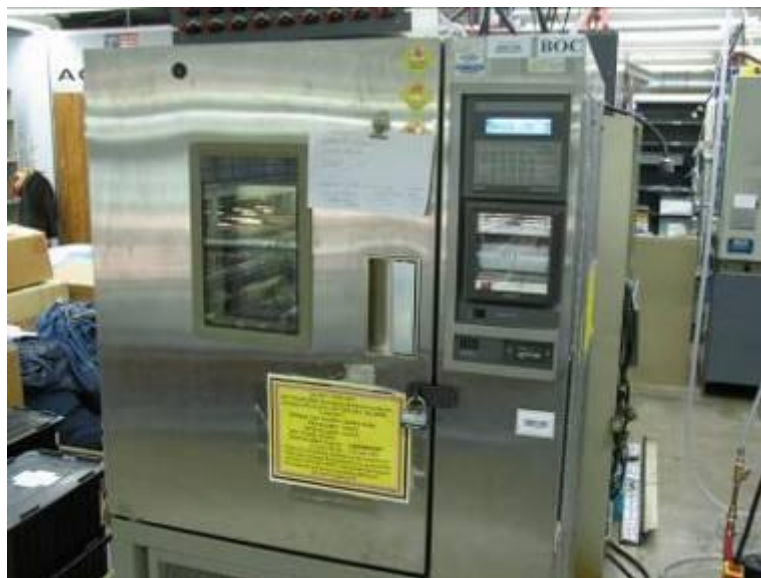
**Figure 2 Conditioning Chambers: High Temperature/Humidity**

Figure 2 illustrates the test chambers used for the conditioning portion of the investigation:
