Avoidance of Ceramic-Substrate-Based LED Chip Cracking Induced by PCB Bending or Flexing

This application note discusses the trends and symptoms observed from failed ceramic-substrate-based LED components in LED luminaires. Cree LED's testing and analysis of such luminaires revealed LEDs that exhibited one or more cracks in the LED chip as well as in the ceramic substrate. It is not the intent of this application note to identify and quantify all the conditions that induce cracks in an LED chip and the underlying

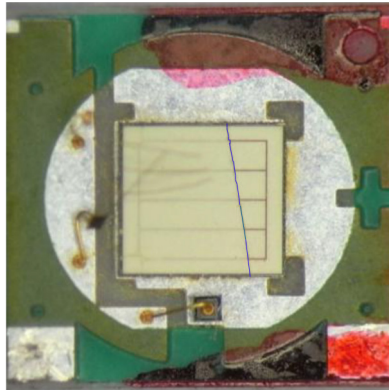
LED chip crack (highlighted in blue) due to PCB bending/flexing

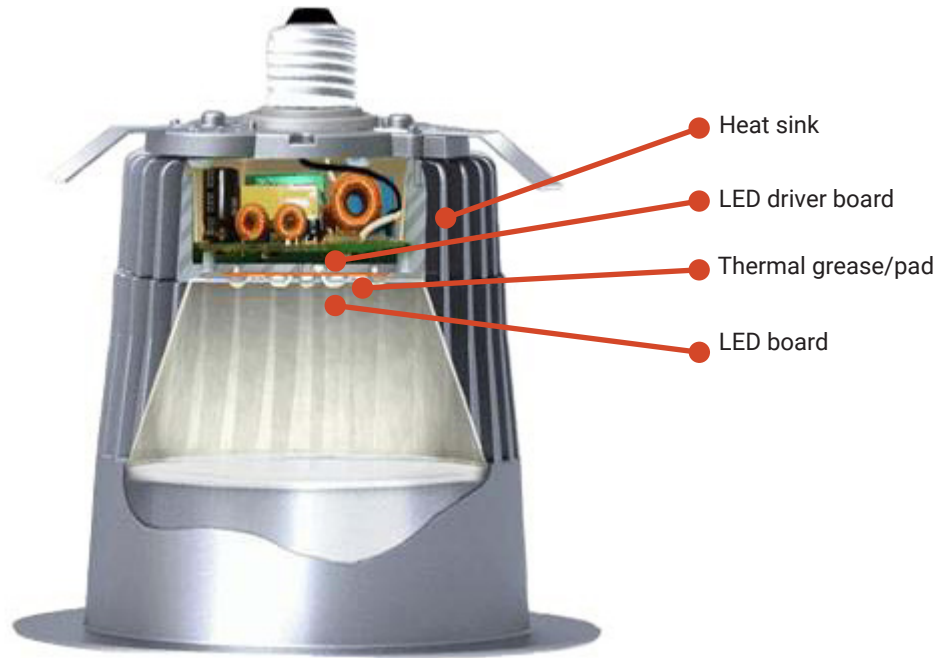
In a typical LED luminaire, the LED board is secured to the aluminum heat sink/housing using one or more metal screws. Thermal grease or a thermal pad is typically applied between the LED board and the aluminum heat sink to help with thermal conduction during luminaire operation. An electronic driver circuit may be included either internal or external to the luminaire depending on the size and design constraints of the luminaire. Figure 1 shows an example of a typical LED luminaire. Figure 2 shows LED boards secured to the underlying heat sink assembly with screws.

Figure 1: Example LED luminaire

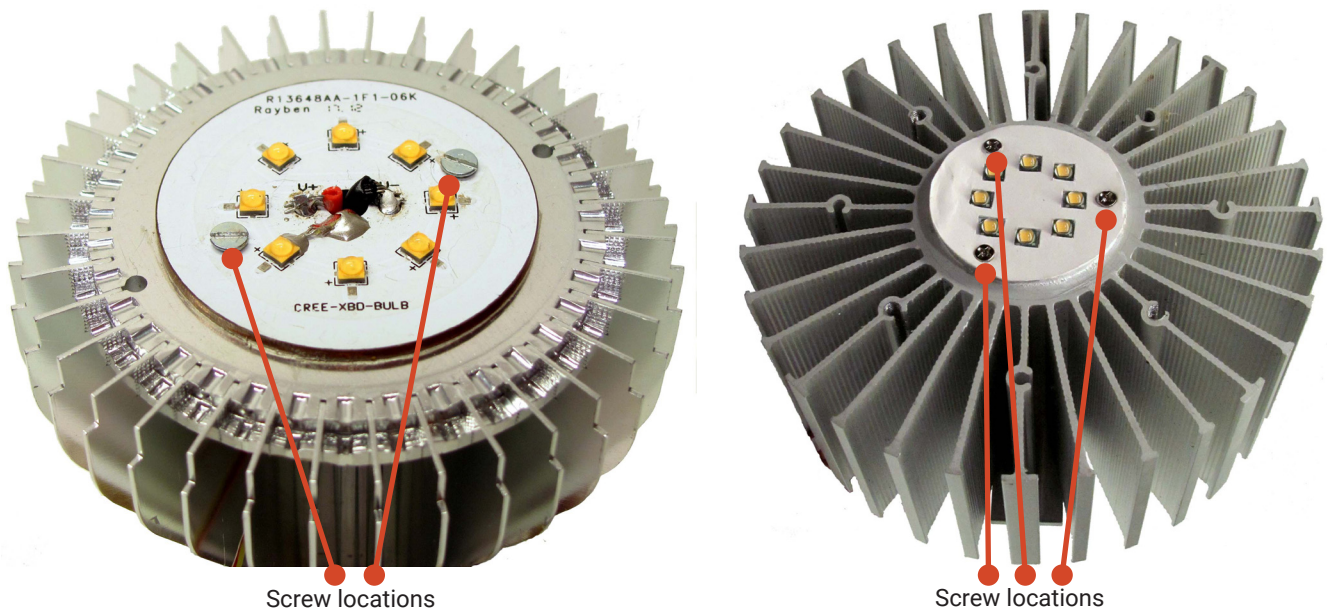
Figure 2: Examples of LED boards attached to a heat sink. Metal screws are typically used in addition to thermal grease/tape to ensure close adhesion to the underlying heat sink assembly.

1. Do not overtighten the screws when attaching an LED board to a heat sink.
2. Always use automated torquing and tightening of the screws with set torque force.

3. Do not use an excessive amount of thermal grease or a thick thermal tape/pad.
4. Do not manually apply thermal grease; use a controlled-volume dispensing method.

5. Do not use partial application of thermal grease or tape, i.e., application under the LED component only. An even spread and controlled volume are critical to minimize possible board bending/flexing during the fastening process.

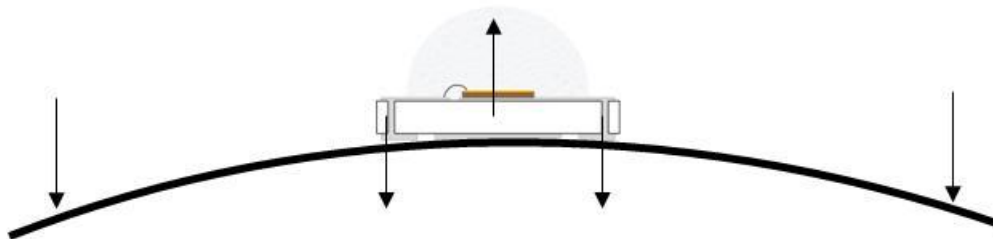
Manual tightening or automated torquing of metal screws is typically used to attach an LED board to the heat sink assembly during LED luminaire manufacturing. PCB flexing, which occurs due to the board's natural characteristic to form an arc when it is deflected, can easily occur during this process, inducing stress directly on the ceramic-substrate-based LEDs soldered on the PCB. This force is transmitted through the solder to the ceramic substrate and to the eutectically attached LED chip. Figure 3 is a pictorial representation of the directions of stress applied to an LED during PCB bending/flexing.

Figure 3: Direction of stress forces applied to LED when PCB is bent/flexed

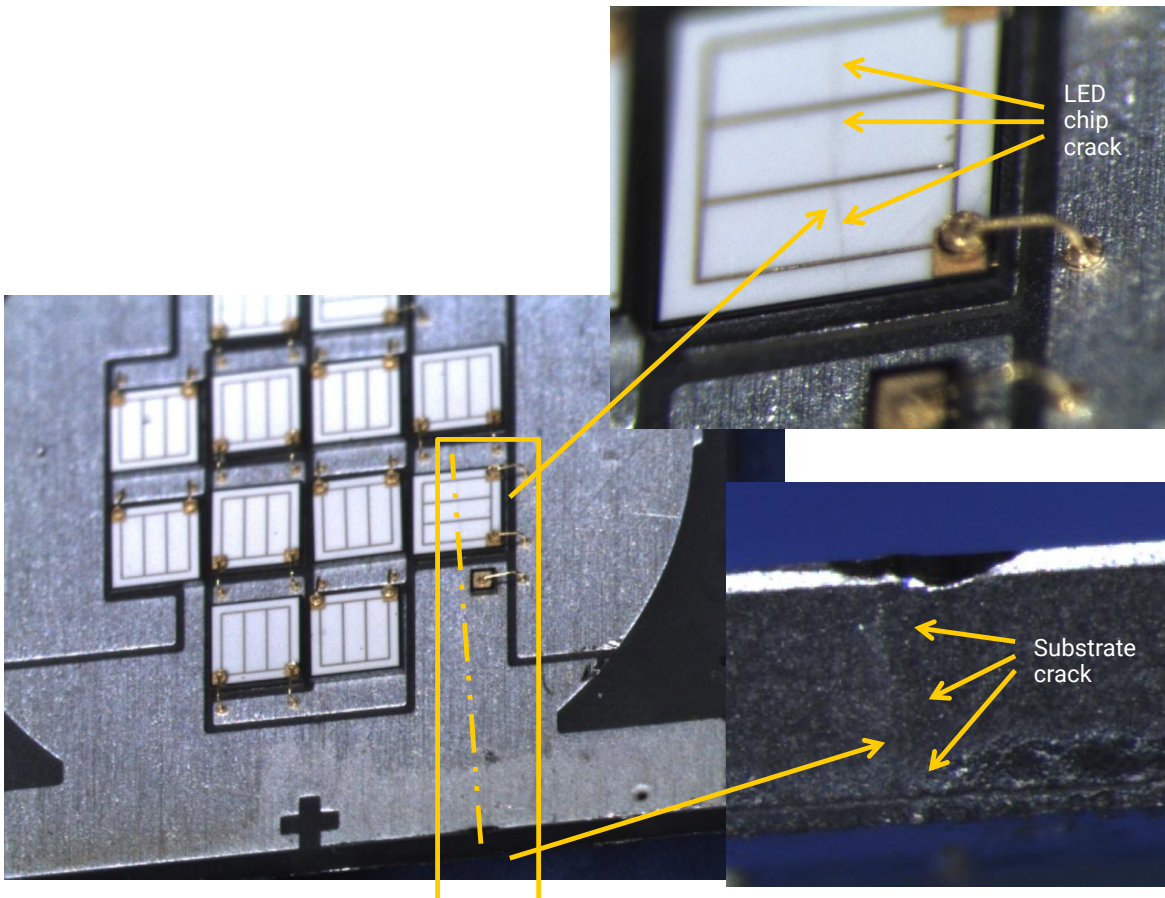
One of the primary failure modes observed in LED chips used in LED luminaires is an LED chip that exhibits leaky and/or shorted LED current/voltage characteristics. Most of the time, a crack in the ceramic substrate onto which the LED chip was soldered can be observed in addition to the LED chip crack. Both cracks are in the same direction and in line, meaning if the crack in the ceramic substrate was extended, it would look as though the crack continues to the LED chip. This is a good indication that the cracks in the LED chips were induced by cracks in the underlying ceramic substrate. Figure 4 shows an example LED exhibiting this trend.

Figure 4: Crack observed on ceramic-based multichip LED in same direction as ceramic substrate crack

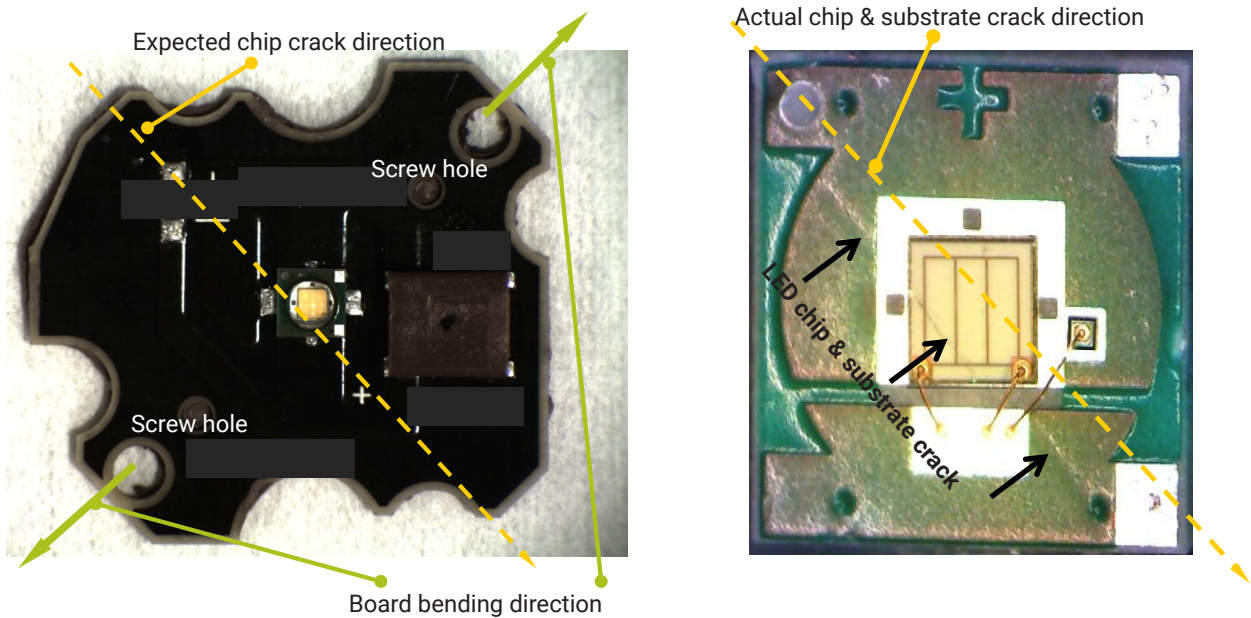
Another trend observed from the LED chip cracks was that, for assemblies that used an even number of screws, the direction of the cracks was always perpendicular to the axis of the screw locations. Figure 5 shows a damaged LED chip that was removed from an LED luminaire. The LED board was attached with two screws.

Figure 5: LED crack perpendicular to the stress direction. Image on the right is a close-up view of the PCB on the left.

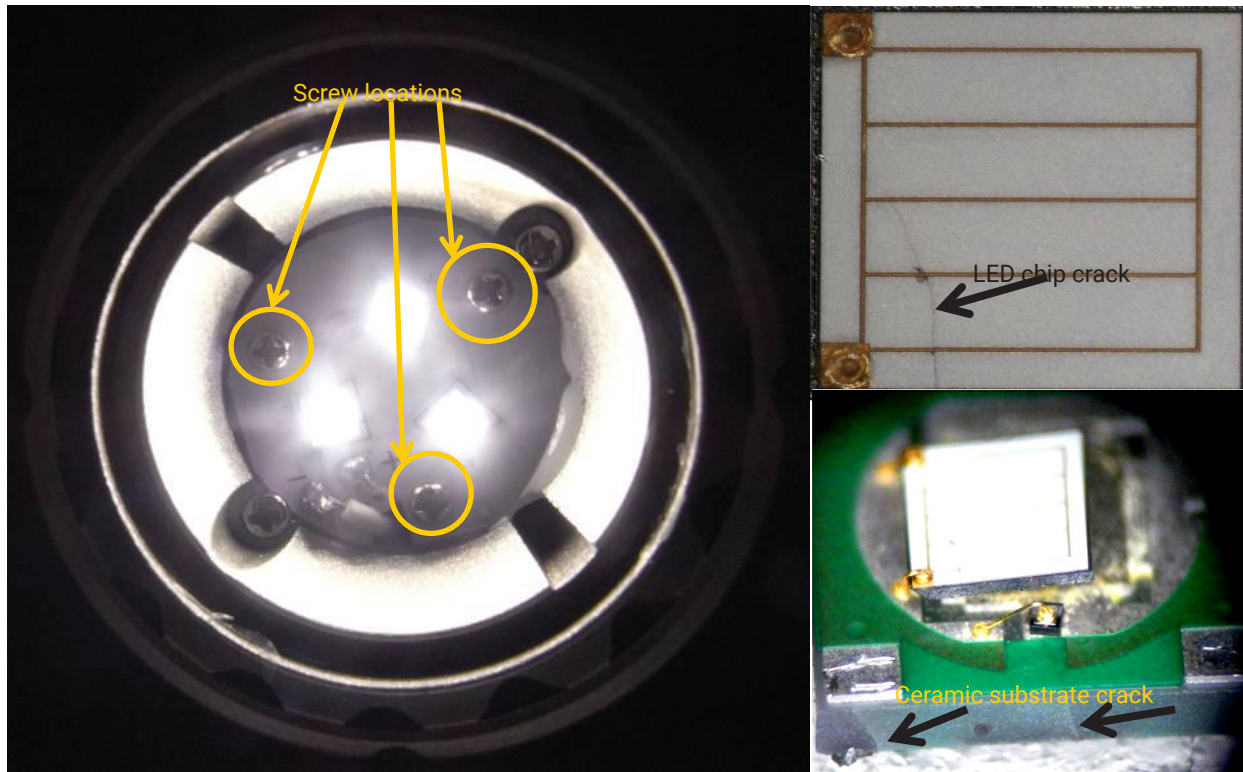
If an odd number of screws was used to attach the PCB, the cracks observed on the LED chip were in the shape of an arc in the direction opposite the board bending direction. Figure 6 shows a damaged LED chip that was on a PCB attached with three screws.

Figure 6: LED chip crack in an arc shape. Images on the right are close-up views of the LED lamp on the left.
