Latent short circuit failure in high-rel PCBs caused by lack of cleanliness of PCB processes and base materials

Stan Heltzel

European Space Agency
Components Technology and Space Materials Division
Noordwijk, Netherlands
Stan.Heltzel@esa.int

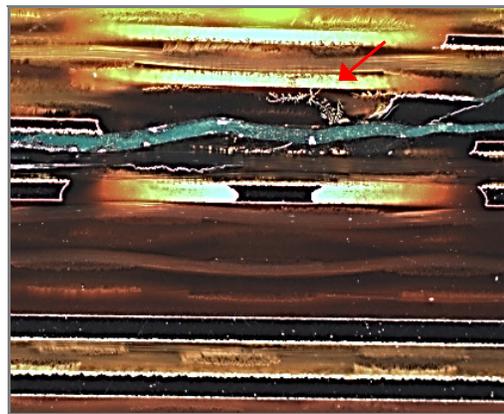
Fig. 1. Cross section of a failed PCB showing extensive damage due to electrical overstress and a dendritic structure.

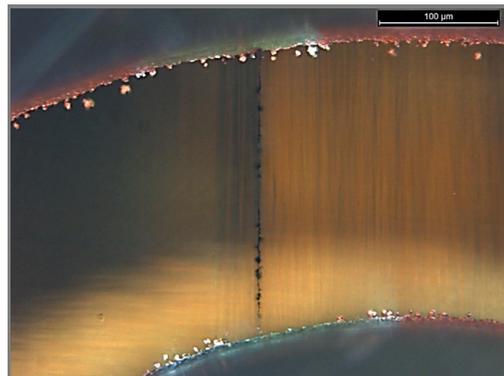
Fig. 2. In-plane section of a failed PCB showing a trace of electrical discharge along glass fibers in the clearance of a via through a plane.

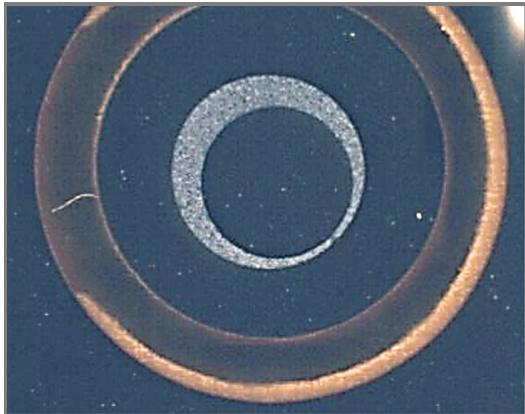
Fig. 3. In-plane section of a failed PCB showing fiber contamination in a clearance of a plated through-hole.

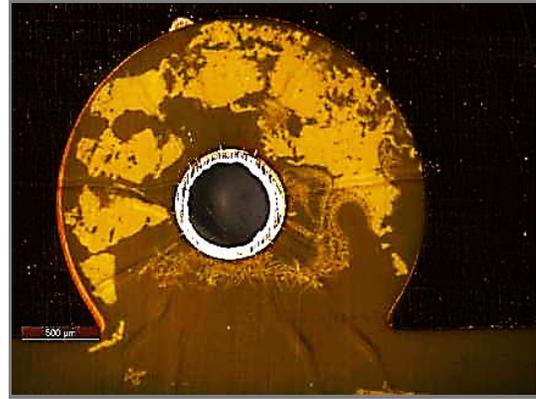
Fig. 4. In-plane section of a via showing radial resin cracks and a dendritic structure on a delaminated flex layer.

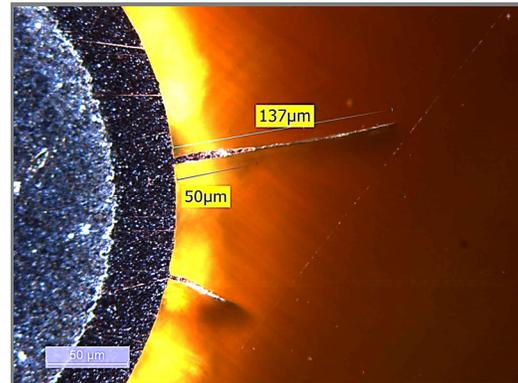
Fig. 5. In-plane section of a via without capture pad showing cracks and copper ingress caused by drilling in brittle resin.

Furthermore, the ECSS-Q-ST-70-12 specifies the presence of non-functional pads to mitigate the risk of drilling cracks in resin-rich areas and it specifies the use of two sheets of prepreg between copper layers as well as two layers of woven glass reinforcement in laminate, to mitigate the risk of contamination.

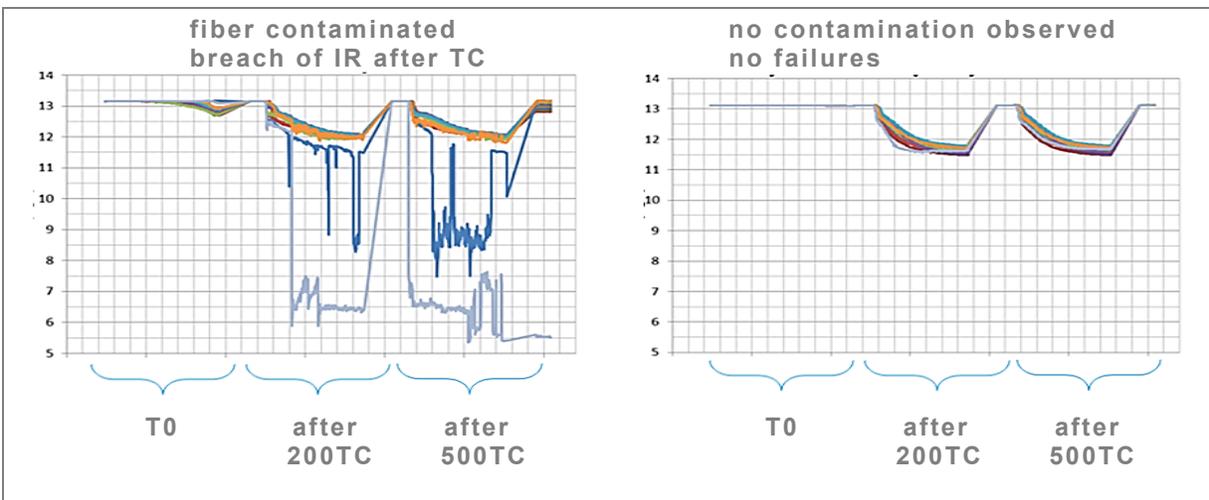
Fig. 6. Insulation resistance ($\log \Omega$) before and after thermal cycles (TC) from -65°C to $+135^{\circ}\text{C}$, showing two failed innerlayers of a comb pattern that appeared to be fiber contaminated.

An unexpected result of the test campaign was that one set of coupons appeared to be contaminated with fibers, which caused breach of insulation after thermal cycling. After the campaign, the short circuit was located using infrared thermography while applying a low current. Destructive Physical Analysis (DPA) was performed and progressive polishing finally revealed the fault location. In all cases for which the fault location could be identified in this manner, it was observed that the breach of insulation was associated with fiber contamination. In some cases it was evidenced that copper migrated from the comb pattern and re-deposited along the fiber. The fibers were observed in prepreg layers and therefore associated with the PCB manufacturing processes.

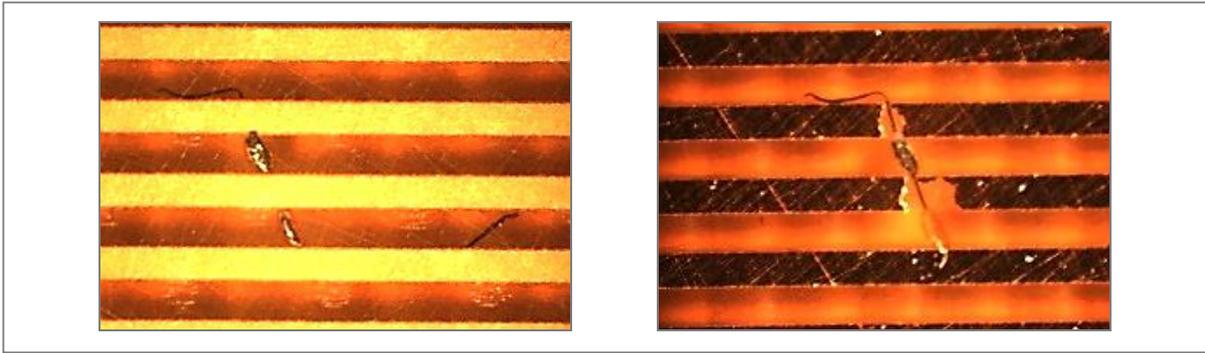
Fig. 7. In-plane sections of comb pattern after progressive polishing showing copper migration from the conductor along the fiber contamination.

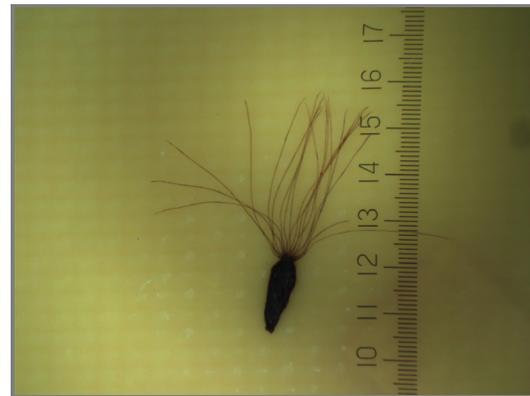
Fig. 8. Top view of a laminate after etching of copper cladding, showing a plant seed embedded in the dielectric material, probably carried into the clean room on clothes of personnel. The scale is in mm.

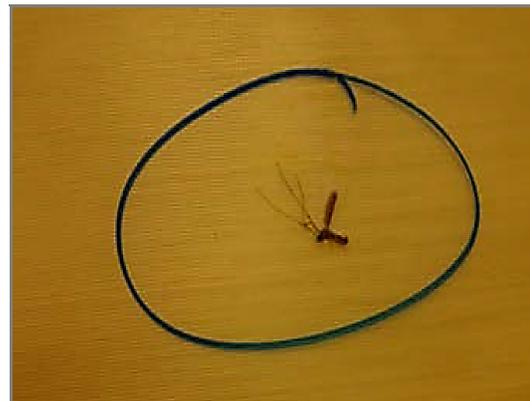
Fig. 9. Top view of a prepreg showing an embedded insect.

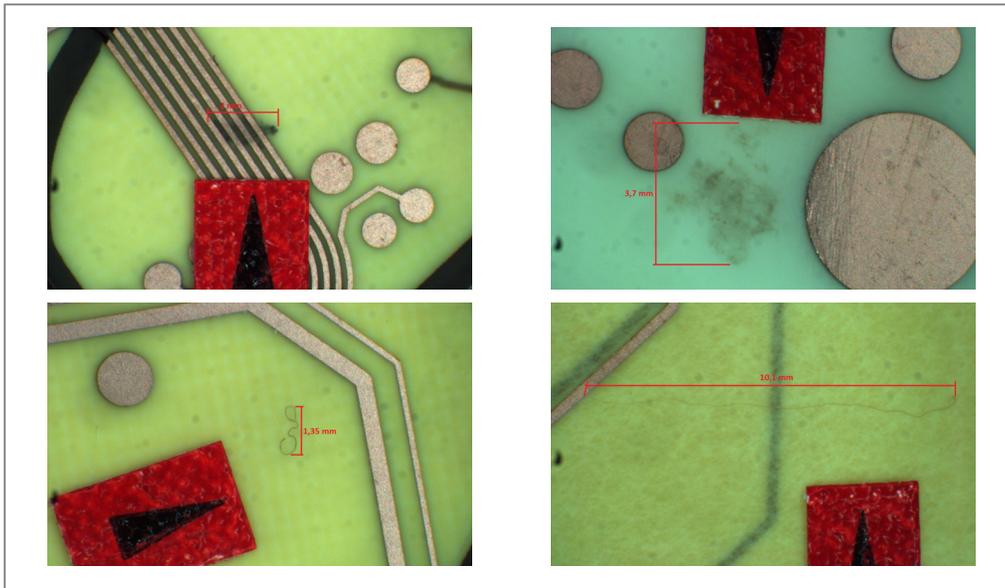
Fig. 10. Examples of etched innerlayers scrapped due to the presence of contamination.

To overcome the lack of statistical significance of sample inspections on base laminates, one PCB manufacturer implemented a 100% visual inspection of clearances on etched innerlayers using a light table. During manufacture of a critical batch of PCBs for a power unit, it was reported that 130 innerlayers were scrapped out of a total of about 10'000, due to the presence of embedded contamination as shown in figure 10. Not only is this a laborious inspection method; in addition low yield has a high cost impact that late in the manufacturing process flow.

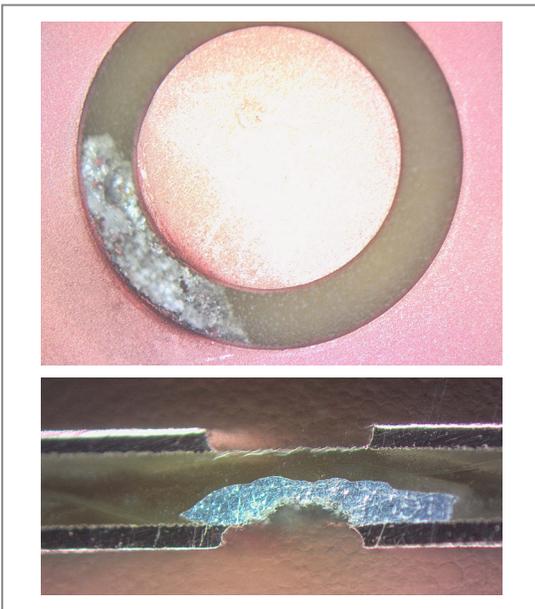
Fig. 11. In-plane view (top) of contamination embedded in clearance of etched innerlayer and cross section (bottom).

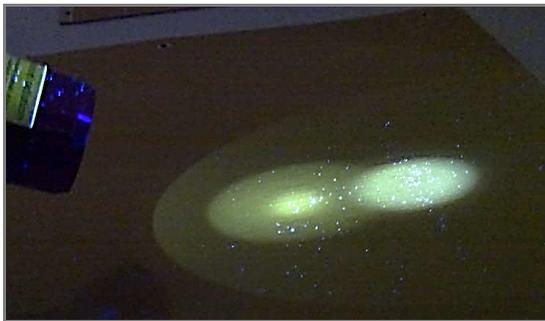
Fig. 12. Inspection of a sealed bag of polyimide prepreg showing UV fluorescence of particulate contamination.

Verification of the efficiency of the cleaning can be done by visual inspection under bright light and ultraviolet (UV) light. UV flash lights as well as bright lights are readily available in various wavelength ranges. Using UV light inspection it was shown that sealed bags of polyimide prepreg are occasionally contaminated as delivered from the base material supplier. Polyimide resin dust was shown not to be fluorescent, whereas epoxy resin as well as dust fibers do show UV fluorescence. Either source of contamination is unacceptable in polyimide production processes at high temperature.

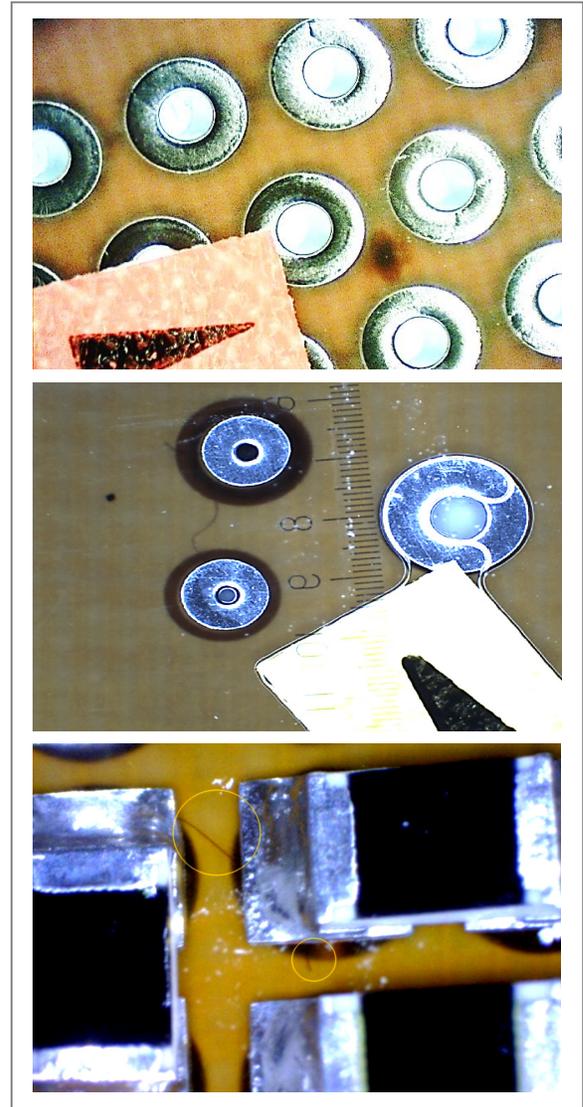
Fig. 13. Contamination embedded in base laminate on external layers bridging the insulation between pads, at outgoing inspection and after assembly.

In some recent cases, small but critical fiber contamination remained undetected at outgoing inspection as well as incoming inspection at the customer, which is described as NC#1 as part of ESA Alert EA-2014-EEE-3-A. Only after assembly and conformal coating, it was discovered that fiber

contamination was embedded within the outer layer laminate and bridging the gap between pads. Waiving such non-conformance by repair and testing under careful assessment by NRB was performed but requires high effort and cost, in particular when the delivery of the PCB assembly is on the critical path of satellite integration.

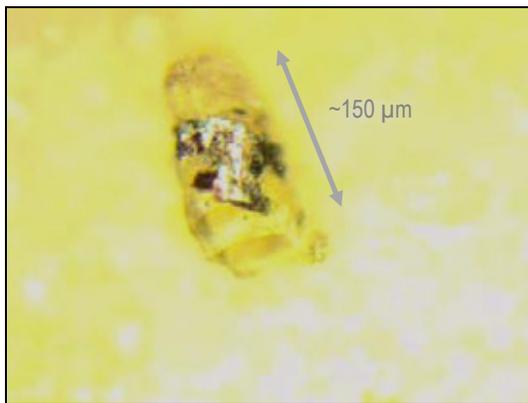
During recent use of this test method, one PCB manufacturer reported failure of a PCB at 160 M Ω insulation. When the PCB was submitted to 250 V sustained for a longer period of 1 minute, the net eventually failed in short circuit. Subsequent analysis and DPA showed particulate contamination in a 4 mil base laminate. Scanning Electron Microscopy (SEM/EDX) identified the presence of Titanium and Iron, among others. The high-Ohmic path would have remained undetected with other test methods.

Fig. 14. In-plane section of particulate contamination with metallic constituents embedded in base laminate causing high-Ohmic short.

The working group specified a new high resistance electrical test method [5] with a 1 G Ω threshold and monitoring of Voltage during ramp-up, to determine the quality of the insulation and to detect possible imperfections in the dielectric material. The rationale is that contamination between nets can provide a high-Ohmic path that can be detected under high voltage bias and therefore fails this test. The requirement for G Ω insulation resistance is specified in ECSS-Q-ST-70-10C [6] and is substantiated by the typical volume resistivity of 10⁸ M Ω -cm, determined on dielectric materials at humid conditions of 90% RH in accordance with IPC-TM-650 2.5.17.1.
