AN INVESTIGATION INTO THE DURABILITY OF STENCIL COATING TECHNOLOGIES

Greg Smith and Tony Lentz
FCT Assembly
Greeley, CO, USA

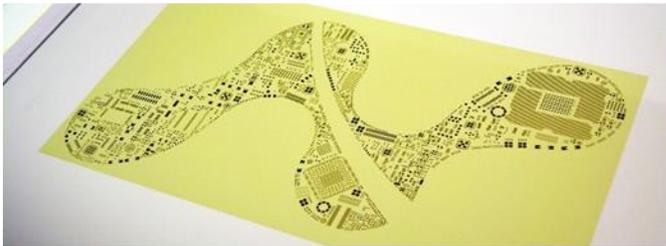
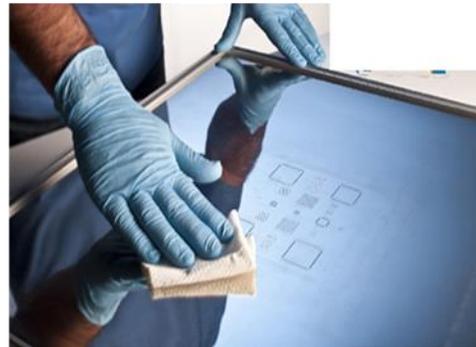
Figure 1: FPN and Phosphonate Nano-Coatings on Stencils

Phosphonate coatings are based on self-assembled monolayer (SAM) technology. Phosphonate coatings are thin, essentially 1 molecule thick and are invisible on the stencil. FPN coatings are roughly 1000 times thicker than Phosphonate coatings due to the polymeric structure (Figure 2). FPN coatings are easy to see on the stencil and typically have a dye added to give a color to the coatings. Some FPN coatings also have a fluorescing dye added to aid in viewing the coating in the aperture walls.

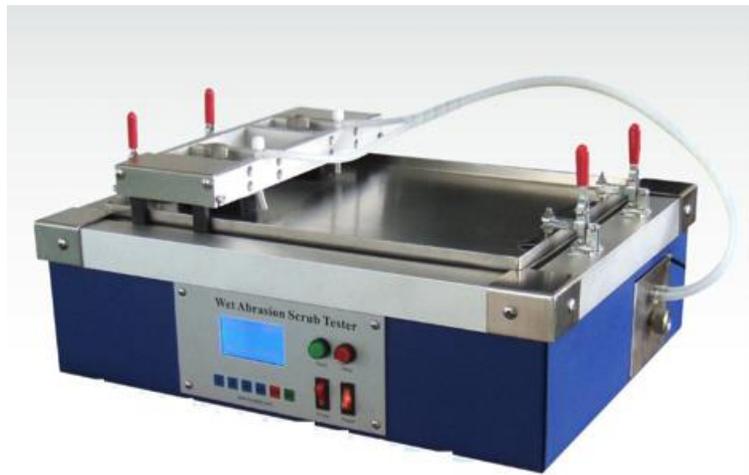
Figure 3: Wet Scrub Tester

Wet scrub testing was performed using the ASTM D2486 method for paints and coatings. Scrub testing was run to 2000 cycles and repeated with a few different chemicals pumped over the surface. Dry scrubbing was done without chemicals as a baseline. Scrub testing was repeated using de-ionized (DI) water, isopropanol (IPA), and a rosin based liquid flux. The contact angle of DI water on the coated stencil surface was measured every 500 scrub cycles. A decrease in contact angle corresponds to a loss of hydrophobicity (Figure 4). The results from a previous study [1] are summarized and presented as part of this investigation.

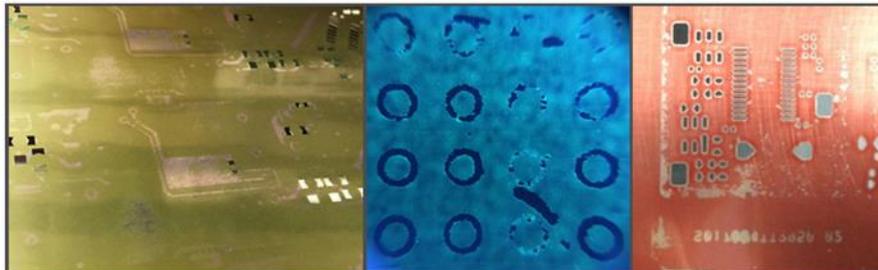
Figure 5: Damage to FPN Coatings

- When the sharp, thin edge of the squeegee pushes down against the stainless foil, over raised areas on the PWB, the friction between the coated side of the stencil and the uneven surface of the PWB eventually causes both types of coating to be worn away. In many instances this can be seen with PWB traces, venting patterns and even silkscreen rubbing off the coating in specific patterns as per the examples in Figure 5 below.

- In high volume applications, the coating chips or flakes off of the surface of the stencil around the apertures and in areas where there are no apertures. The amount of chipping or flaking varies depending on the process variables that are applied to the particular stencil. This can be seen below (Figure 5).

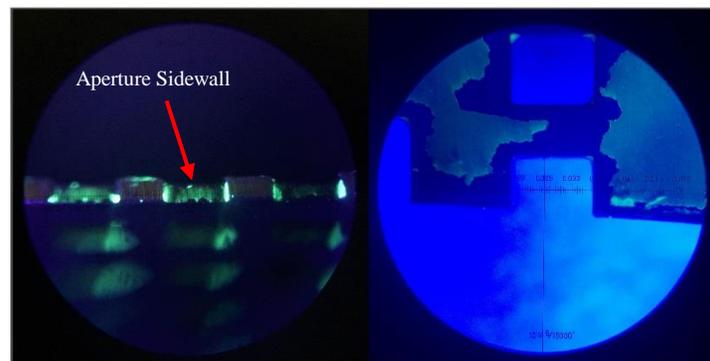
Figure 6: Cross Section and Surface Wear, 10,000 prints

One method to investigate mechanical wear on nano coatings is to observe the coating after the stencil has been used in production. Below (Figure 6), one can see that the FPN coating is coming off of the surface of the stencil but the coating is still on the aperture walls.

Inspecting the retired stencil with 10,000 prints in the images above, the image on the right shows the coating has come off around the surface of the 15 mil apertures. After cross sectioning the same apertures, one can see the coating is still in the aperture walls (left image above). The UV tracer added to the coating fluoresces verifying the coating is still present.

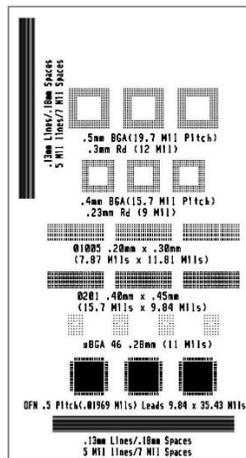
Figure 7: Nano-coating Durability Test Vehicle

One thousand underside dry wipe cycles using a popular midgrade, underside wipe material, were applied to both stencils on a commonly used automated stencil printer. A 30 Dyne/cm pen was used on the bottom side of both the Phosphonate and FPN coated stencils after the 1000 underside dry wipe cycles to determine if the coating was still present and active. 10 boards were printed with the Phos-2 coated stencil using a common no-clean paste, type 3 powder with a UV indicator added to the flux. Photos of the board side of the stencil were taken and compared to an uncoated stencil. Twenty boards were printed with the FPN coated stencils using the same no-clean paste and photos of the board side were taken.

The impact of squeegee pressure and speed is suspected to play a role in the degradation of the coating. One thousand dry squeegee prints were made on both the Phos-2 and FPN coated stencils, images were taken of the coating to see if there was any impact from 1000 dry squeegee prints to the coating. No underside wipes were used in this study and no solder paste was used to minimize the variables being observed. A common automatic printing machine was used with a squeegee pressure of 0.45 kg/cm (2.5 lb/in) and 40mm/sec squeegee speed. The test vehicle shown above (Figure 7) was used made with 2 oz copper and HASL finish.

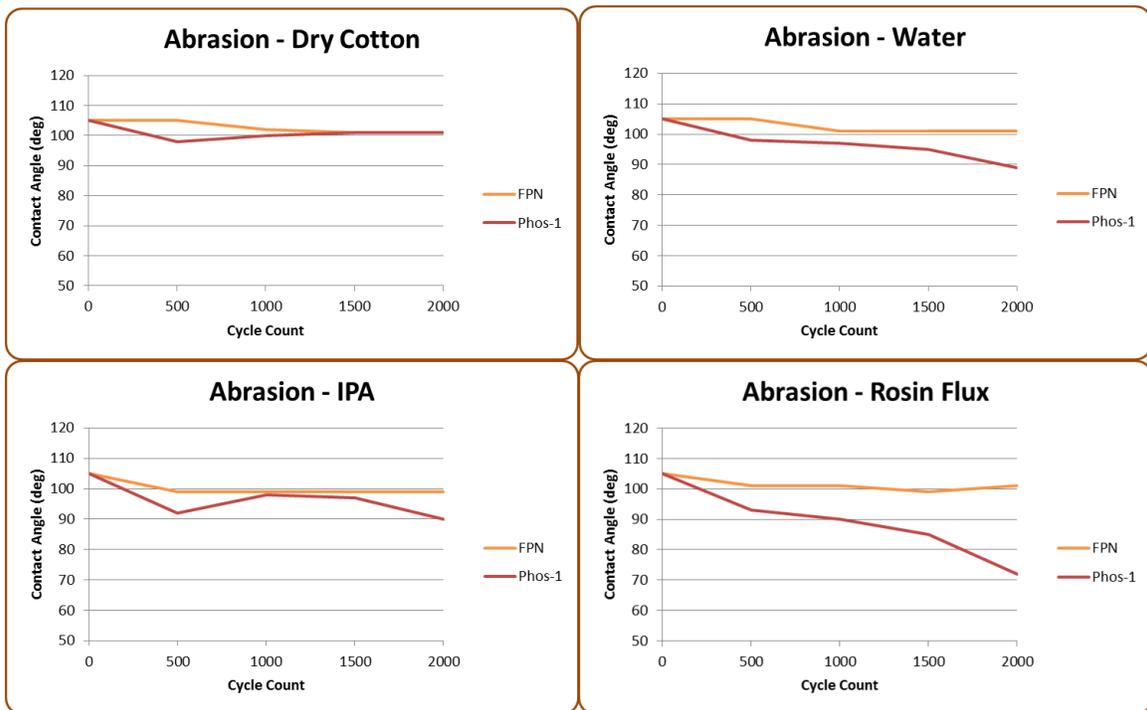
Figure 8: Contact Angle Over 2000 Scrub Cycles with Dry Cotton, DI Water, IPA, and Rosin Flux

Initial wet scrub tests were run with the FPN coating as compared to the Phos-1 coating. Contact angles were measured every 500 scrub cycles over 2000 scrub cycles total (Figure 8).

Scrubbing with dry cotton showed very little change to the contact angle of both of the coatings. Scrubbing with DI water showed a decrease in contact angle for the Phos-1 coating. This indicates that the coating lost some hydrophobicity and was wearing off. Scrubbing with IPA showed a slight drop in contact angle for the Phos-1 coating. Scrubbing with the rosin flux showed the biggest change in contact angle for the Phos-1 coating and a significant loss of hydrophobicity was observed. The contact angle dropped slightly for the FPN coating in all of these tests, but the hydrophobicity was retained in all cases.

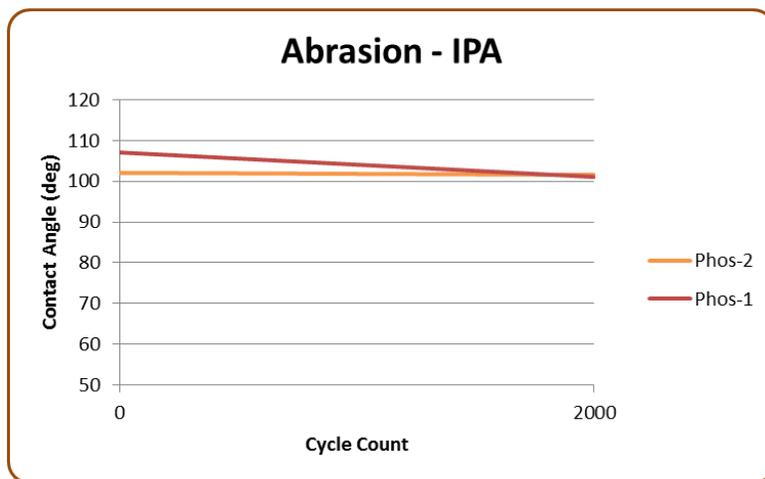
Figure 9: Contact Angle of Two Phosphonate Coatings Over 2000 Scrub Cycles with IPA

This scrub test was repeated comparing coatings from two different suppliers Phos-1 and Phos-2 (Figure 9). Both were scrubbed to 2000 cycles using IPA and the contact angle was measured after scrubbing.

This test shows a slight decrease in contact angle for the Phos-1 coating while the contact angle for the Phos-2 coating did not change. Both coatings retained their hydrophobicity in this test. When running these type of abrasion / chemical resistance tests the data must be interpreted as a comparison of one technology to another within that particular test run. It is common for different batches / lots of monolayer phosphonate coatings to give slightly different contact angle results. Contact angles also change slightly from one stencil surface to another based on coating uniformity. Phosphonate coatings are applied manually which induces some variability in the uniformity of the coating.

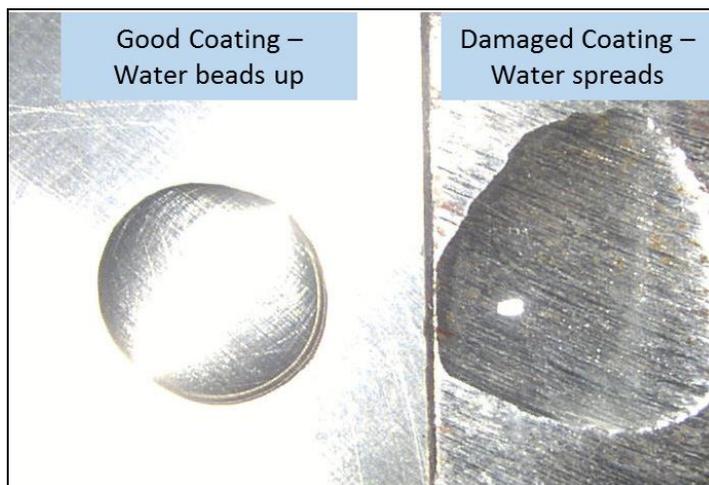
Figure 10: Fresh Coating (Good Hydrophobicity) and a Damaged Coating (Poor Hydrophobicity)

A variety of chemicals may attack and damage nano-coatings. This damage can take the form of partial loss of hydrophobicity, visual change in the appearance of the coating, or complete stripping of the coatings. Visual changes are readily apparent for the FPN type coatings. Phosphonate type coatings are invisible and therefore it is difficult to determine when damage has been done to the coating. The chemicals used in these tests fell into three categories: solvents, surfactants, and mild bases. After testing the coatings were evaluated for damage by flooding the surface with DI water and looking for loss of hydrophobicity. Examples of DI water on a fresh coating and a damaged coating are shown below (Figure 10).

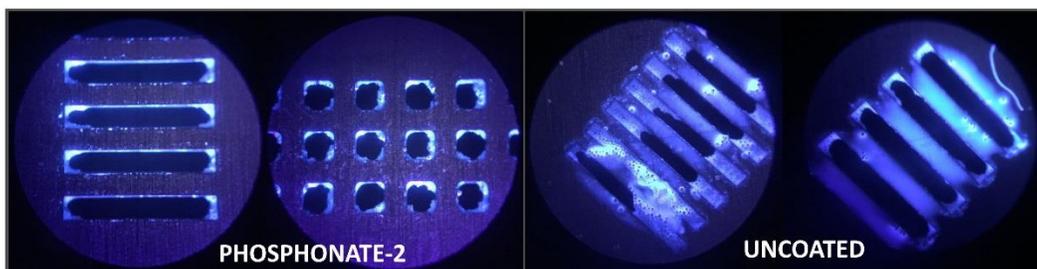
Figure 11: Phos-2 Coating, 1k Dry Wipes versus Uncoated, 10 Prints/No Underside Wipe

When 1000 underside dry wipe cycles were applied to both Phosphonate and FPN coated stencils using a mid-grade commonly used underside wipe material, both types of coatings passed a 30 Dyne/cm pen test. This test is commonly used to test Phosphonate coatings and verify that the coating is still present on the underside of the stencil. After passing the 30 Dyne/cm test, 10 boards were printed with the Phos-2 coated stencil using type 3, no-clean paste with a UV indicator added to the flux and no underside clean cycles. The images below (Figure 11) are taken from the board side of the Phos-2 coated stencil with UV light. One can see that there is very little flux/solder paste on the underside of the Phos-2 coated stencil indicating again that the Phosphonate coatings are present and preventing flux and solder paste from adhering to the underside of the stencil after being exposed to 1000 dry wipe cycles. It is easily seen that the uncoated stencil after 10 prints would cause bridging.

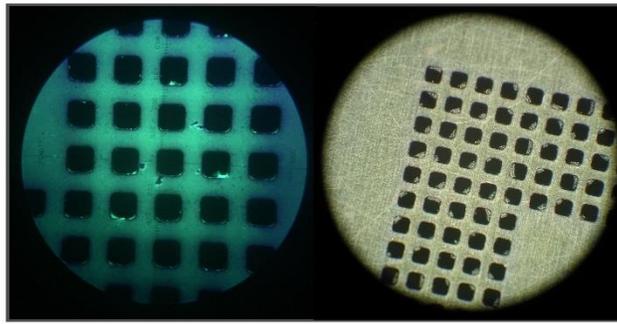
Figure 12: FPN Coating, 1000 Dry Wipes (left), 20 Prints with No Underside Wipe (right)

After passing the 30 Dyne/cm test, 20 boards were printed using the FPN coated stencil with type 3, no-clean paste. The left image below (Figure 12) is taken from the coated side of the stencil prior to printing paste after 1000 dry underside wipe cycles. Small areas can be seen with no coating present indicating the coating is coming off in small areas during the 1000 dry wipe process under UV light. No UV light was used in the right image below after printing 20 boards with no underside clean cycles. When UV light was used, the entire image fluoresced making it difficult to see flux and paste residue. One can see that there is very little flux/solder paste on the underside of the stencil in the right image below indicating again that the FPN coating is present on the surface after 1000 dry wipe cleaning cycles and then 20 prints with no underside wipe.

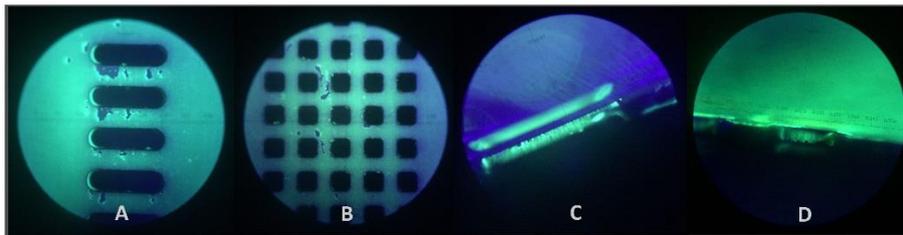
Figure 13: 1000 Dry Prints, FPN Coated Stencil

The squeegee test consisted of 1000 dry squeegee prints and were made on both the Phos-2 and FPN coated stencils. Since the Phos-2 coating is clear and contains no fluorescing dye, wear damage could not be seen in the images. Images of the FPN coated stencils after 1000 dry squeegee prints are shown below (Figure 13).

In image A and B above (Figure 13), damage can be seen in the FPN coated surface of the stencil. When apertures were cross sectioned, however, the coating was still intact inside the apertures. This can be seen in images C and D above with the coating fluorescing in the aperture walls indicating that the coating is still intact.

By observing both the squeegee testing images and the underside wipe images above, one can come to the conclusion that both the underside wipe process and the downward pressure and movement of the squeegee blade across non-planer PWBs contribute to coating wear during the print process.

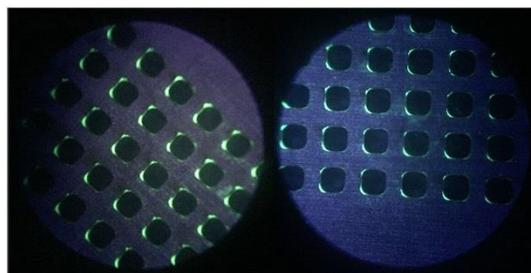
Figure 14: FPN Coating in Aperture Walls, Phosphonate on Board Side of Stencil

The final stencil nano coating that was tested was an R & D hybrid coating. The coating consisted of an FPN coating applied to the stencil aperture walls and the Phosphonate-2 coating being applied to the underside of the stencil. The advantage given by this new technology is the Phosphonate-2 coating provides a non-stick surface on the bottom of the stencil and the FPN coating gives solder paste printing benefits on the aperture walls. When wear occurs the Phosphonate-2 coating could be easily reapplied to the bottom of the stencil by the user. The images below (Figure 14) show the board side of the stencil with coating fluorescing on the apertures walls where the FPN coating is present.

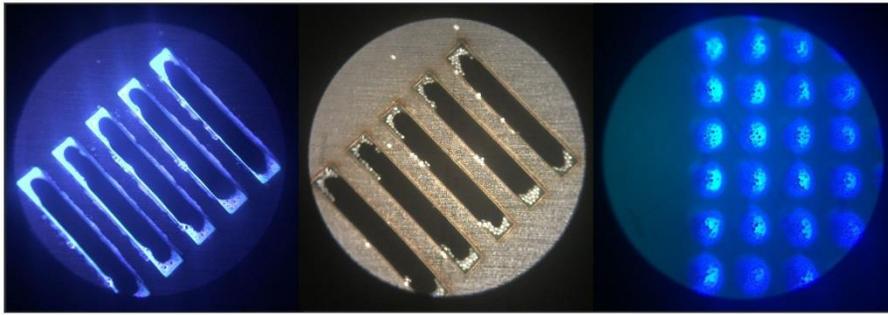
Figure 15: FPN Coating in Aperture Walls, Phosphonate on Board Side, 50 Prints, No Underside Clean

To test the effectiveness of the R & D stencil coating, 50 consecutive prints were completed with no underside wipes between the prints using the previous test vehicle and a solder paste including the UV dye in the flux. The images below (Figure 15) show the bottom of the stencil after 50 consecutive prints with no underside wipes along with images of the 0.4mm micro BGA prints onto copper clad.

Minimal flux and paste are visible on the underside of the stencil after 50 prints with no under stencil wipe and no bridging is present in the paste deposited on the copper clad. Durability studies were not done on this particular stencil in that the Phosphonate coating durability along with FPN durability findings in this study will apply here as well. This coating technology is currently under evaluation.

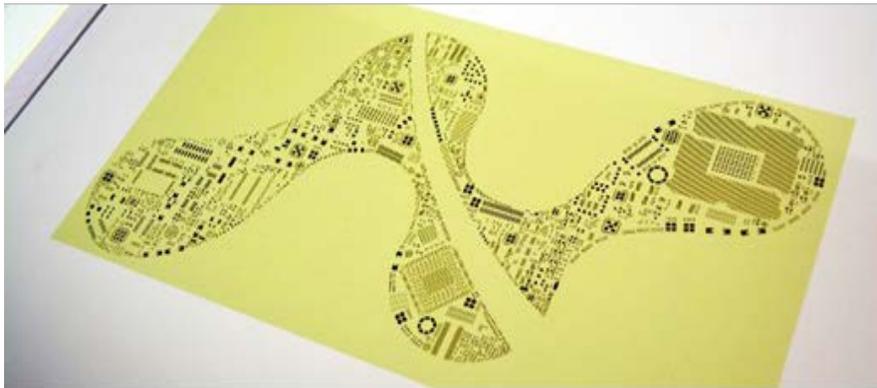
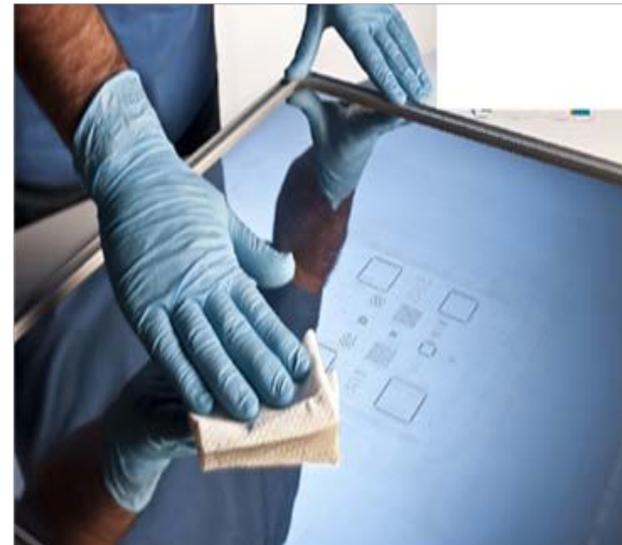
Fluoro-Polymer Coating

Phosphonate Coating

*Nano coatings are used to improve the print process.
The ongoing question is, "How long do they last?"*

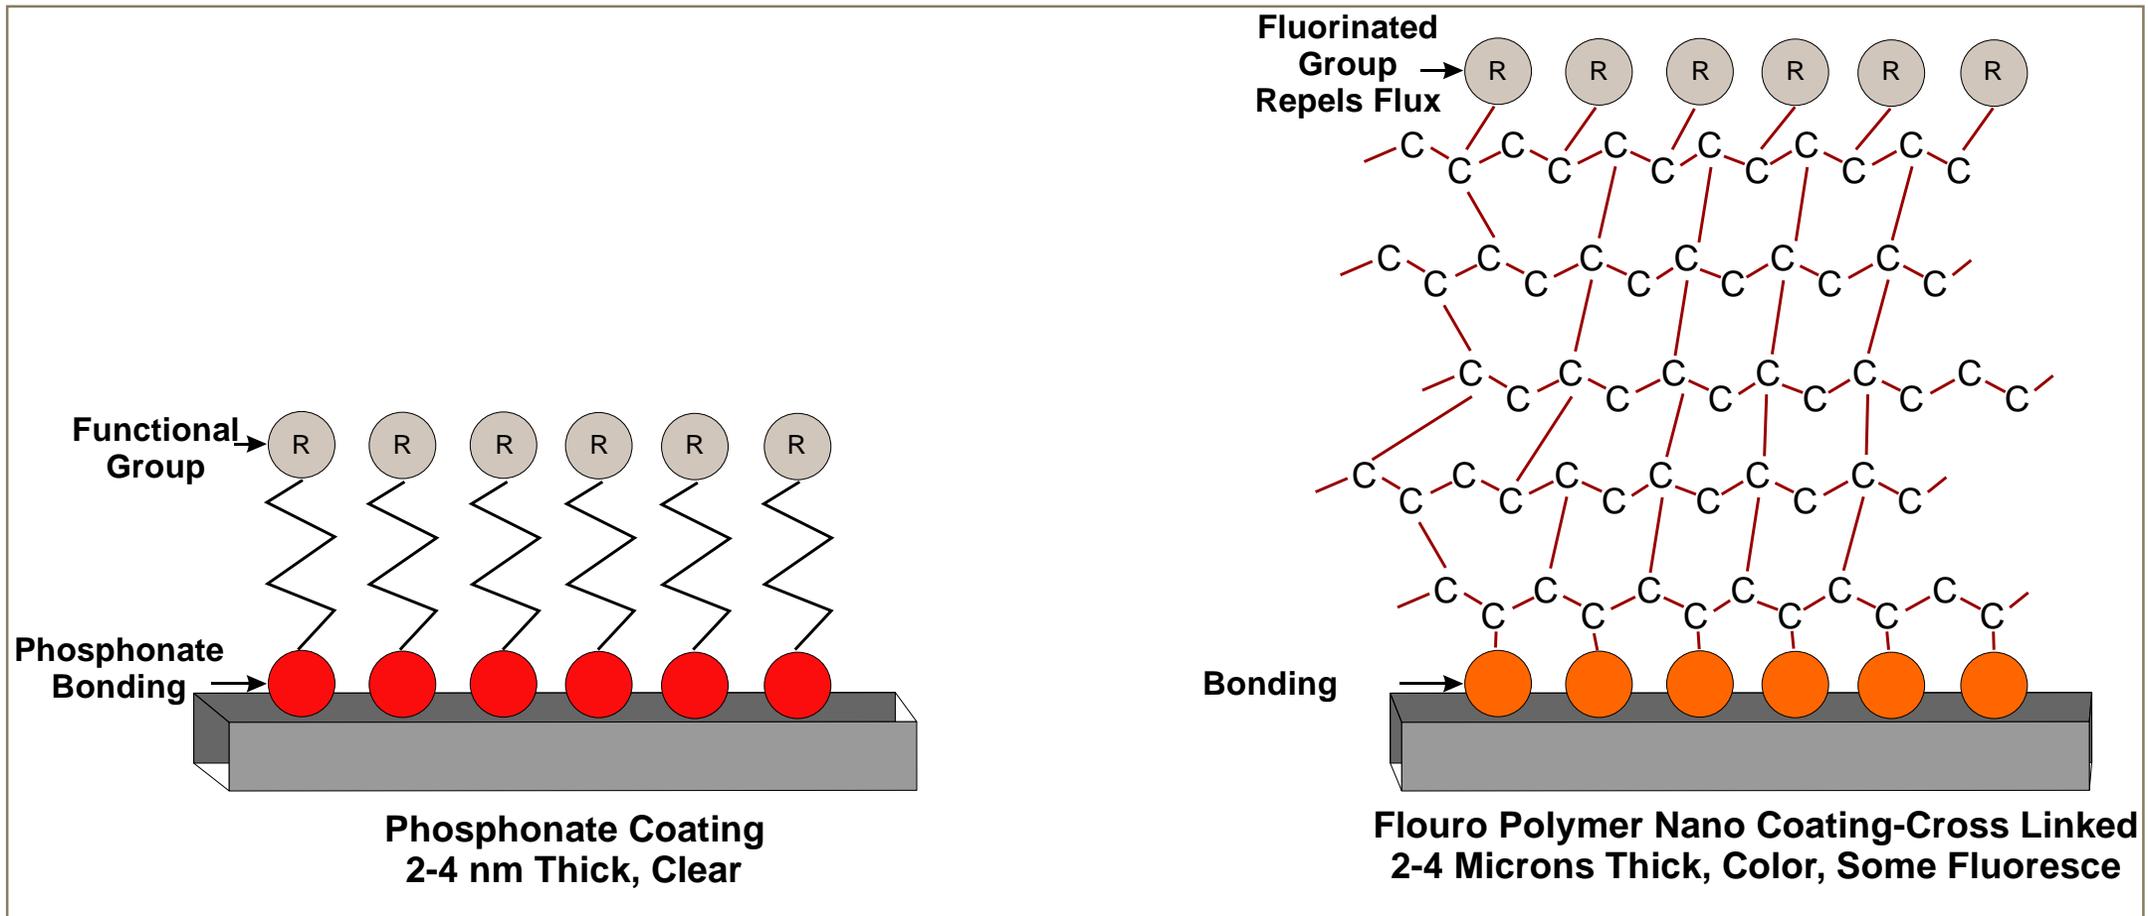
Description of Nano Coating Types

Properties of FPN and Phosphonate Nano-Coatings

Attributes	Fluoro-Polymer Coating	Phosphonate
Application	Spray and thermal cure	Wipe on
Thickness	2-4 microns	2-4 nm
Visible on stencil?	Yes	No
Hydro and oleophobic	✓	✓
Reduces frequency of underside cleaning	✓	✓
Abrasion resistant	✓	Wears off
Chemical resistant	✓	Wears off
Re-coating possible?	No	✓
Solder paste volume	15 - 25% increase in TE	Slight decrease < 5%
Minimum Area Ratio	0.10 lower than foil	Same as foil

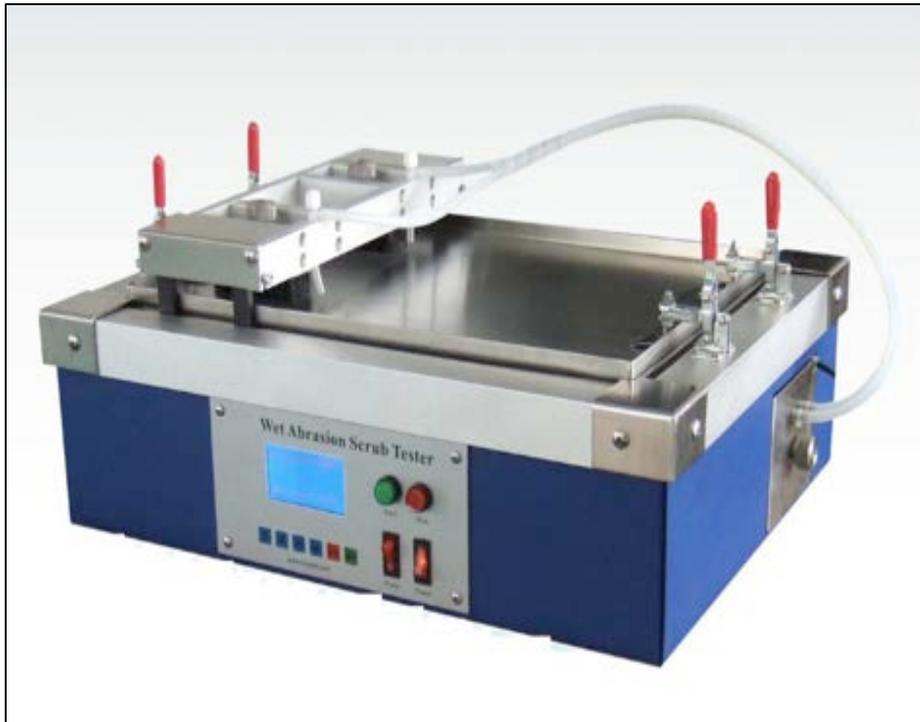
ASTM D2486 Wet Scrub Tester

- 2000 scrub cycles
- Dry and wet chemical scrub

Measured contact angle change

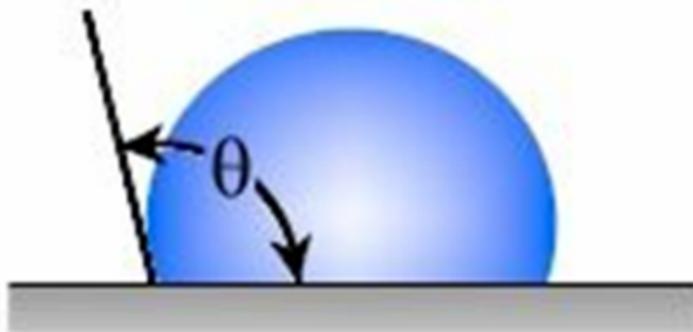
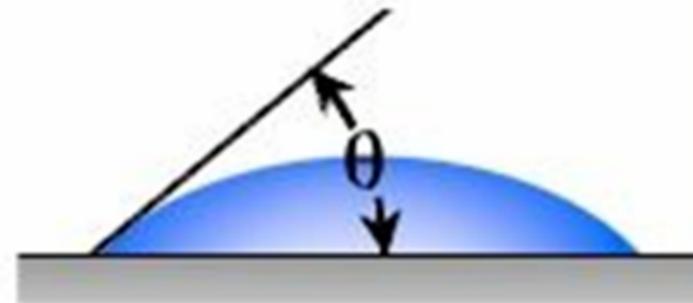
Chemical Damage to Nano-Coatings

Hydrophobic Surface		Hydrophilic Surface
High	Contact Angle	Low
Poor	Adhesiveness	Good
Poor	Wettability	Good
Low	Surface Free Energy	High

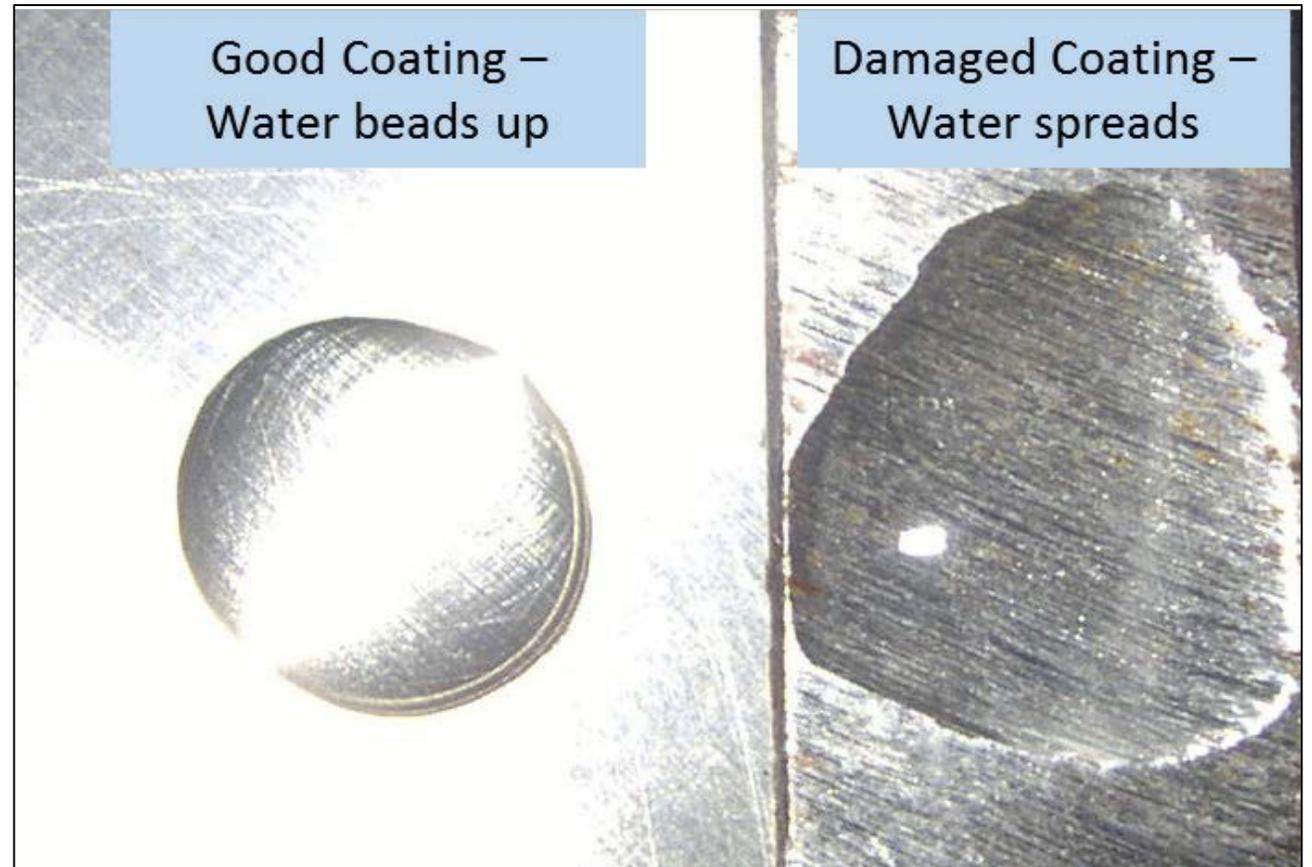
Chemical Damage to Nano-Coatings

Immersion 48 hours at Room Temp

Rinsed and dried

Evaluated for DI water spread

The results from chemical attack testing are shown below (Table 2). The chemicals that damaged the coatings are highlighted in yellow and the chemical that stripped the coatings is highlighted in red. The blank cells indicate that no damage was observed.

The intention of this chemical attack testing was to show that nano-coatings are not compatible with every solder paste or stencil cleaner. Some chemicals will shorten the life of the nano-coatings through chemical attack. It is recommended that nano-coating users check with their suppliers to ensure that the nano-coating is compatible with the materials that come into contact with the stencil.

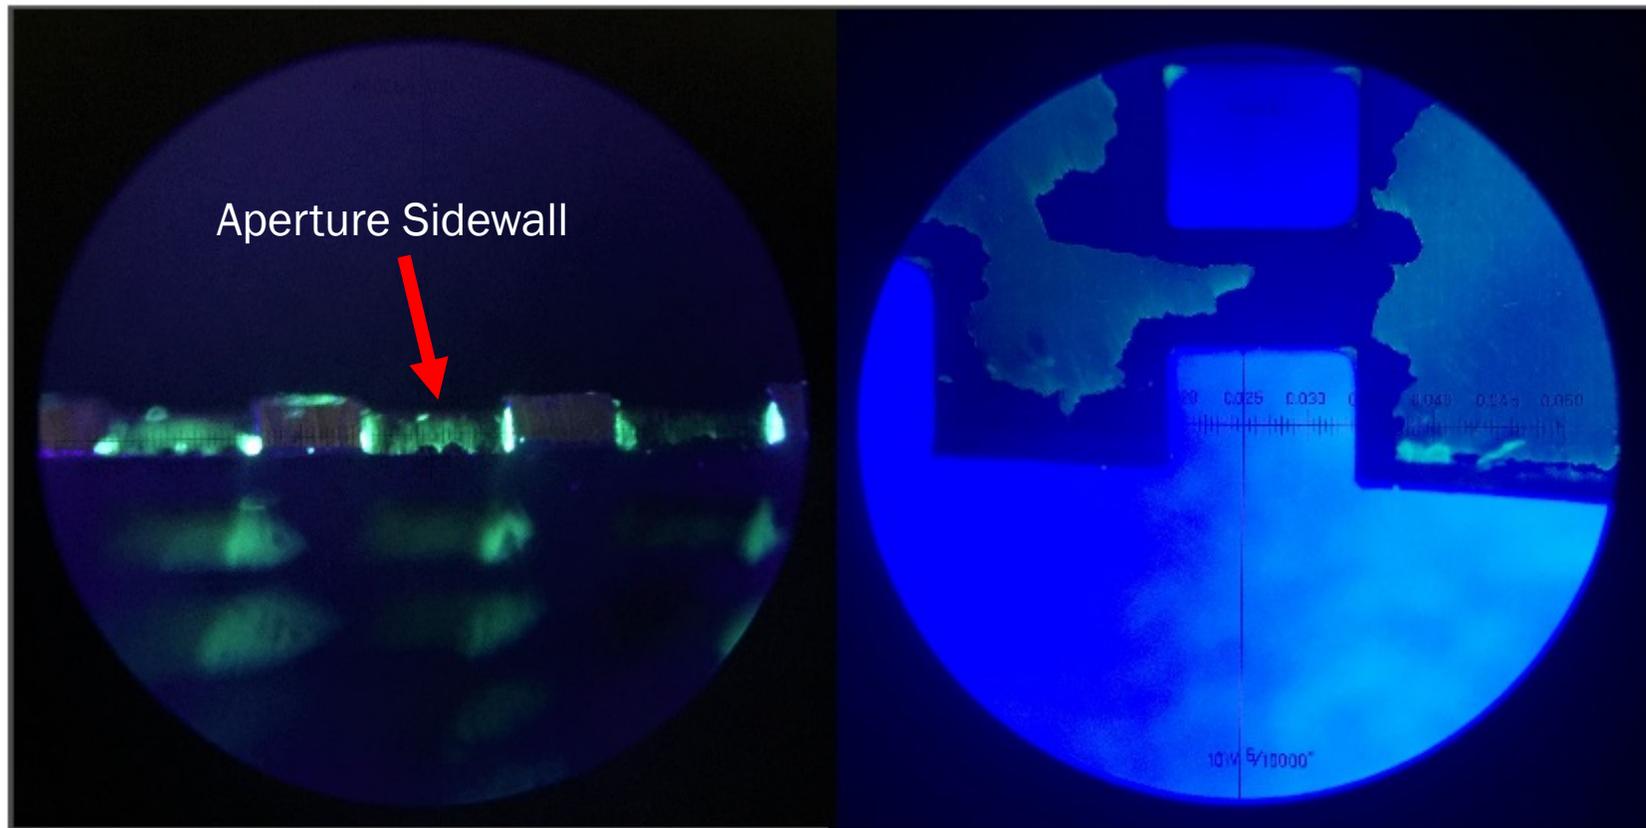
Mechanical Damage to Nano-Coatings Retired Stencil with > 10,000 Print Cycles

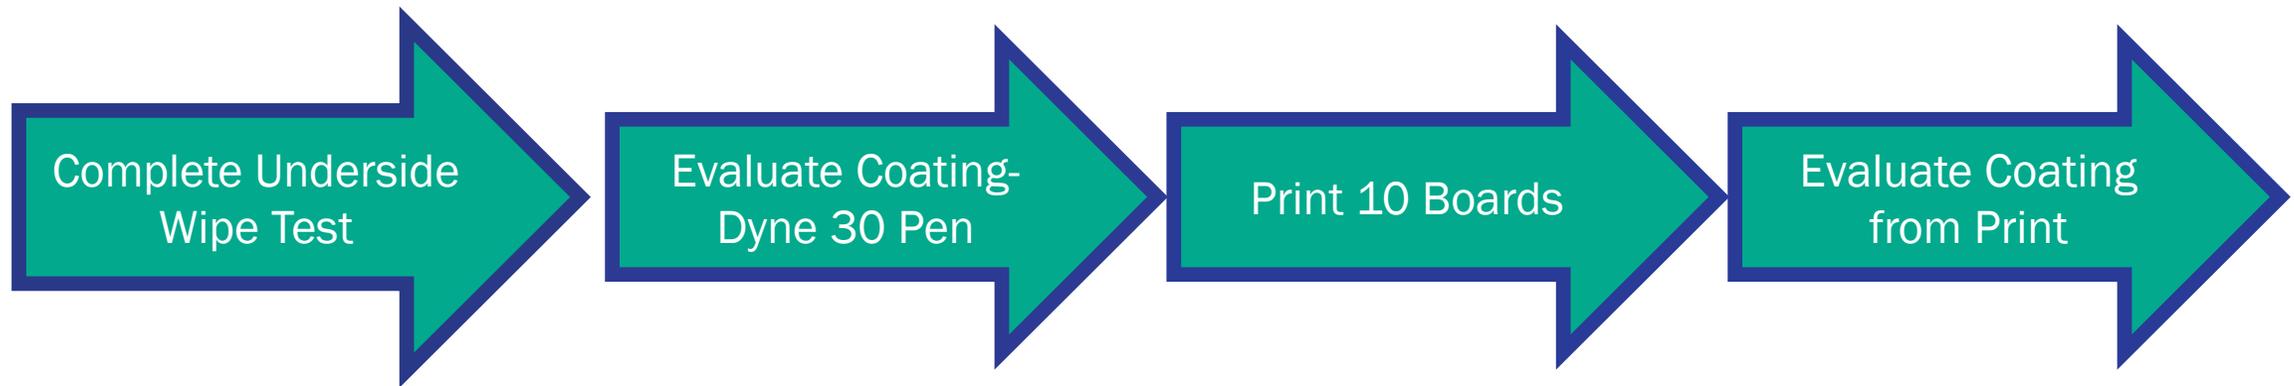
Mechanical Damage to Nano-Coatings Underside Wipe Test

Underside Wipe Test	Squeegee Print Test	50 Cycle Print Test
Coating	PHOS-2 and FPN	FPN	Hybrid(FPN/PHOS-2)
Variable Tested	1000 Dry Wipe Cycles	1000 Dry Squeegee Cycles	50 Print Cycles
Solder Paste	None	None	No Clean, SAC 305, Type 4
Squeegee Length	300 mm	300 mm	300 mm
Squeegee Wipe Material	Mid-Grade Stencil Wipe Material	No Underside Wipe	No Underside Wipe
Squeegee Pressure	1 Kg	12 Kg	12 Kg
Squeegee Speed	50 mm/sec	50 mm/sec	50 mm/sec

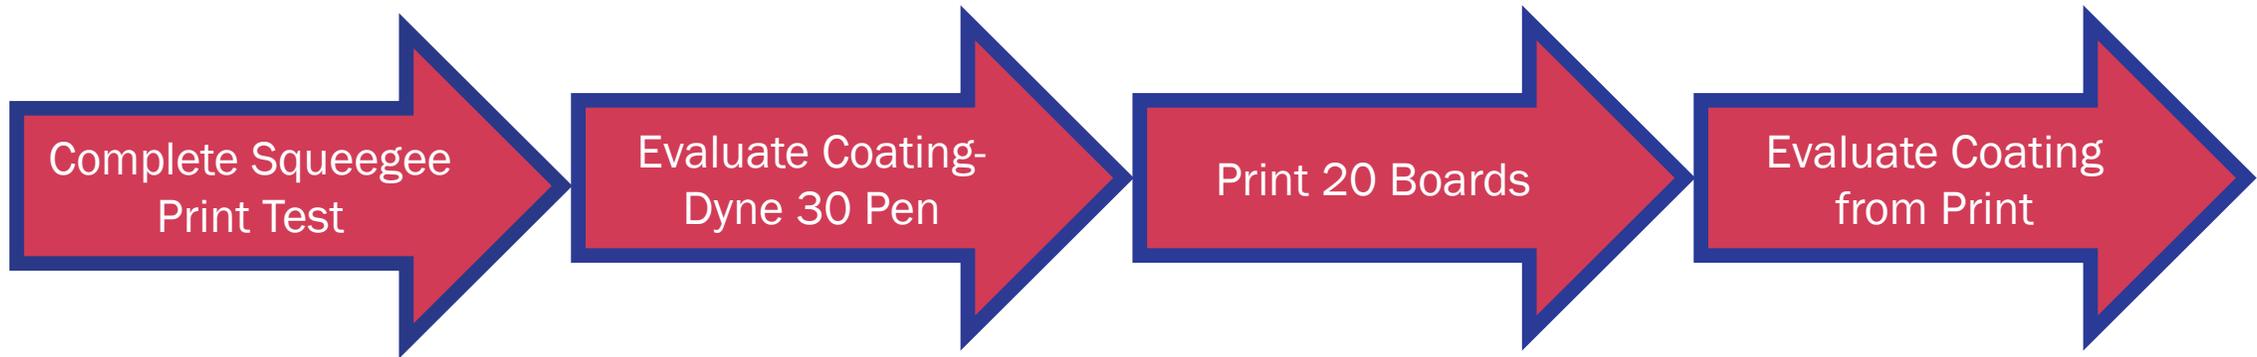
Mechanical Damage to Nano-Coatings Squeegee Print Test

2 Oz. Cu, HASL Test Vehicle

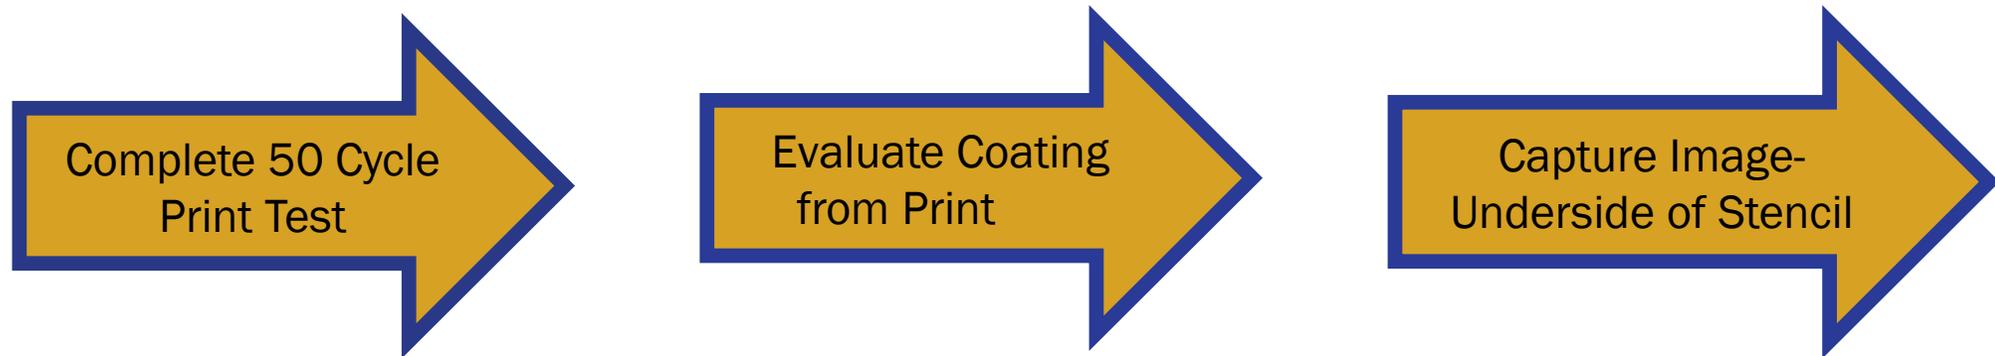
Mechanical Damage to Nano-Coatings 50 Cycle Print Test-Hybrid Technology

2 Oz. Cu, HASL Test Vehicle

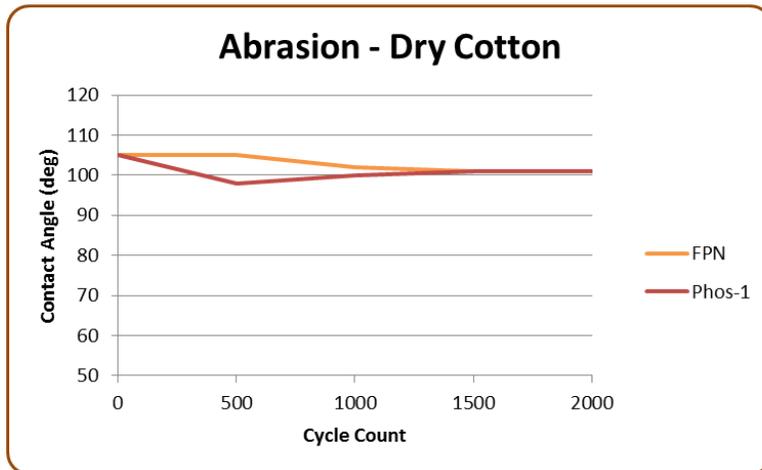
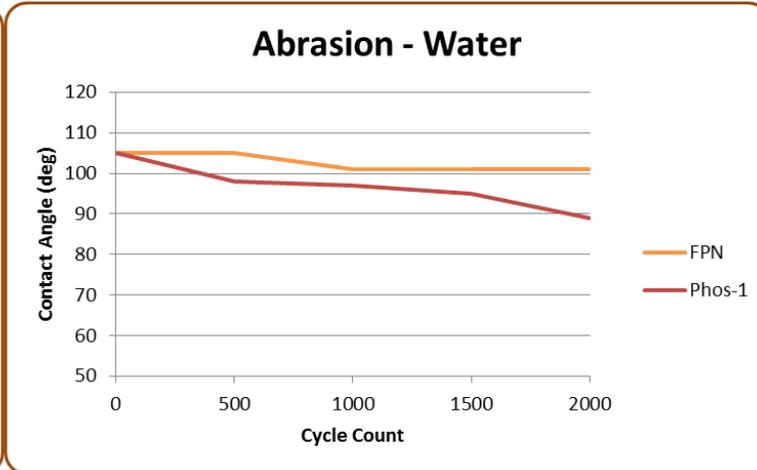
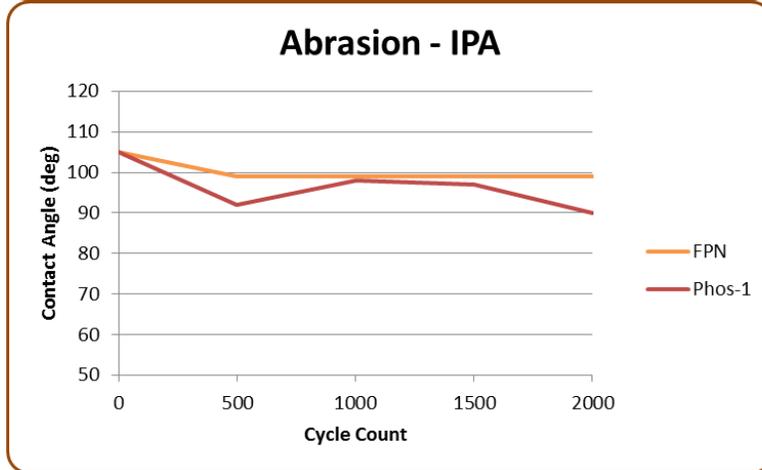
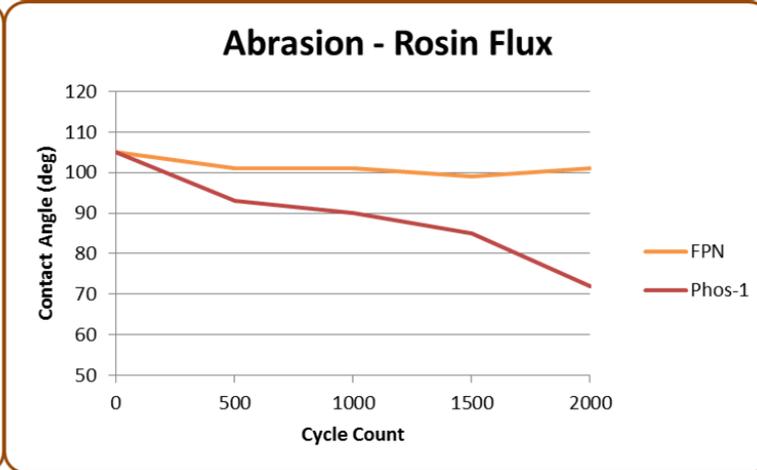
Chemical Damage to Nano-Coatings Scrub Test Results

Contact angle decrease indicates loss of hydrophobicity

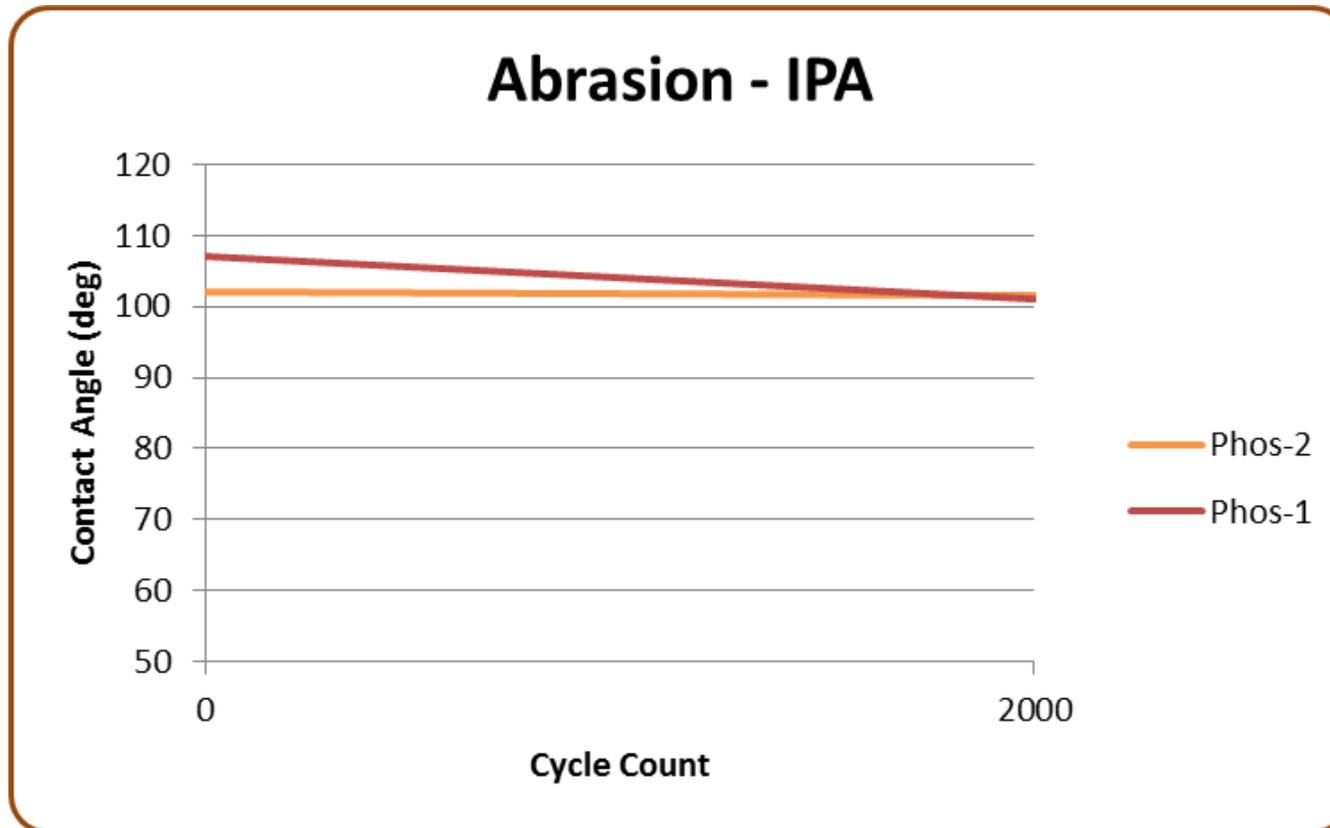
Chemical Damage to Nano-Coatings Scrub Test Results

Contact angle decrease
indicates loss of
hydrophobicity

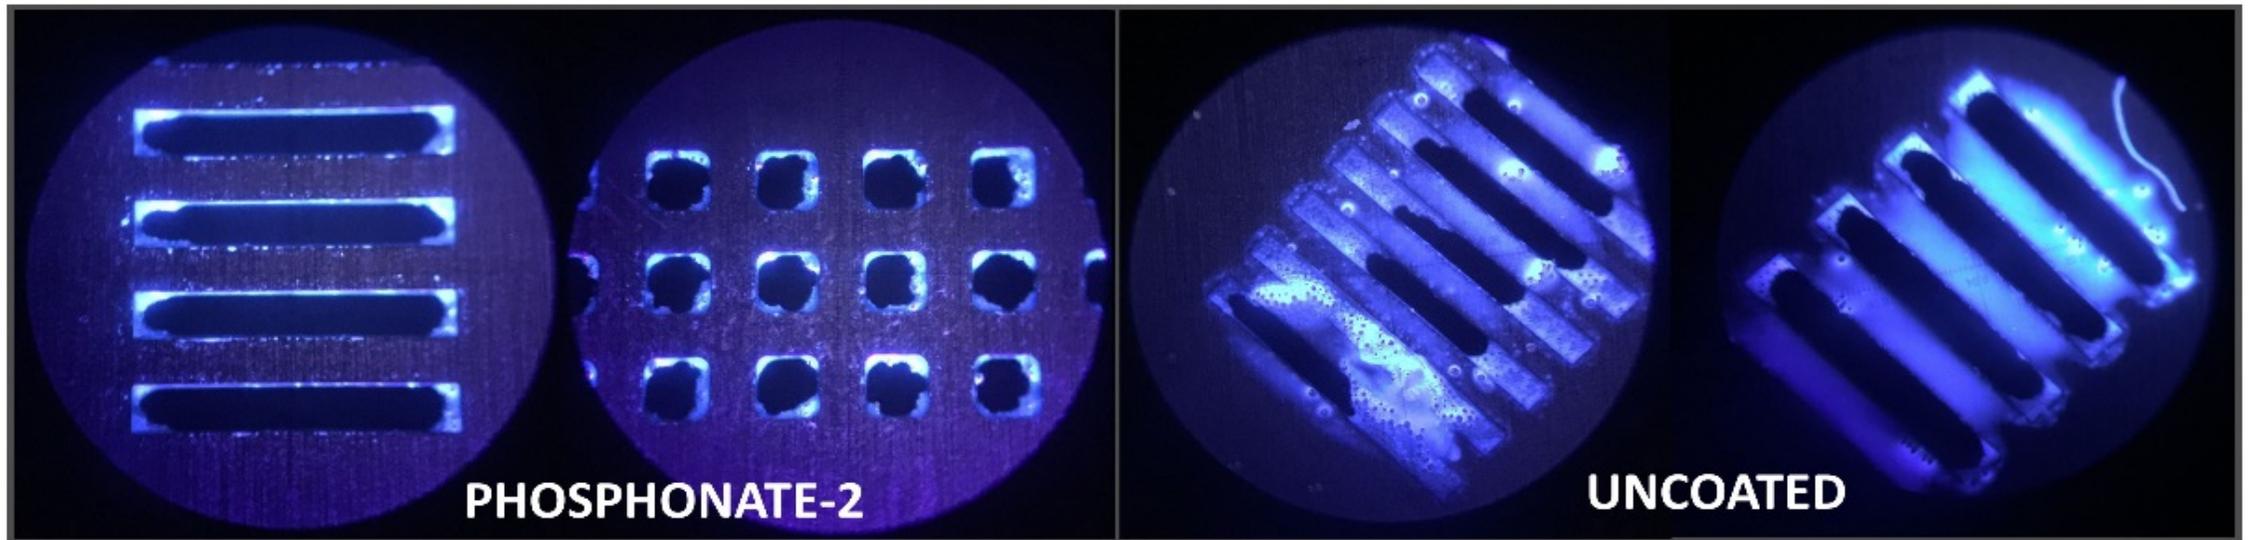
Mechanical Damage Testing Underside Wipe Test Results

10 Prints, No Under Side Wipe

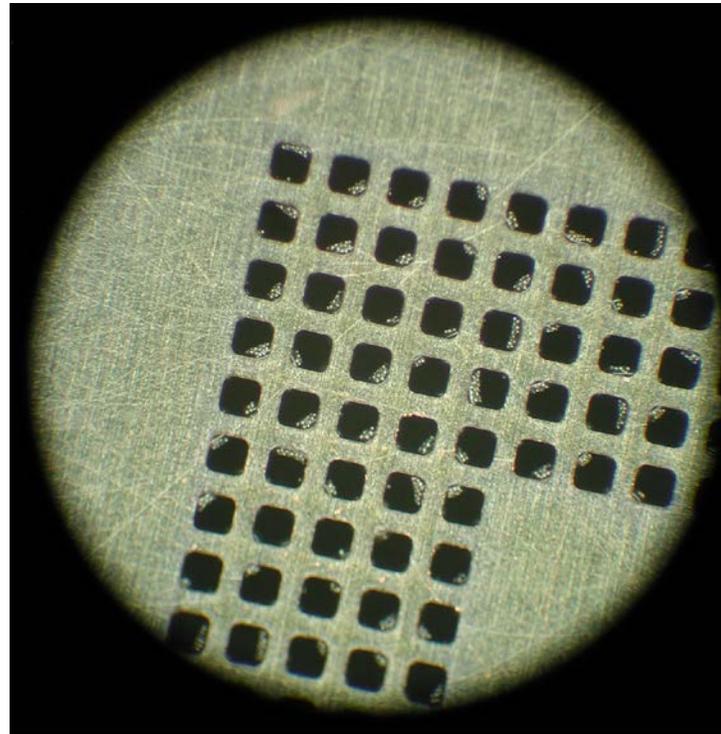
Mechanical Damage Testing Underside Wipe Test Results

20 Prints, No Under Side Wipe

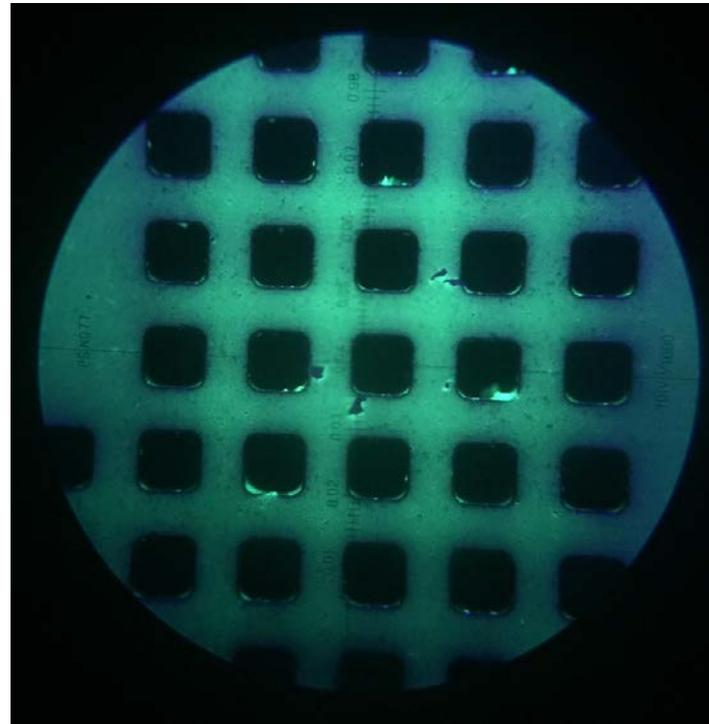
Mechanical Damage Testing Underside Wipe Test Results

Mechanical Wear after 1000 Underside Wipes

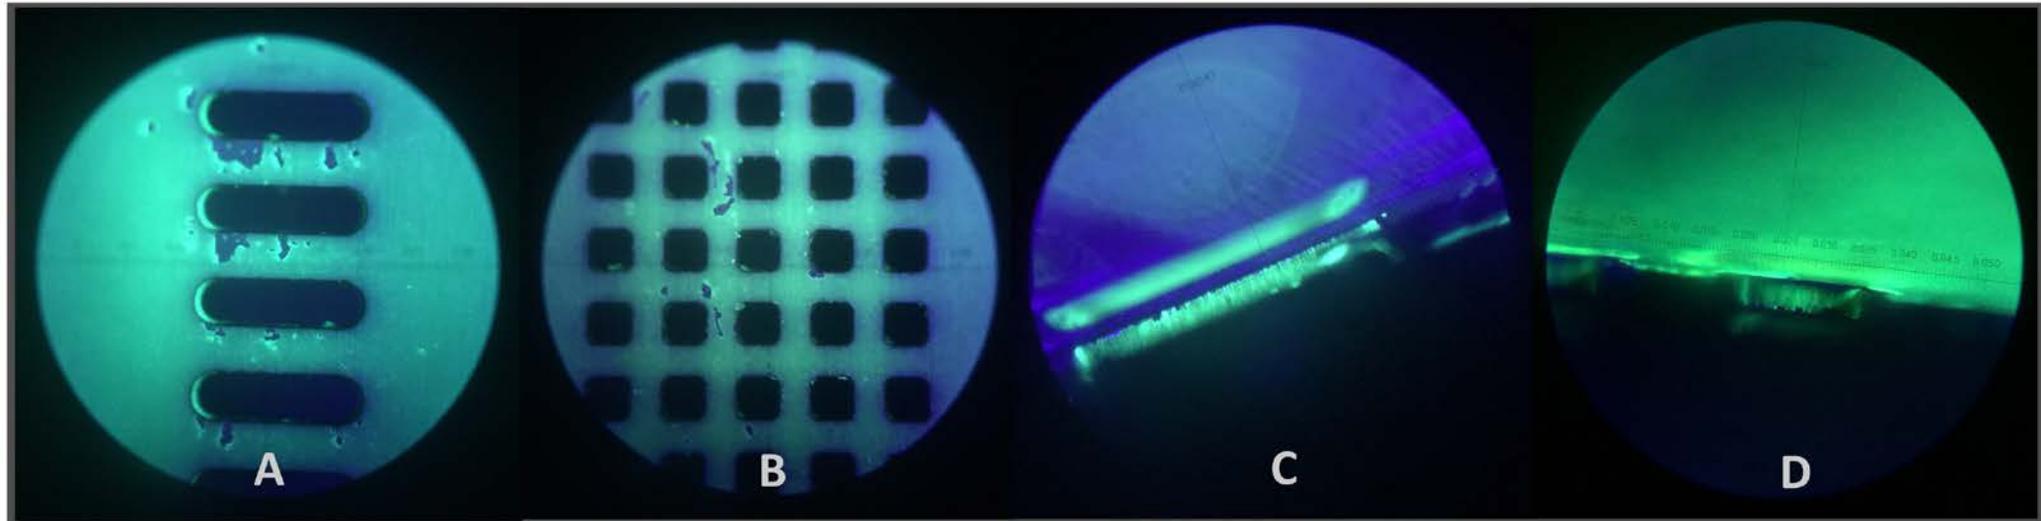
Mechanical Damage Testing Squeegee Print Test Results

Mechanical Damage after 1000 Dry Squeegee Prints
