AN INVESTIGATION INTO THE DURABILITY OF STENCIL COATING TECHNOLOGIES

Greg Smith and Tony Lentz
FCT Assembly
Greeley, CO, USA

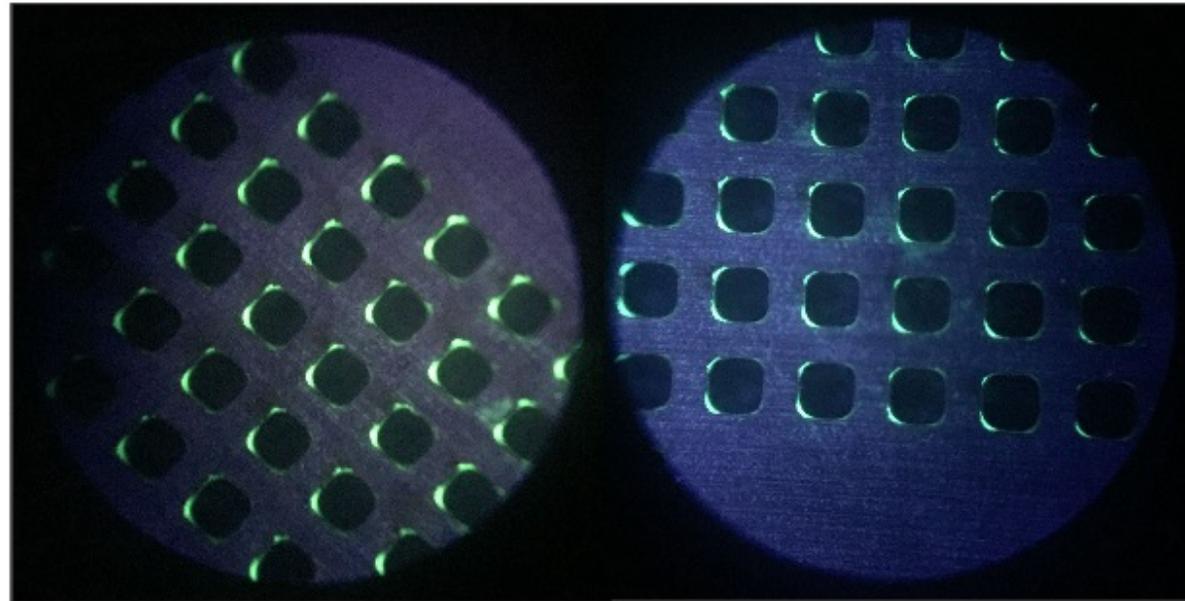
Mechanical Damage Testing 50 Cycle Print Test-Hybrid Results

R & D Hybrid Stencil

The final stencil nano coating that was tested was an R & D hybrid coating. The coating consisted of an FPN coating applied to the stencil aperture walls and the Phosphonate-2 coating being applied to the underside of the stencil. The advantage given by this new technology is the Phosphonate-2 coating provides a non-stick surface on the bottom of the stencil and the FPN coating gives solder paste printing benefits on the aperture walls. When wear occurs the Phosphonate-2 coating could be easily reapplied to the bottom of the stencil by the user. The images below (Figure 14) show the board side of the stencil with coating fluorescing on the apertures walls where the FPN coating is present.

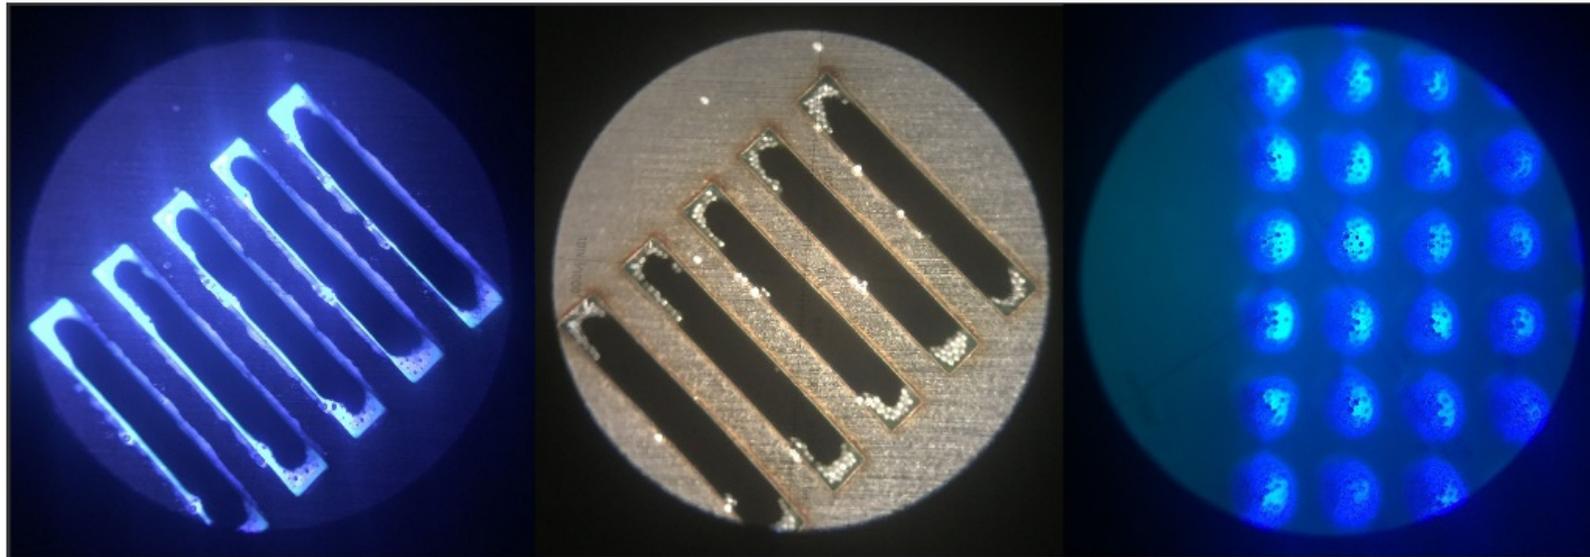
Mechanical Damage Testing 50 Cycle Print Test-Hybrid Results

R & D Hybrid Stencil
