Transient Solder Separation of BGA Solder Joint During Second Reflow Cycle

Steven Perng and Weidong Xie
Cisco Systems, Inc.
San Jose, CA

Transient Solder Separation of BGA Solder Joint During Second Reflow Cycle (Phase II)

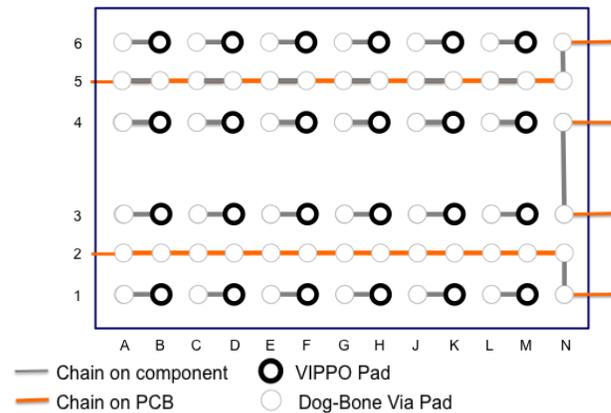
Figure 1 Daisy chain configuration at the VIPPO and dog-bone pad mixed design site, U2

In order to answer these questions, a unique daisy chain design with only one VIPPO joint per chain was incorporated (Figure 1). The VIPPO joint was surrounded by dog-bone via pads, which has a CTE mismatch of 16 versus 260 ppm/°C with Material A at temperature above Tg.

There are a total of 25 chains at U2 location, which has the VIPPO and dog-bone via mixed design. Twenty-four chains are single VIPPO and dog-bone via pair. With the expectation of no solder separation failures, the rest of the thirty dog-bone via pads are all chained together in the 25th chain.

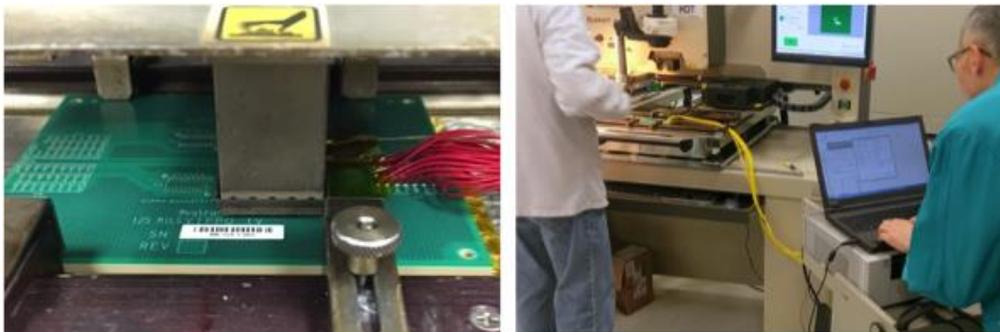
Figure 2 Experimental setup for the second reflow process

The test vehicles were assembled on a production SMT line. Then, they were reflowed again using a production rework station. Twenty-five daisy chains and two type-K thermocouples were wired to a data logger for real time data monitoring and recording.

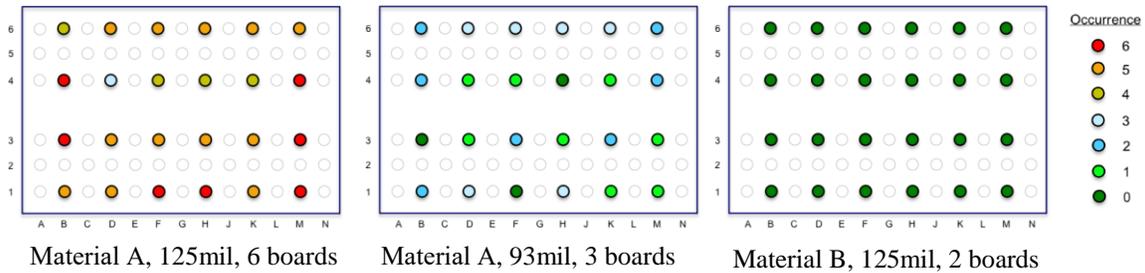
Figure 3 Frequency of Separated Solder Joint Location Analysis

The location analysis depicting the frequency of separated solder joints are shown in Figure 3. Please note that the total number of boards are different. As shown in Table 2, there are 6 boards for 125mil Material A, 3 boards for 93mil Material A, and 2 boards for 125mil Material B.

The pin mapping illustrating the frequency of separation was to determine if there is any significant failing trends on corner versus edge or inner pins. For the 125mil Material A boards, all 7 pins with 100% failing rate (6 out of 6) were all edge pins. A similar trend occurs with the 93mil Material A boards: all 6 pins with 100% failing rate (3 out of 3) were all edge pins. However, corner pins fail less frequently in both thicknesses. This may be an indication that the CTE mismatch (between VIPPO and dog-bone pad design) inducing the local stress (or warpage) is dominating the thermal stress inducing the global warpage during the reflow cycle. In other words, the typical thermal Moiré warpage measurement may not serve as an effective control gate for alerting of solder separation.

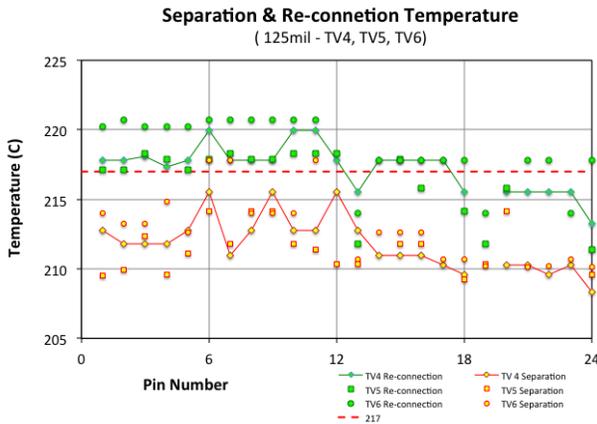
Figure 4 Separation and Re-Connection Temperature

Since each daisy chain has only one VIPPO pad, the separation and reconnection temperature can be detected when the resistance value changes abruptly. A sample analysis using 125mil TV4, TV5, and TV6 is shown in Figure 4. Out of the 71 VIPPO joints on these three boards, 63 separated. All 63 separated VIPPO joints re-connected in a short period of time.

The majority of the VIPPO solder joint separation initiated between 210°C and 215°C and re-connected just above 217°C. It indicates the VIPPO solder joint separates from substrate in solid state, just before melting. Therefore, the failure mechanism is similar to the brittle crack along the IMC line.

Due to the differences of thermocouple installation, the temperature reading of the reflow simulator is higher than the rework thermocouple readings by 7~10°C. After adjusting with liquidus temperature and synchronization with the data logger, the separation is initiated at 211~214°C and reconnects at 215~218°C. This is consistent with the resistance-temperature measurement from the data logger (Figure 4).

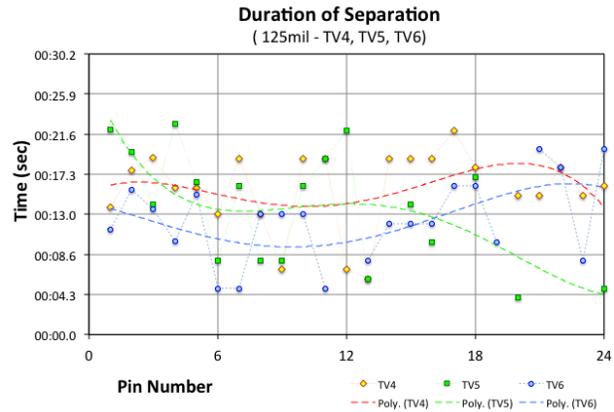
Figure 5 Duration of Separation

The duration of separation is defined as the time when the resistance value changes abruptly to a value that is less than 10 Ohms. As shown in Figure 5, the duration is in the range of 4 ~ 22 sec. The overall trend is between 9 ~ 18sec.

and component substrate, when the solder is in solid state. The solder joint starts to melt at 2:42 (222°C). As the surface reflection pattern changes, the solder joint becomes fully liquidus at around 2:50 (224°C). The solder joint re-connects at 2:53 (225°C). The duration of separation is about 18 seconds, which is consistent with the data from resistance value measurements in Figure 5.

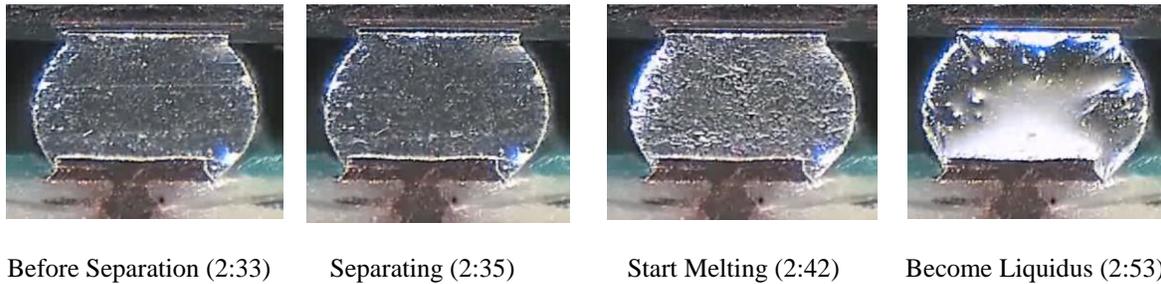
Figure 6 Solder Joint Images from Reflow Simulator

In Figure 6, the four images are from the same VIPPO joint at different time of the reflow cycle. Comparing to the image on the very left (2:33), the VIPPO joint in the middle left at time code 2:35 (221°C) exhibits a separation between the solder ball

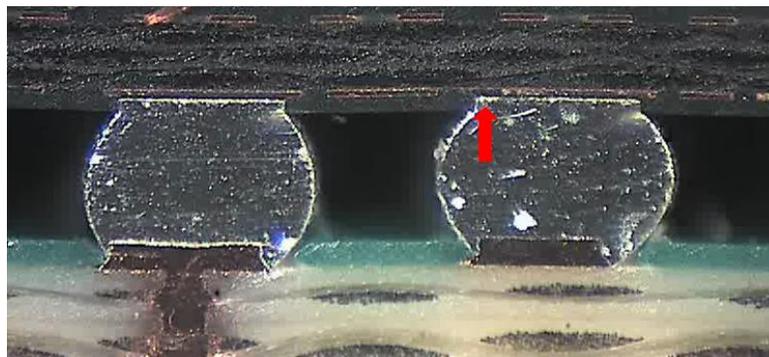
Figure 7 Solder joint image prior to separation, the dog-bone joint at the right side showed an upward pushing

By reviewing the video, it is observed that the dog-bone joints showed upward pushing as the reflow temperature increases, due to the excessive out-of-plane thermal expansion of the PCB material (as the red arrow indicates in Figure 7). The VIPPO joint separates before solder liquidus at the interface between solder and IMC of the component side; a small magnitude of pop-up of VIPPO joint at such an interface has been observed along with the sign of relief of upward pushing of the nearby dog-bone joint (Figure 8).

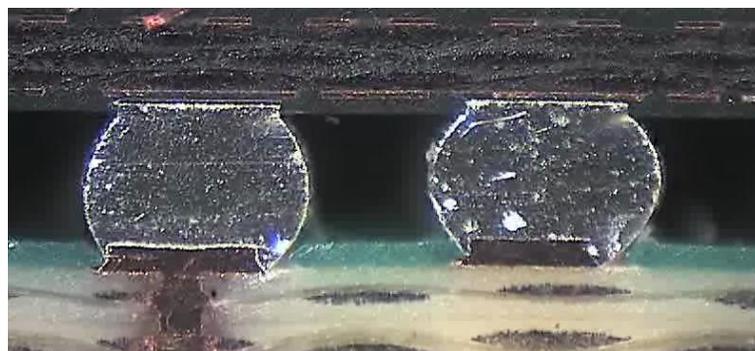
Figure 8 Solder joint image post separation, a pop up at the interface of VIPPO joint has been observed. Also, notice the relieve of the dog-bone joint on the right side

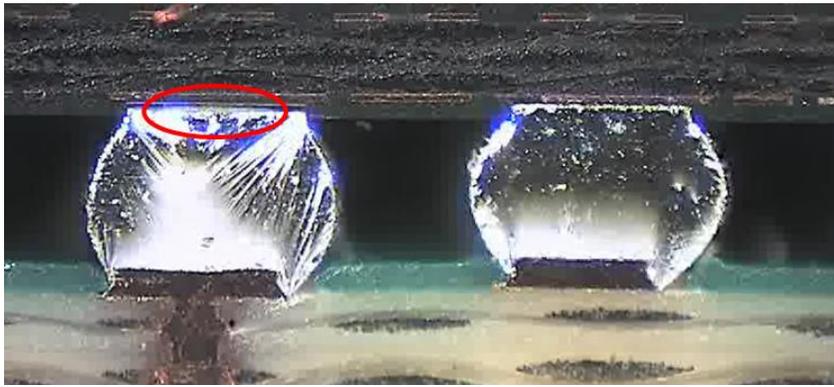
Figure 9. Molten solder of a separated VIPPO joint (left in the picture) retouching the top pad

Post-melting point, the molten solder forms a spherical shape due to the surface tension, and the solder sphere retouches the previously separated top pad (the red circle in Figure 9 shows the retouching). The phenomenon is consistent with the datalogger monitoring and confirms the previous FA findings [1] as shown in Figure 10.

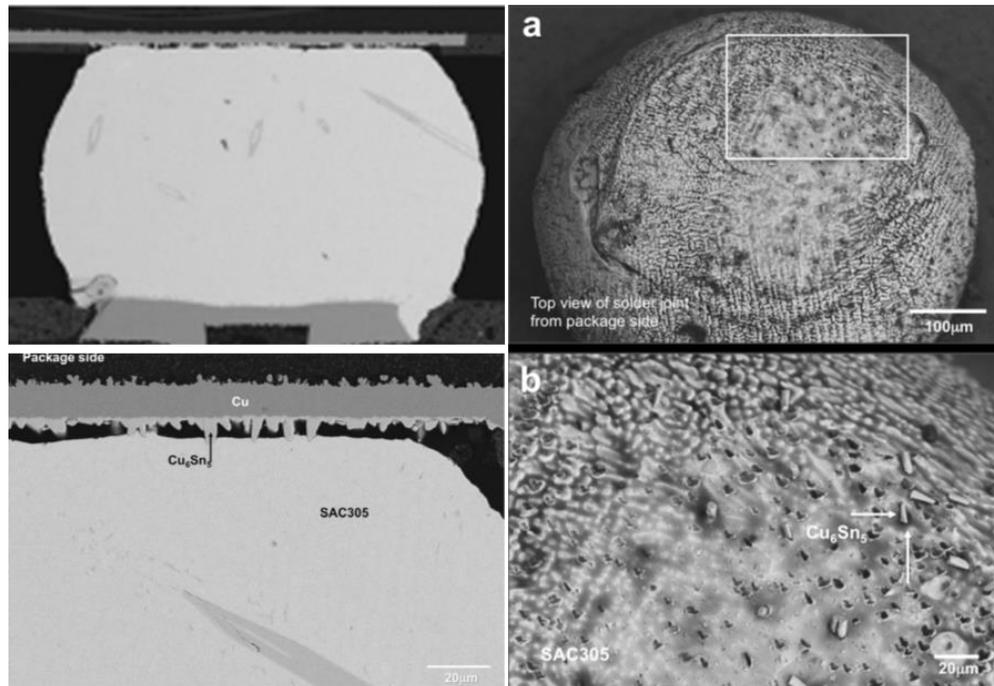
Figure 10. Cross section view of separation (left), and IMC pinching marks (right)

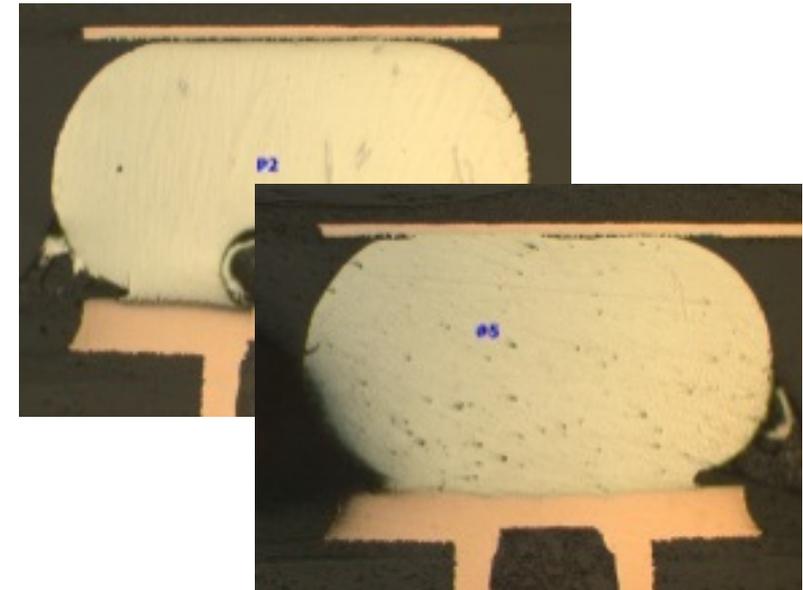
What Is Solder Separation

- Solder Separation is observed after the 2nd reflow cycle with a VIPPO and Dog-bone via mixed design.
- After separated, the solder joint can be either fully separated or form a partially connected joint without coalescing into a reliable solder joint.
- The partially connected solder joints are likely to pass electric tests.
- In the field, under certain mechanical or thermal stress, it may fail.
- It is considered as a High Risk Latent Defect.

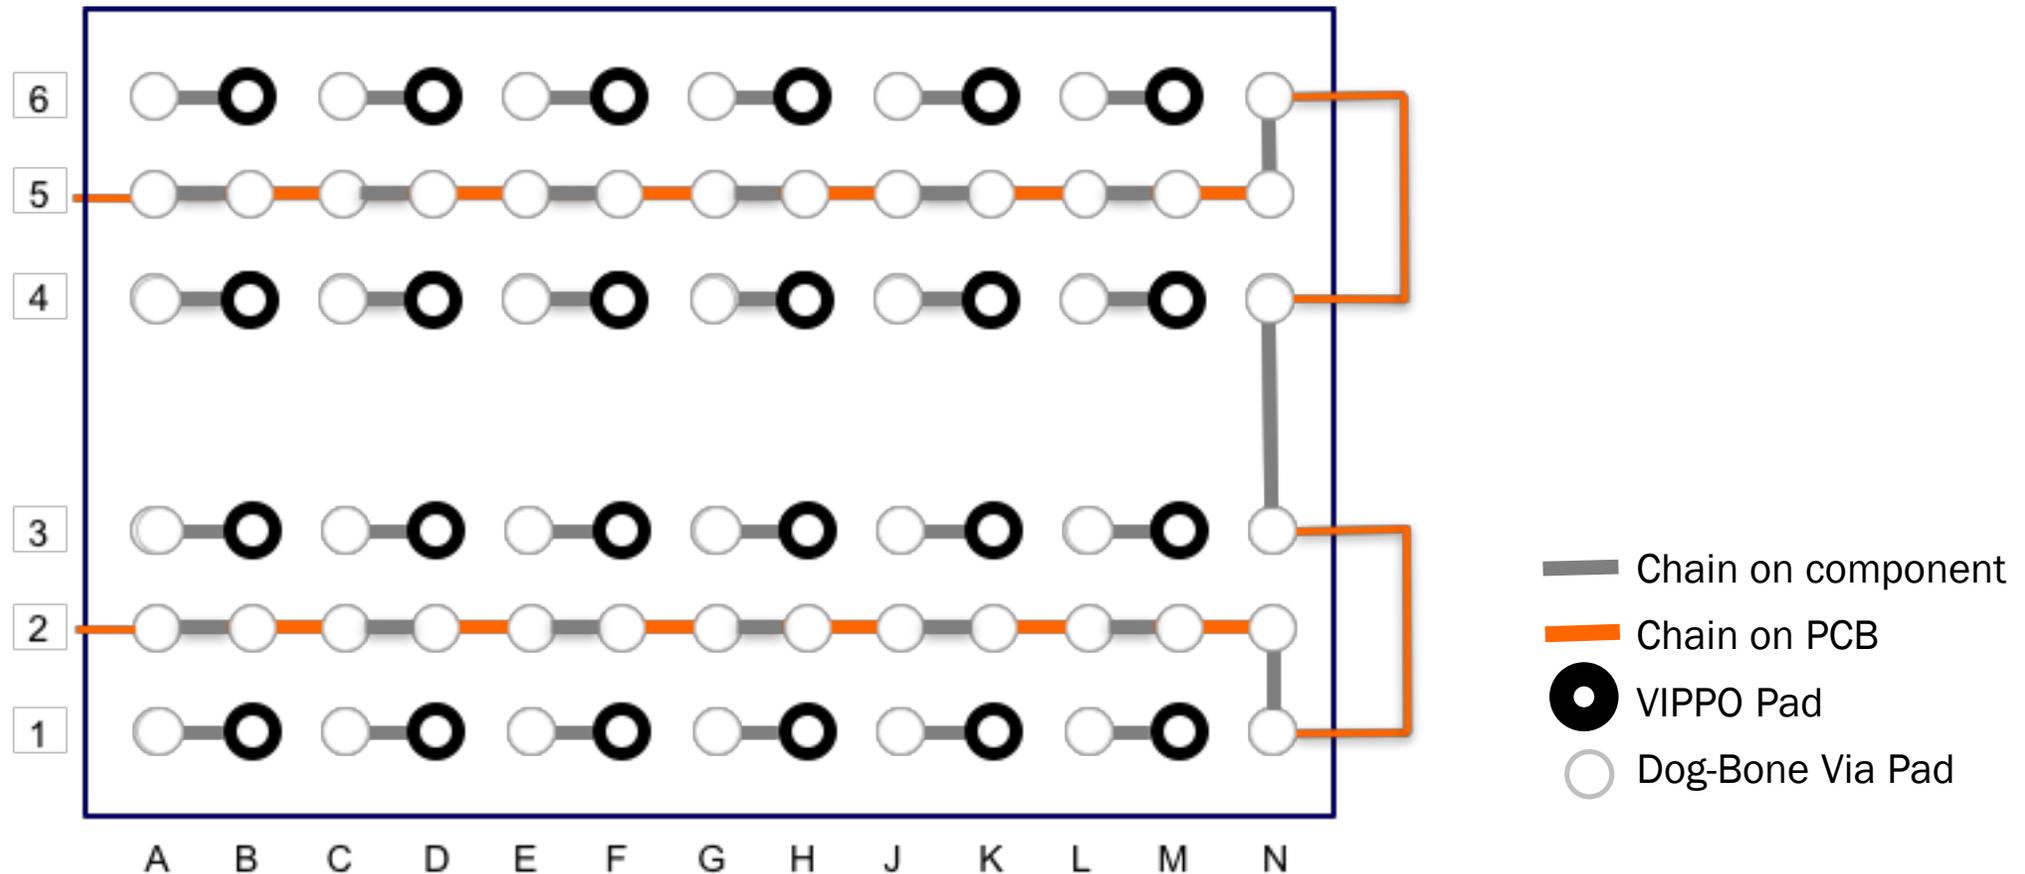
Test Vehicle & Daisy Chain Design

The test vehicle is designed such that each VIPPO pad is surrounded by dog-bone via pads and each of the VIPPO joints has independent daisy chain for in-situ monitoring during the second reflow cycle.

There are four different pad designs: all VIPPO design; VIPPO and dog-bone mixed pad design; VIPPO and skip via mixed pad design; and back-drilled VIPPO mixed pad design. The all VIPPO design is the baseline benchmark. The VIPPO and dog-bone mixed pad design is expected to be the worst case scenario. The VIPPO and skip via mixed pad design together with the VIPPO and back-drilled VIPPO mixed design are included to narrow the magnitude of inherent build-in stress induced by the CTE mismatch which causes the VIPPO joints to separate during the second reflow.

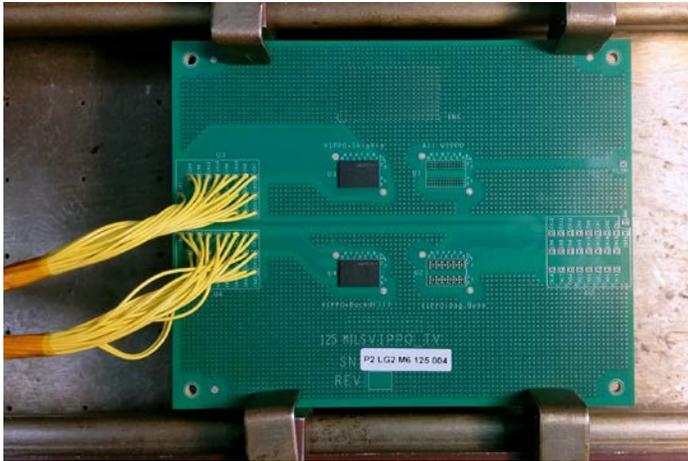
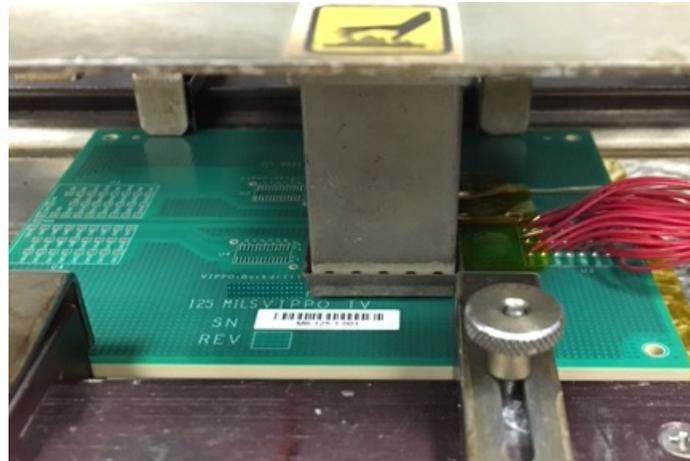
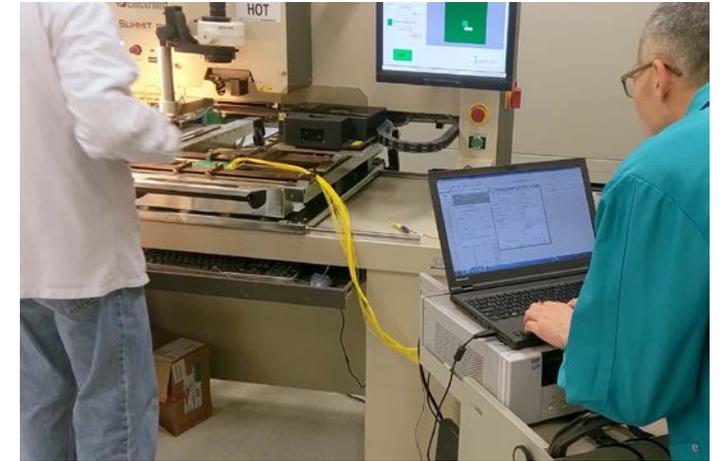
Experimental Setup For The 2nd Reflow Cycle

- The DoE includes U1 (All VIPPO) and U2 (VIPPO & Dog-bone) Mixed sites.
- Both components have been assembled by SMT process.
- There are 28 chains built-in, including 24 for VIPPO's, 1 for dog-bone, 1 for All VIPPO, and 2 for T/C's.

- A BGA rework station is used for the 2nd reflow cycle.
- A nozzle is used to reflow both sites simultaneously.
- One T/C is placed on the board between two sites to monitor the board temperature.
- The other T/C is placed underneath the component.

- A Multifunctional Switch/Measurement Unit is used for real time in-situ resistance monitoring.

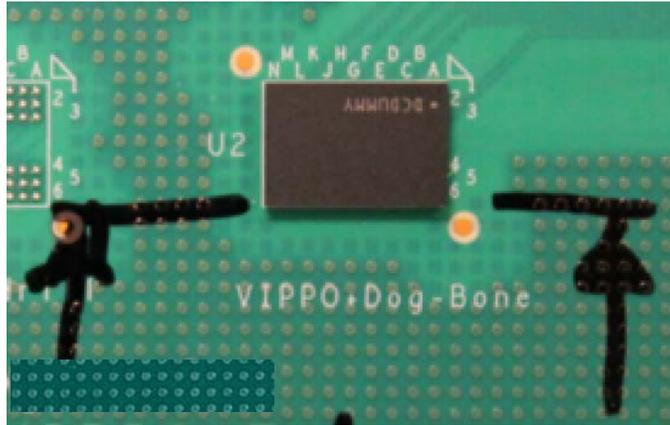
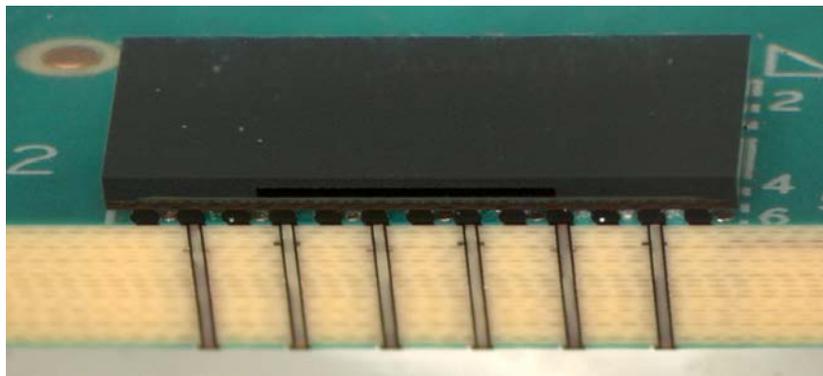
Sample Preparation

- Polish the sample to 1/3 of the first row
- Sent two samples to a third party lab for high resolution reflow simulation
- One sample is for 4-ball macro view
- The second sample is for a 2-ball zoom-in view
- The reflow simulator is equipped with a convection hot air with profiling capability.

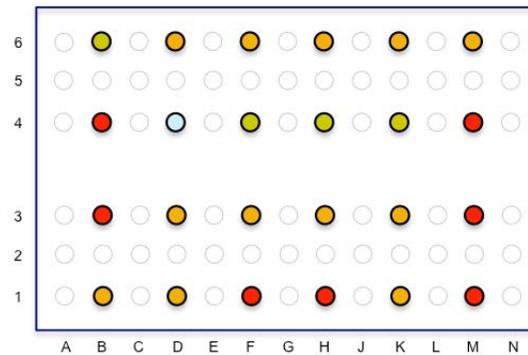
Material A, 125mil, 6 boards

- **84%** VIPPO joints separated (120 out of 143)
- **7 out of 24** joints consistently failed on all 6 boards. All seven joints are on **peripheral**.
- Each of the joints failed at least on 3 out of the 6 boards.

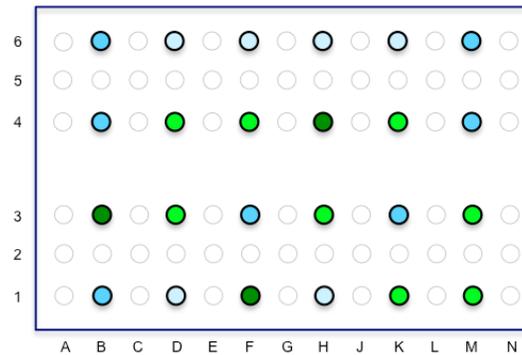
Material A, 93mil, 3 boards

- **58%** VIPPO joints separated (40 out of 69)
- **6 out of 24** joints consistently failed on all 3 boards, all six joints are on **peripheral**.
- 3 joints didn't separate for all three boards.

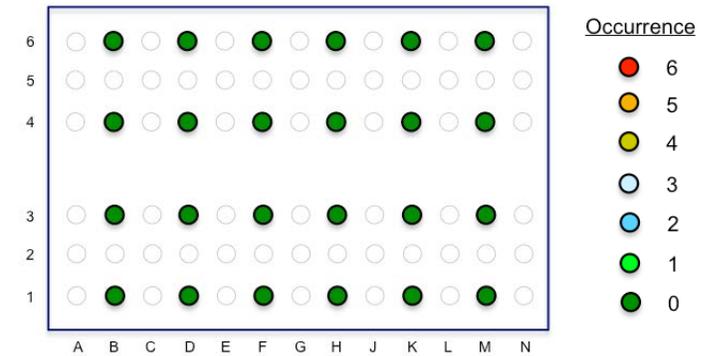
Material B, 125mil, 2 boards

- **No separation** found on 2 boards, total of 48 VIPPO joints.

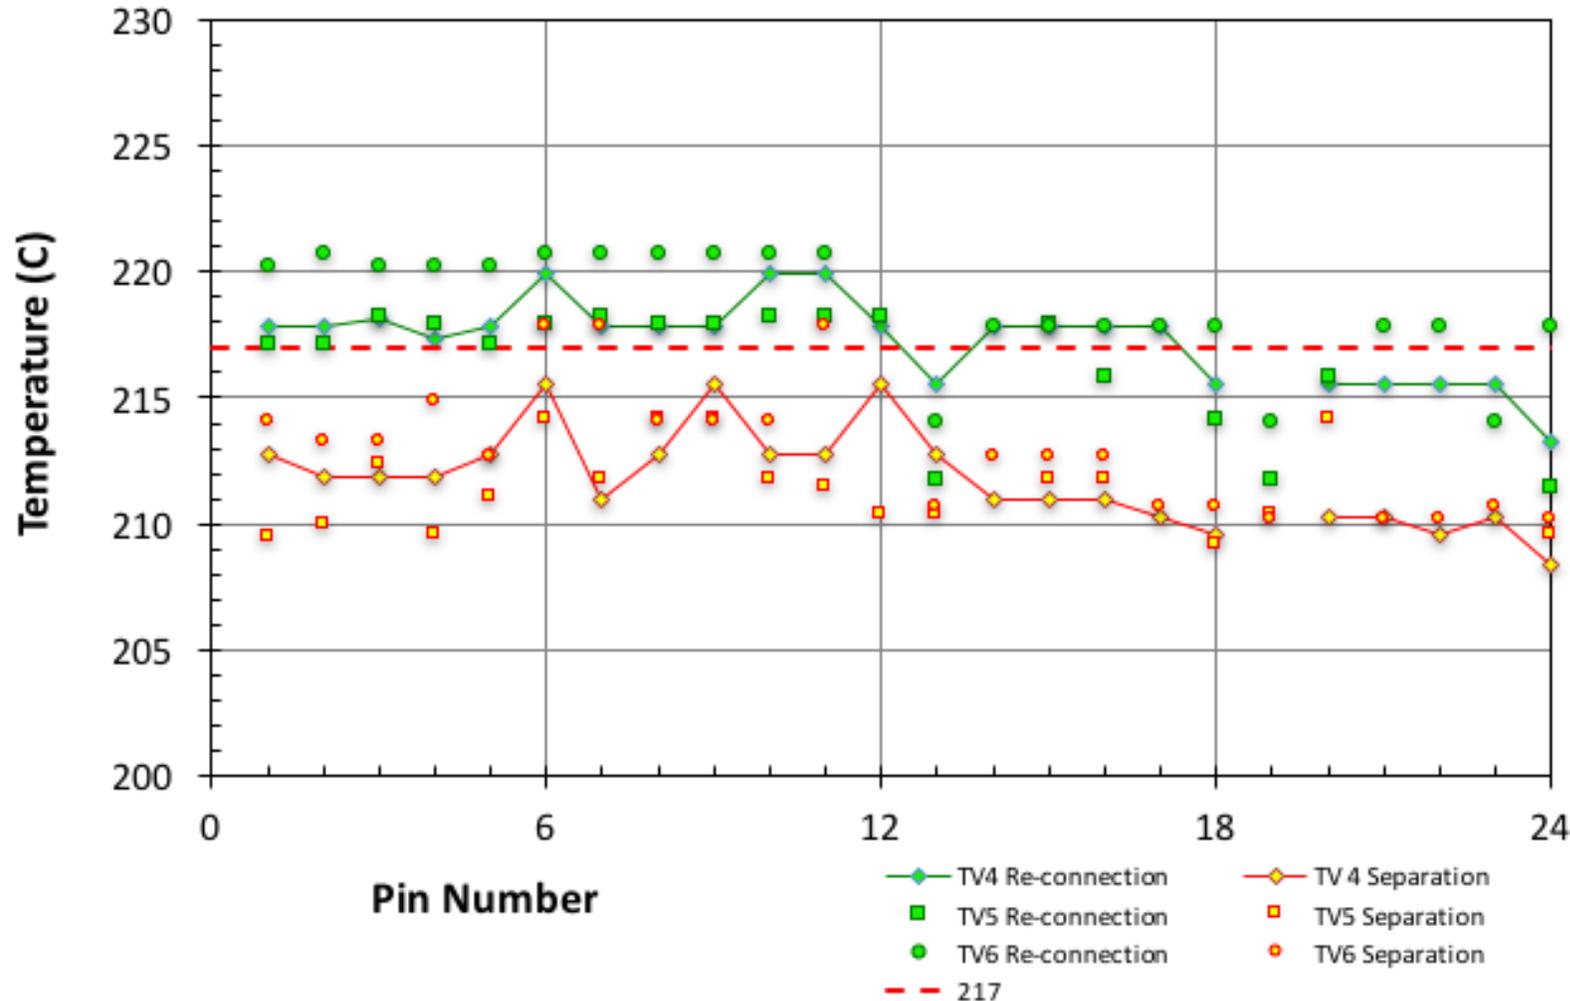
Separation & Re-connection Temperature

TV4, TV5, and TV6 of 125mil Material A are selected for analysis.

Pin 1~5 are in Data Logger 1; while Pin 6~24 are in Data Logger 2.

Pin 1~12 are toward the edge of the nozzle; while Pin 13~24 are in the center of the nozzle. Minor temperature difference is possible.

In general, the separation occurred around 210~215C, during the solid phase (before melted).

The re-connection occurred around 215~220C, either in solid phase or in liquid phase (after melting).

All the separated solder joints were re-connected.

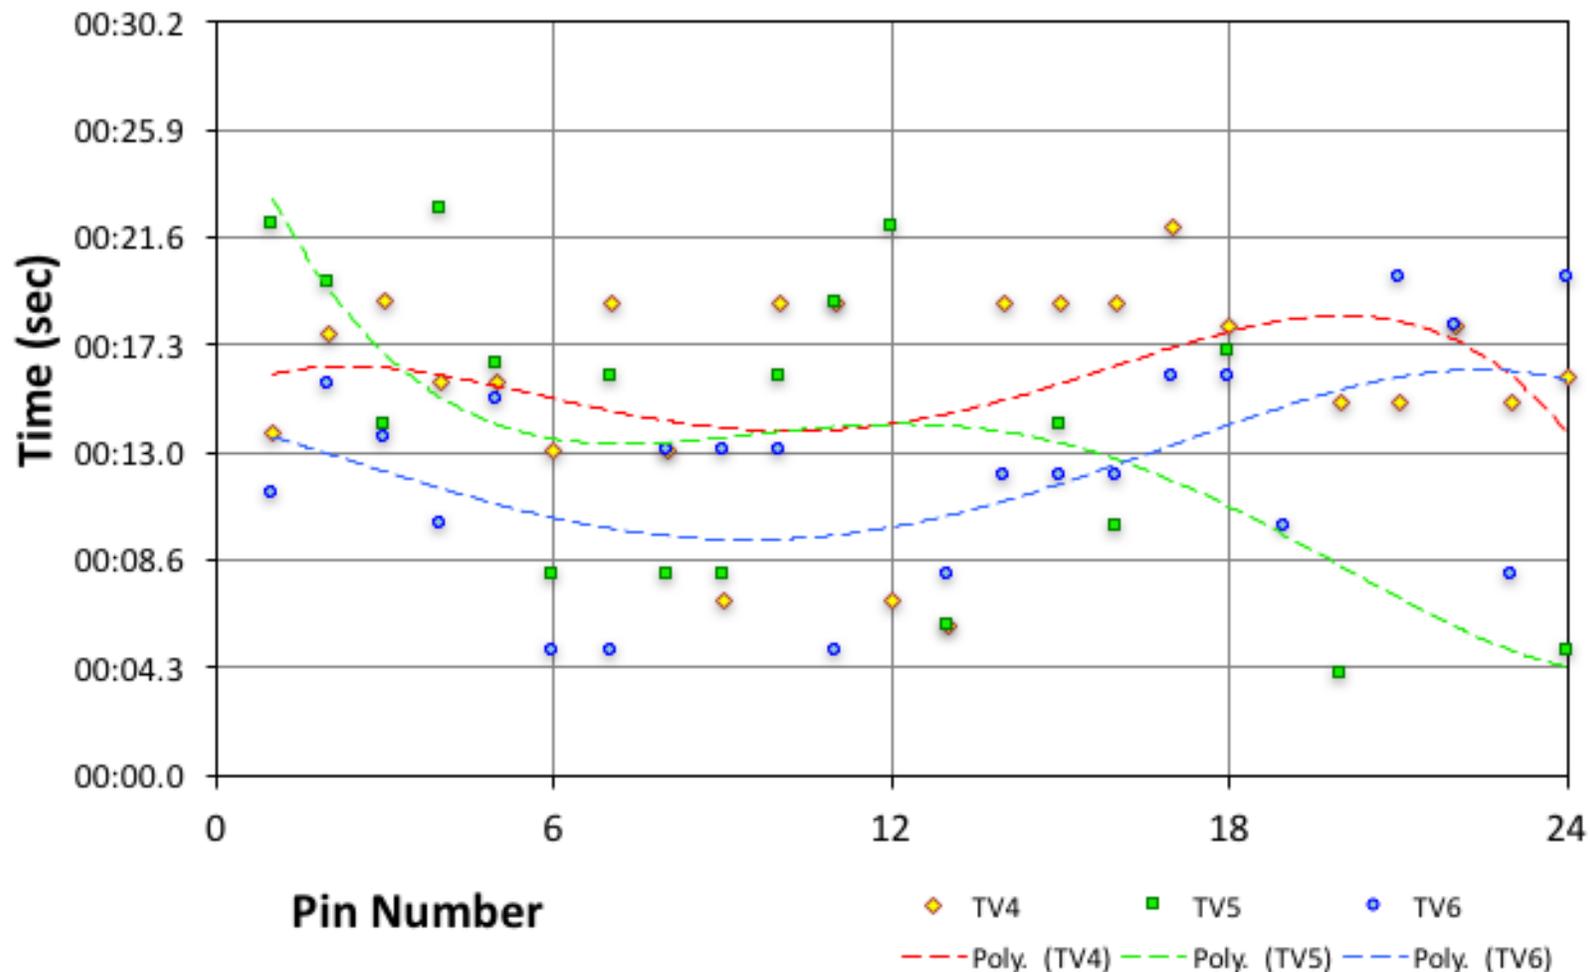
Duration of Separation

- The duration of separation is around 4~20 sec.
- TV5 has only 2 out of 6 joints separated, which may skew the trend.
- Majority of separation duration are around 12~18 sec.

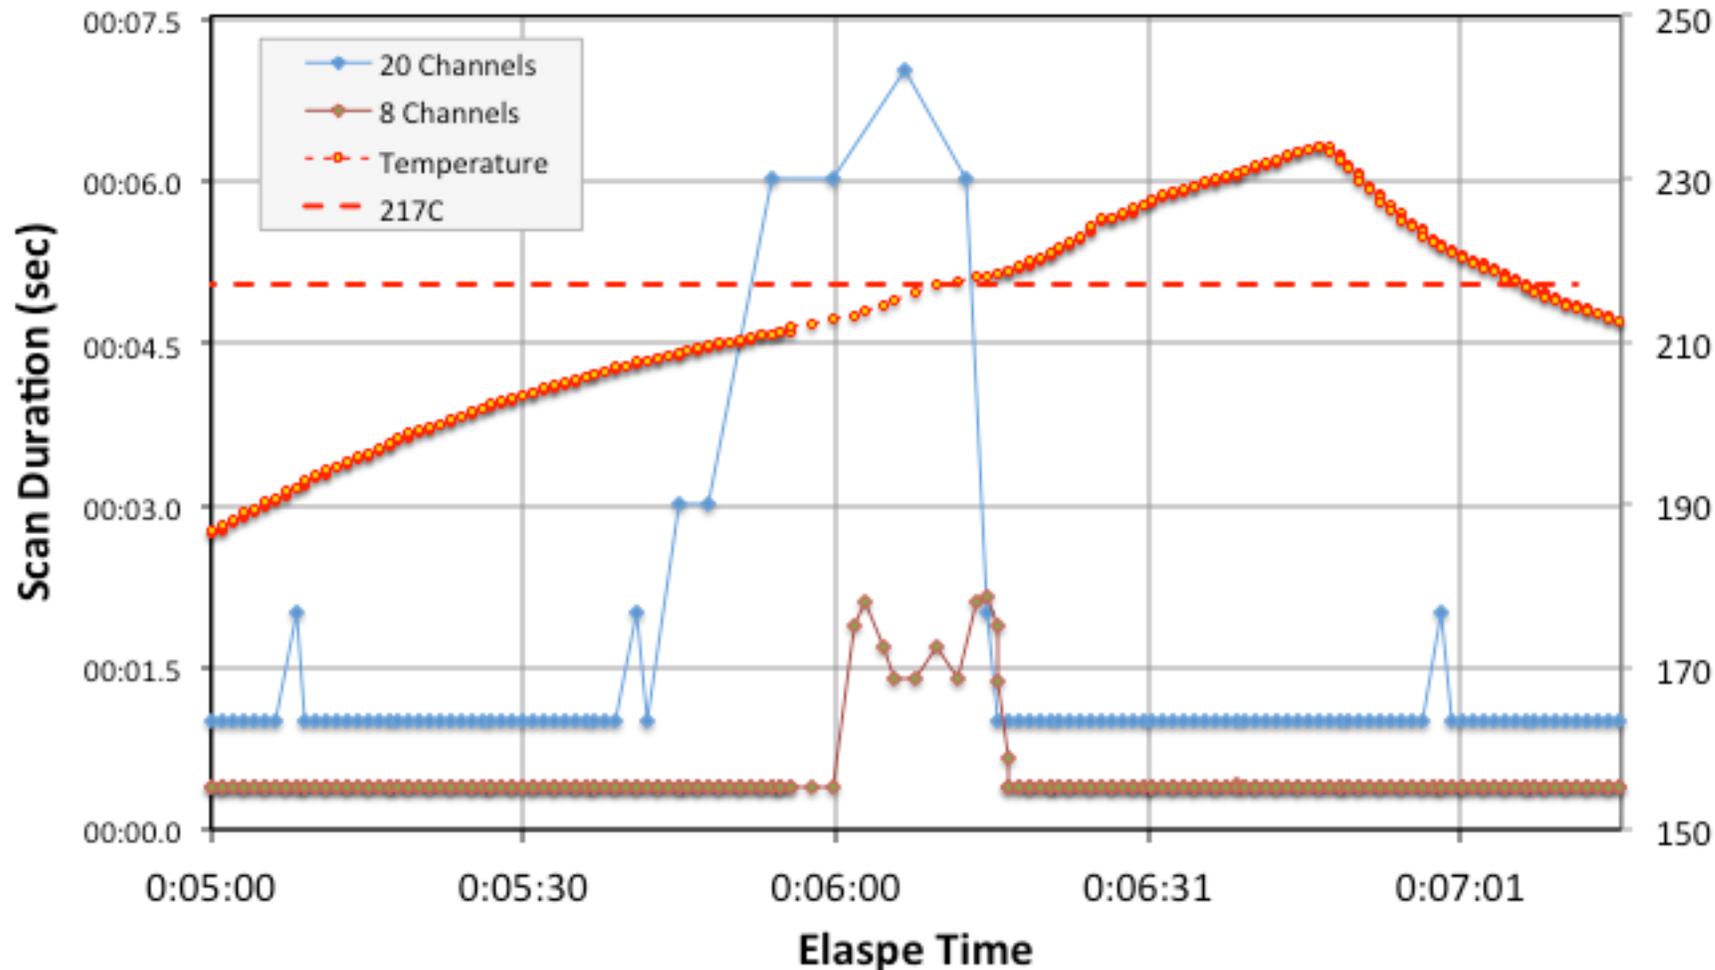
Scan Rate Analysis of One And Two Data Loggers Mode (TV4a vs. TV4b)

- All resistance and temperature measurements are routed to the data logger.
- The typical scan rate is 0.4 sec and 1 sec for 8- and 20- channel, respectively.
- However, when the measurement data is toward the MAX detection value and eventually Out-Of-Range, the scan rate increases to 2 sec and 7 sec for 8- and 20-channel, respectively.

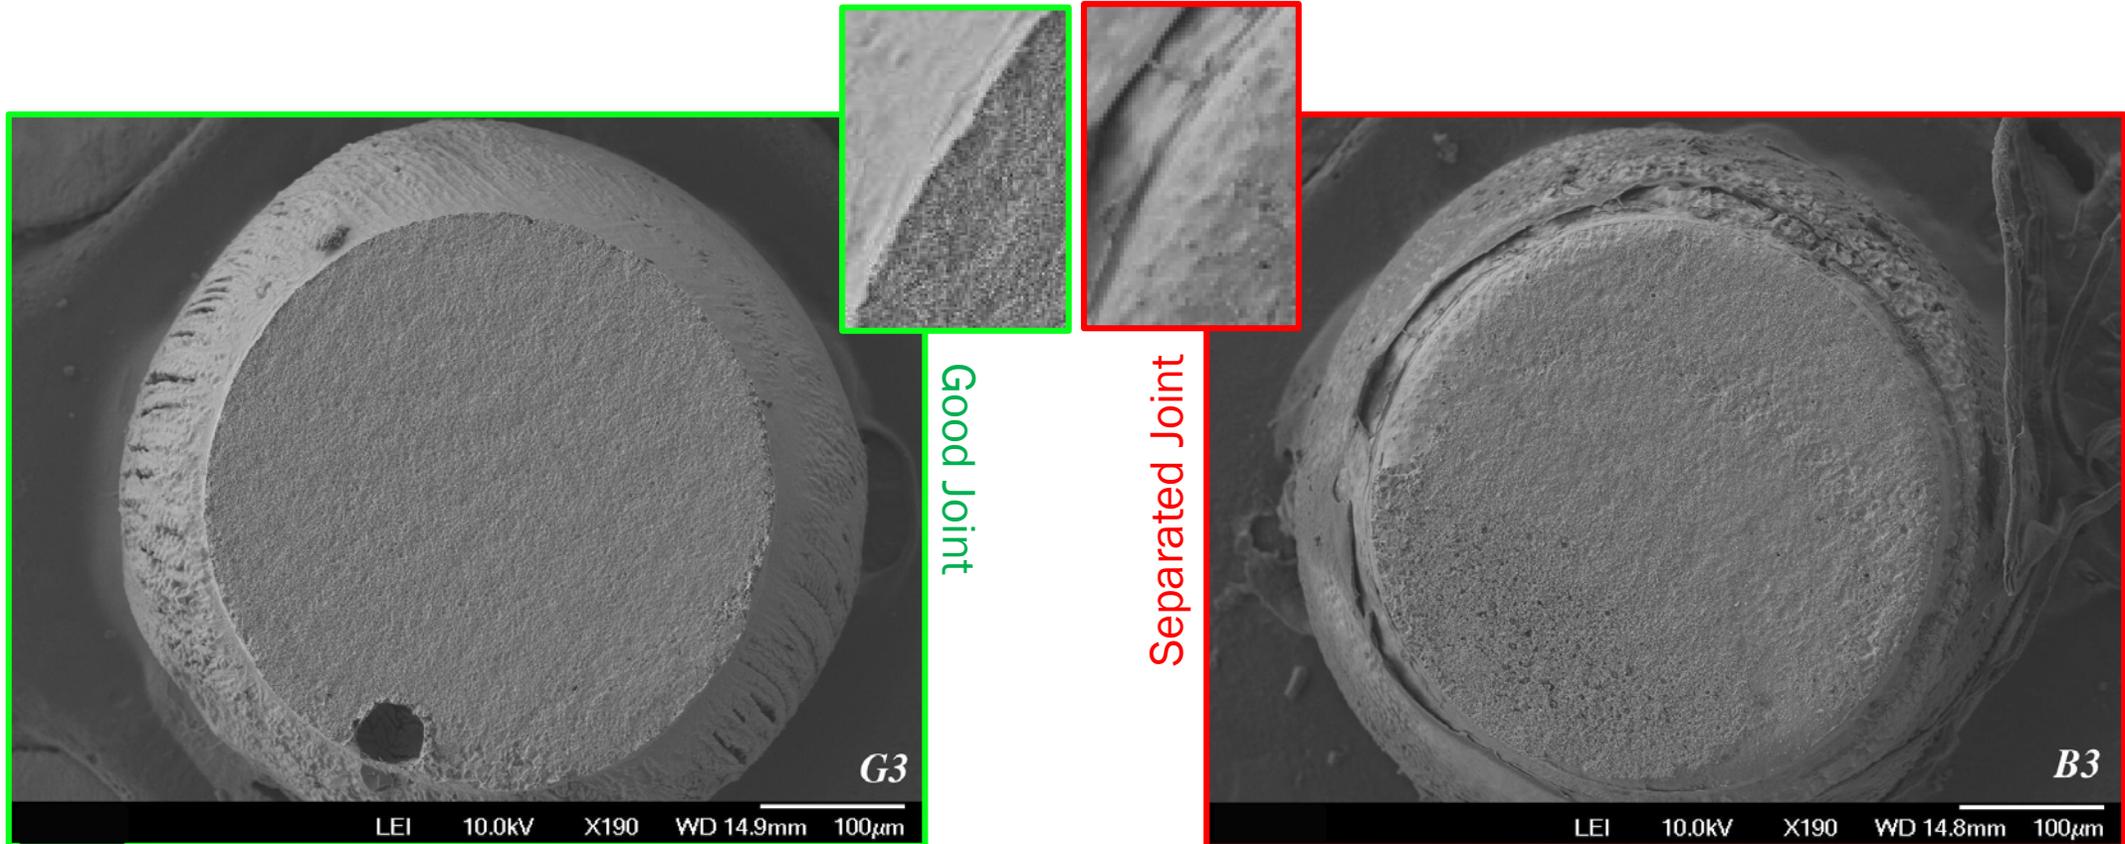
- The "Good" joint has a well defined edge; while the separated joint exhibits a "rounded" edge, which can also be observed in the video.
- The "Good" joint has one grain structure; while the separated has two different grain structure.
- The "Broken IMC" spikes and cavities can be seen on the lower left corner of B3.

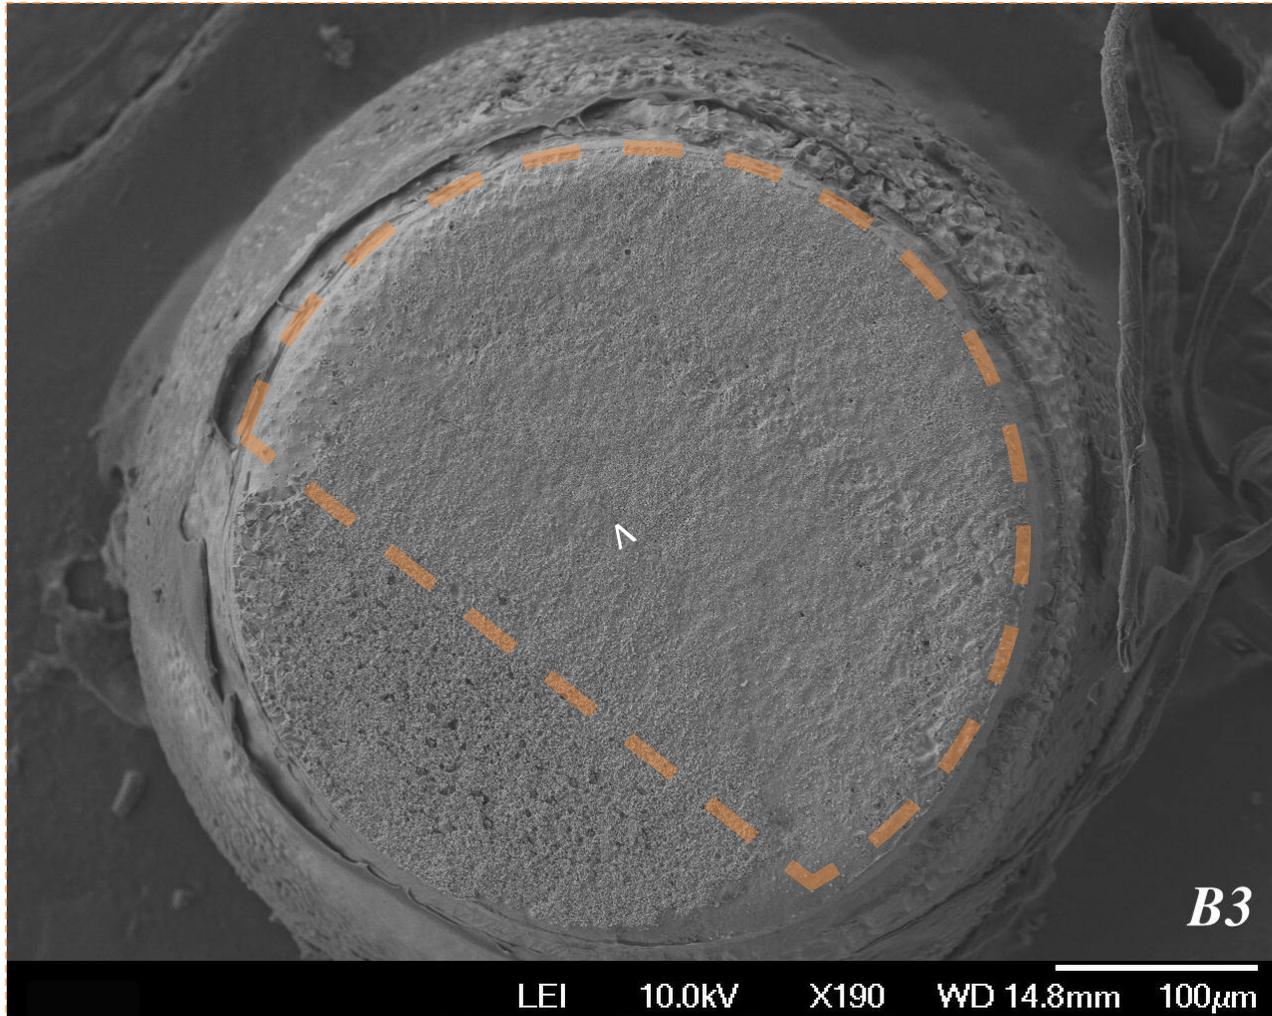
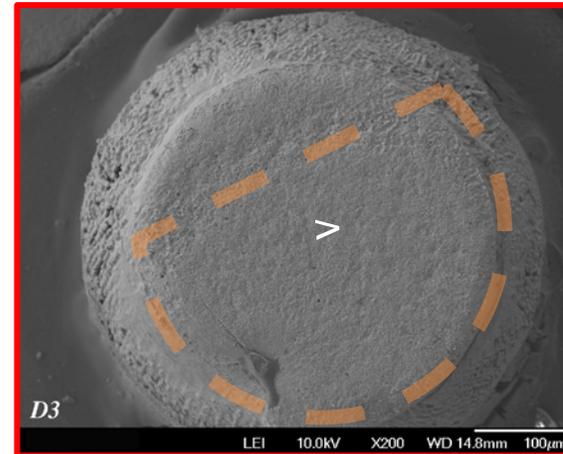
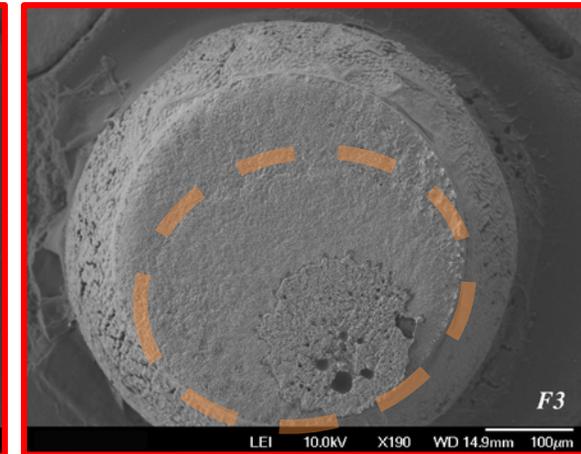
SEM of the Separated Surface (VIPPO, Top of BGA Ball, Inner Rows)

- The highlighted areas denote connected interface, as a regular solder joint.
- The exposed areas are the separated areas.

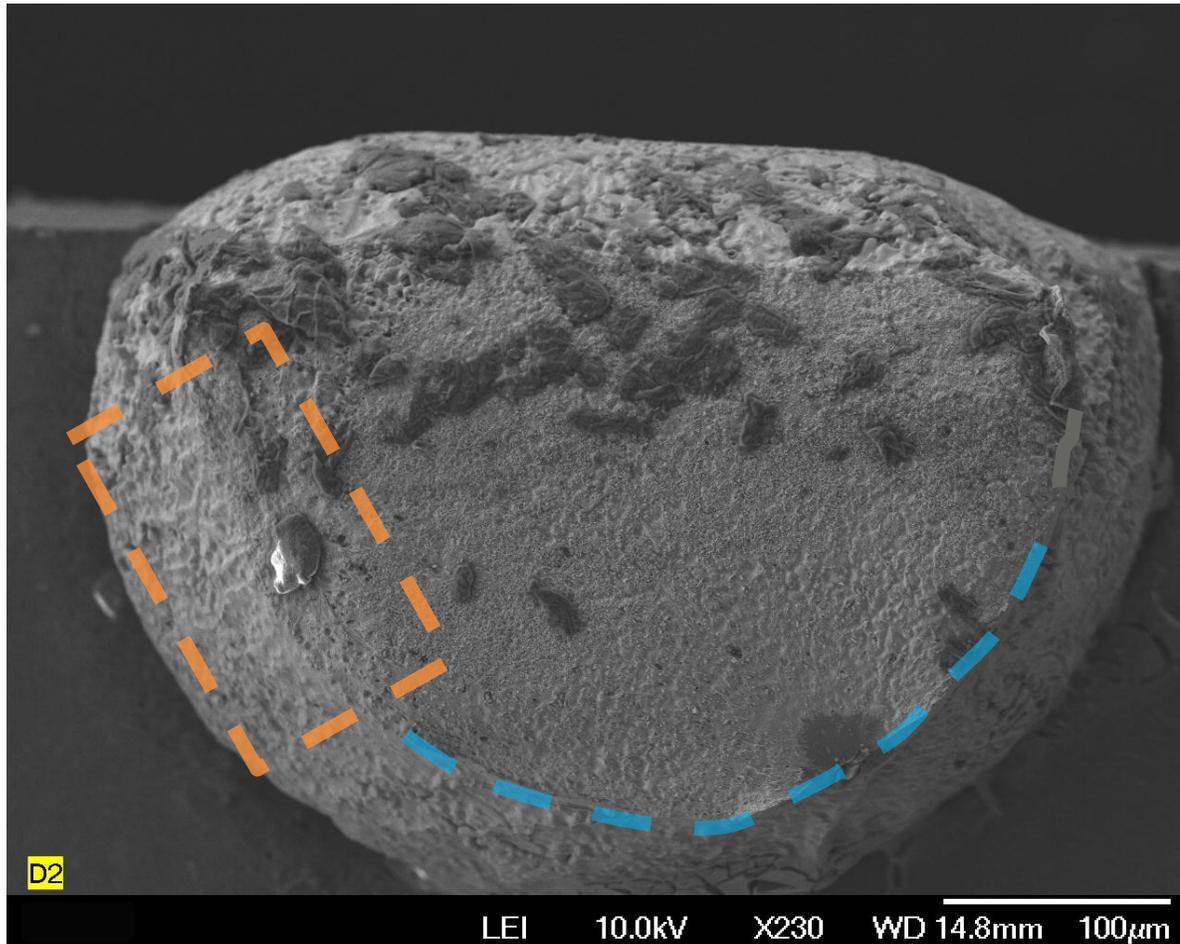
SEM of the Separated Surface (VIPPO, Top of BGA Ball, Edge Ball)

- An SEM image of the edge ball, which has been polished to 1/3 of the ball.
- The “ring” is the mark of component side pad.
- The dark black stuff may come from flux or the polishing process.
- The continuous structure in the dashed line area may be an indication of the separation.

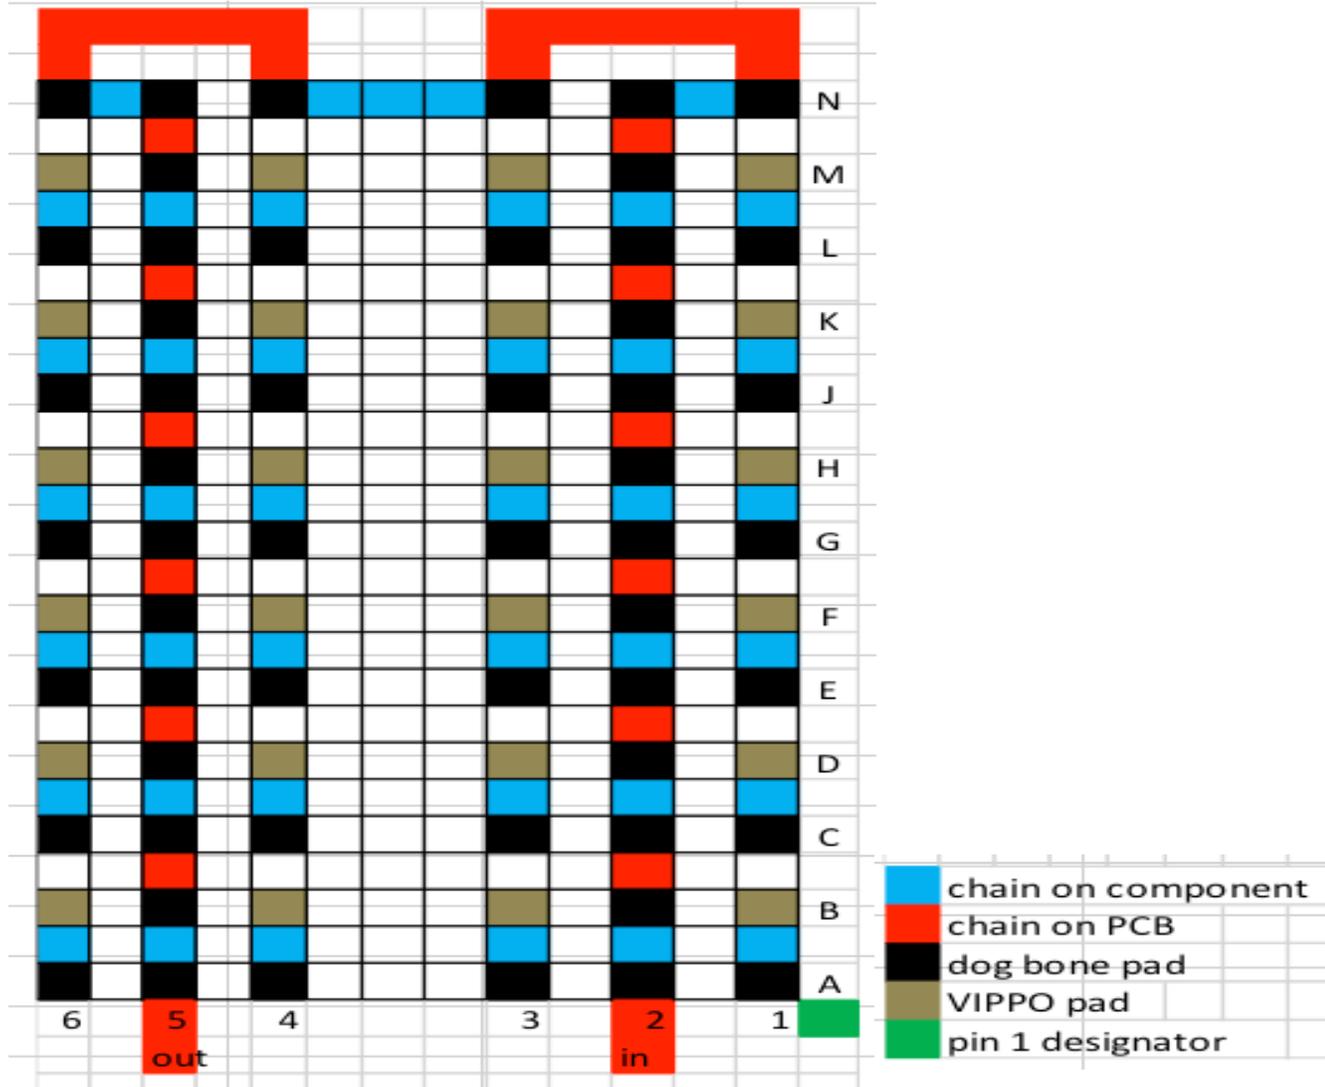
Chain	in	out	One Data Logger	Two Data logger	
1	A1	B1	101	1	101
2	C1	D1	102	1	102
3	E1	F1	103	1	103
4	G1	H1	104	1	104
5	J1	K1	105	1	105
6	L1	M1	106	2	101
7	A3	B3	107	2	102
8	C3	D3	108	2	103
9	E3	F3	109	2	104
10	G3	H3	110	2	105
11	J3	K3	111	2	106
12	L3	M3	112	2	107
13	A4	B4	113	2	108
14	C4	D4	114	2	109
15	E4	F4	115	2	110
16	G4	H4	116	2	111
17	J4	K4	117	2	112
18	L4	M4	118	2	113
19	A6	B6	119	2	114
20	C6	D6	120	2	115
21	E6	F6	201	2	116
22	G6	H6	202	2	117
23	J6	K6	203	2	118
24	L6	M6	204	2	119
25	Dog Bone		205	2	120
26	All VIPPO		206	1	106
27	T/C 1		206	1	111
28	T/C 2		206	1	112

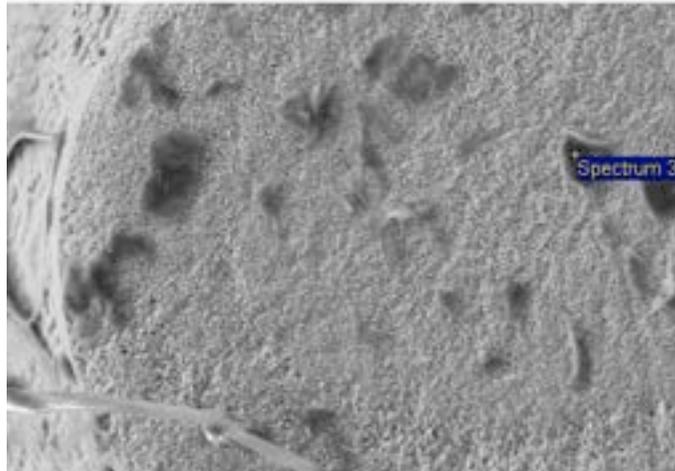
EDX of the Separated Surface (VIPPO, Ball Side)

Element	Weight%	Atomic%
C K	39.72	67.93
O K	16.19	20.79
Na K	2.51	2.24
S K	0.45	0.29
Cl K	2.94	1.70
Ni K	0.68	0.24
Cu K	2.64	0.85
Ag L	1.85	0.35
Sn L	31.54	5.46
Au M	1.49	0.16
