Reliability Screening of Lower Melting Point Pb-Free Alloys Containing Bi

Joseph M. Juarez, Jr., Michael Robinson, Joel Heebink
Honeywell
AZ, US
mike.robinson6@honeywell.com
joseph.juarez@honeywell.com

Polina Snugovsky, Eva Kosiba, Jeffrey Kennedy, Zohreh Bagheri, Subramaniam Suthakaran, Marianne Romansky
Celestica Inc.
Toronto, ON, Canada
polina@celestica.com

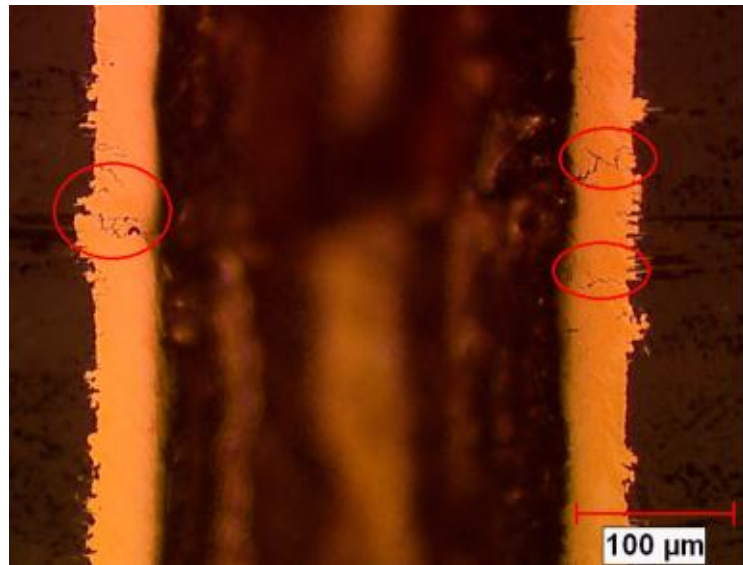
Between 1548 and 3010 cycles, only 3 failures were recorded. These included one BGA built using SnPb solder and SnPb solder balls (1734 cycles) and two BGAs built using Violet solder paste and SAC305 solder balls (2076 cycles and 2466 cycles), all on an OSP finish. Cross-sectioning revealed board failure due to barrel cracks through the via, as seen in Figure 16. Almost-complete cracks were found in the SnPb BGA solder joint (Figure 17: SnPb on OSP). Only partial cracks were formed in the Violet BGA (Figure 18); the electrical failures in this case are attributable to barrel cracks found within the board materials, specifically cracking of the vias.

Figure 16: Via beneath BGA SnPb on OSP

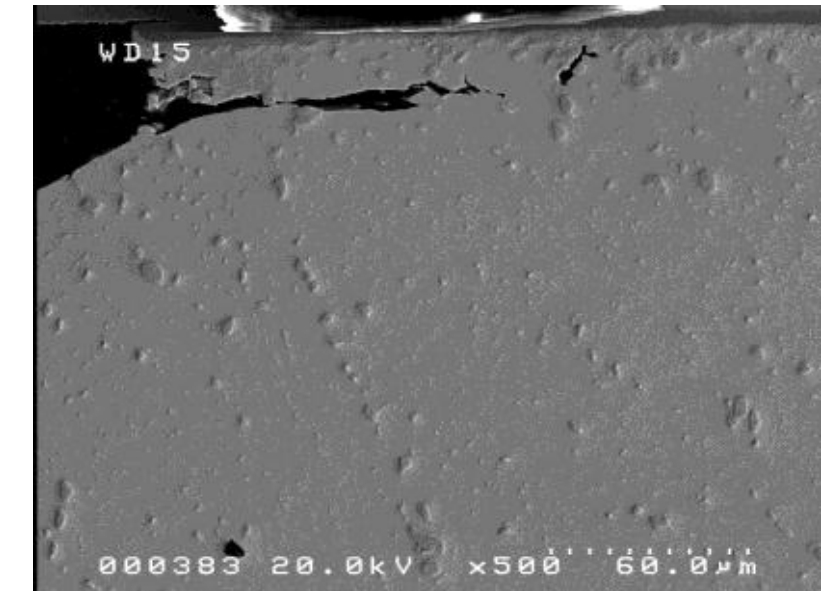
Figure 18: Violet on OSP

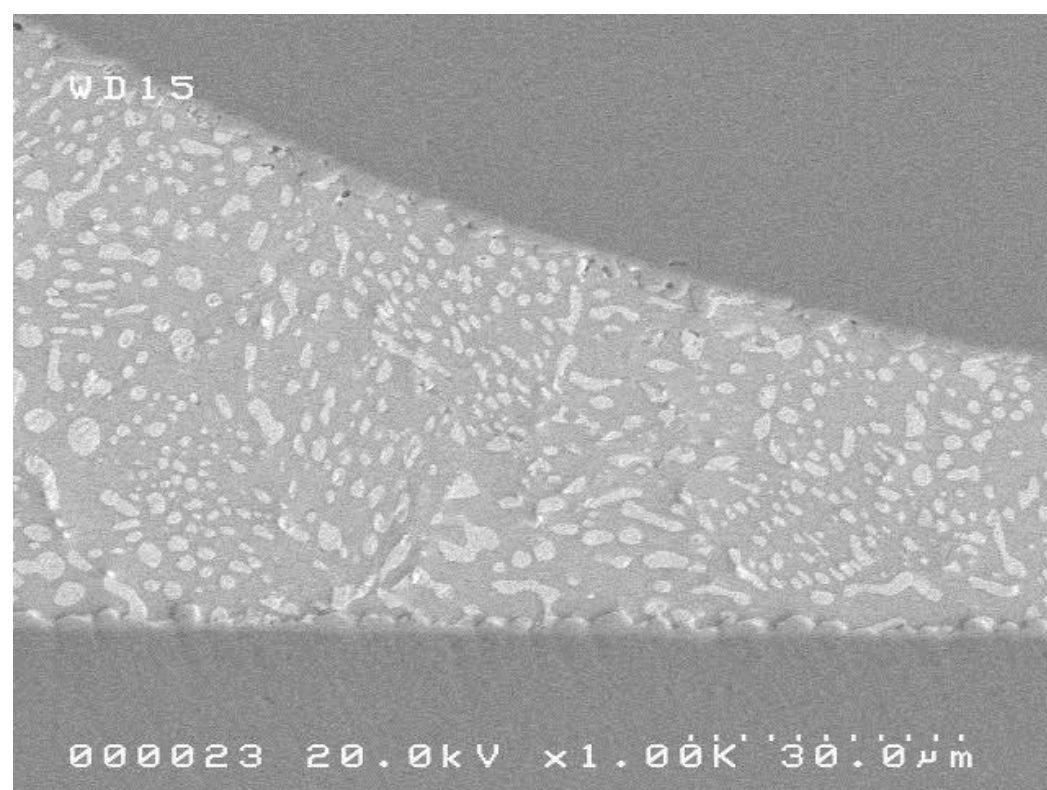
Figure 19 and Figure 20 show the microstructure changes that were observed in the SnPb alloy solder joints. A significant degree of recrystallization and grain growth occurs during the ATC process, resulting in much larger grains and a much larger IMC attach layer. Crack propagation was observed between the grains; in the case of eutectic SnPb between the phases as well as along the intermetallic (IMC). Figure 20 also shows significant pooling of the Pb phase at the IMC layer. As the Pb layer is brittle, this may provide a location for crack propagation.

Figure 19: SnPb at Time 0

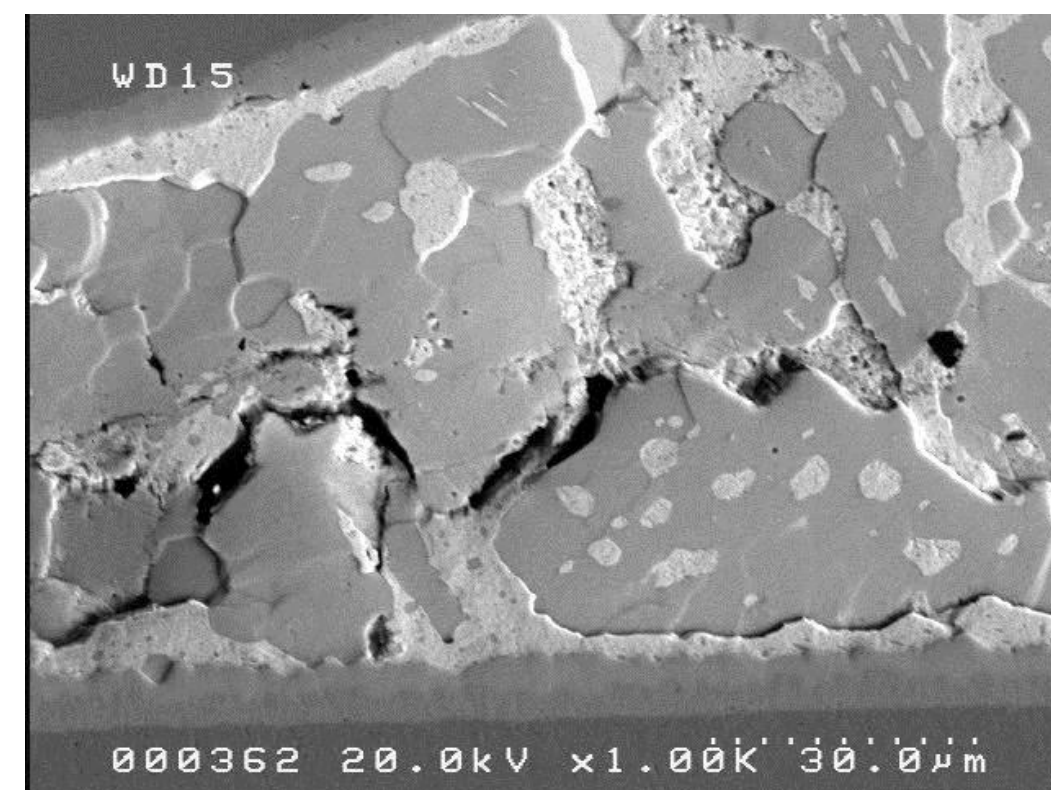
Figure 20: SnPb after ATC

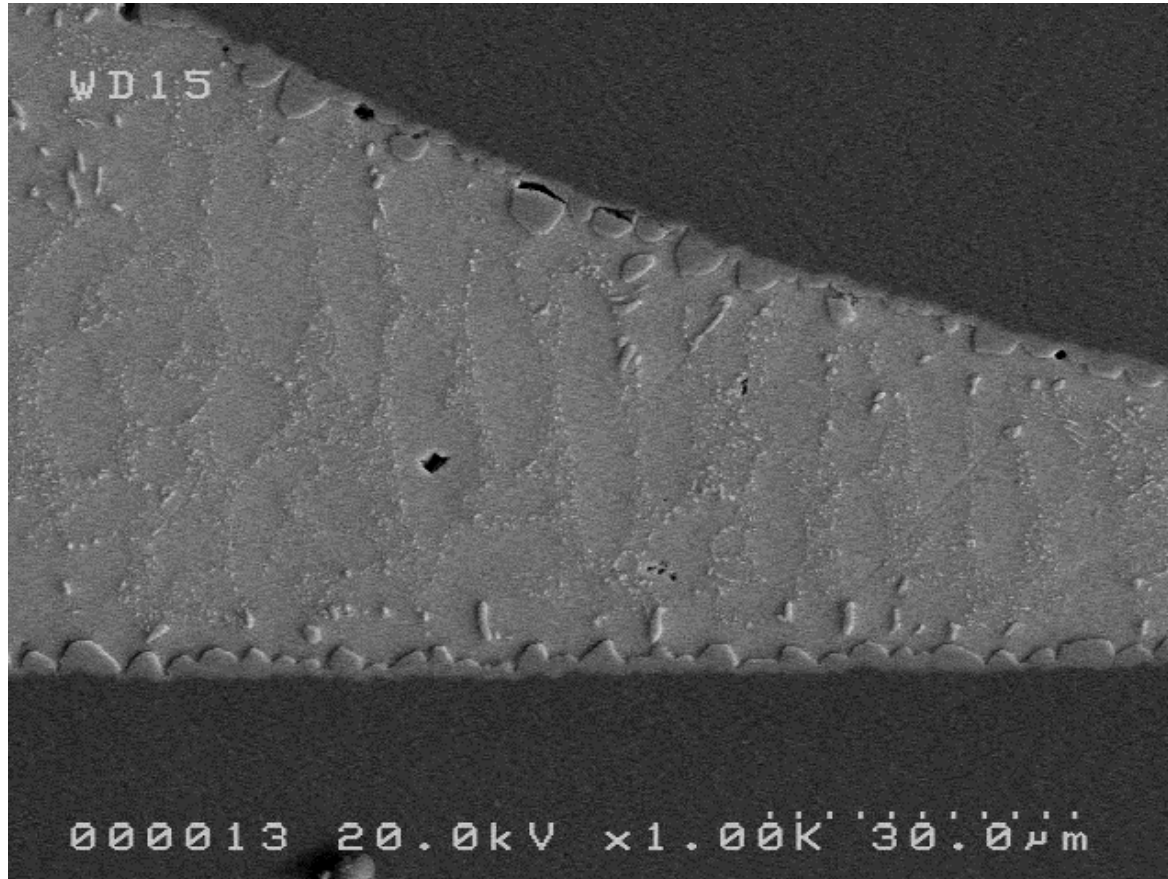
From Figure 21 and Figure 22 one can see the transformation of the SAC305 solder joint between the initial condition and after 3010 cycles. The grains at time zero appear to be surrounded by Ag_3Sn particles and appear significantly smaller than the grains visible after ATC. Also after ATC, the Ag_3Sn particles appear to have coalesced into fewer, larger particles. Additionally, the IMC layers formed between the lead and solder as well as between the solder and copper pad have increased in size and appear to have two phases, Cu_3Sn and Cu_6Sn_5 as seen in Figure 22. A Cu_3Sn layer did not appear to be significant at time zero.

Figure 21: SAC305 at Time 0

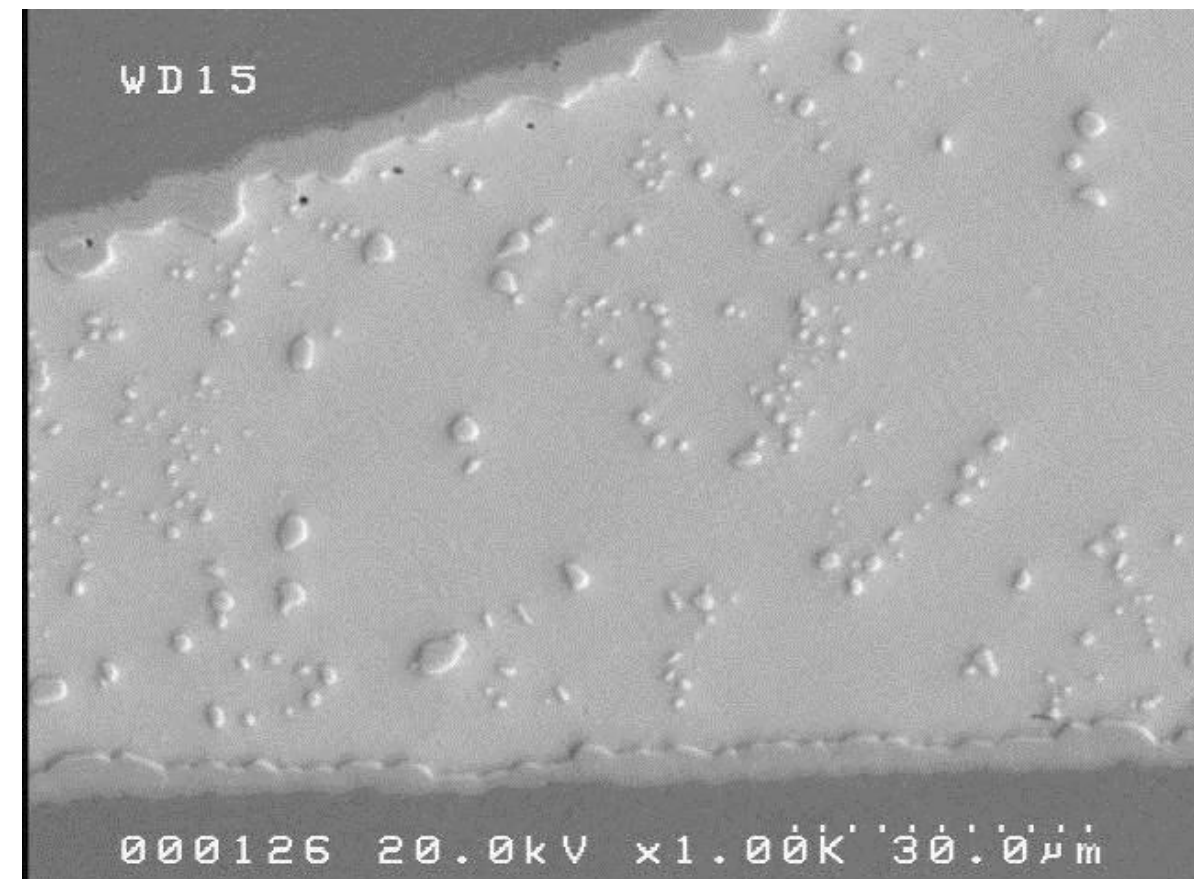
Figure 24: Paul after ATC

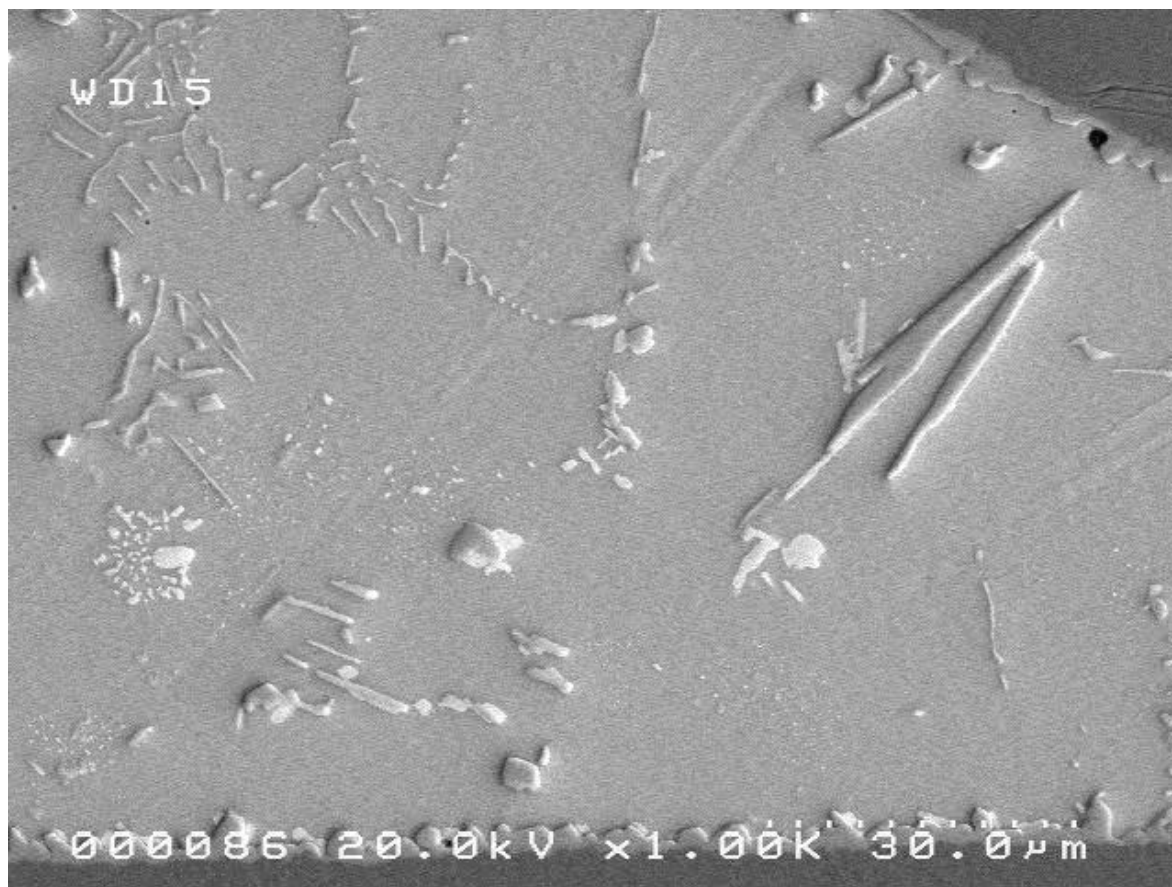
The other Bi-containing alloys, Violet and Orchid, contain 6 and 7% Bi respectively. This amount of bismuth appears to have impacted the microstructure in a significantly different manner during ATC. While the IMC layer grew in a similar fashion to the other alloys, the grains do not appear to have coarsened, as seen in Figure 26 and Figure 28. Additionally, the Bi which had previously been present largely in solid solution with Sn (Figure 25 and Figure 27), appears to have been largely precipitated out of the solid solution. This Bi appears to be randomly distributed throughout the solder joint and has not settled preferentially at the IMC layer in the same manner as Pb does in the SnPb alloy.

Figure 25: Violet at Time 0

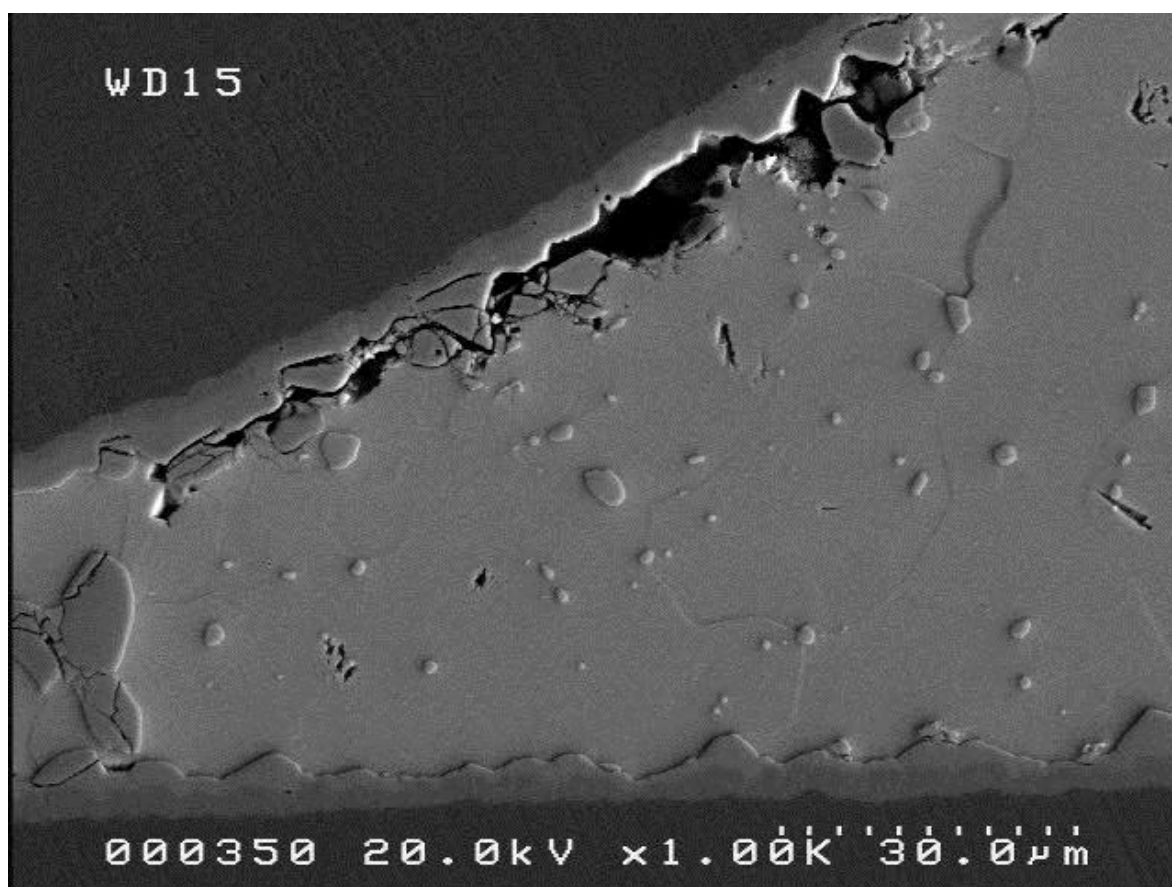
In SAC305 and Paul solder joints, cracks have begun to propagate primarily along the lead-side IMC as seen in Figure 29 and Figure 30: Paul after ATC (QFP crack formation) although none was significant enough to lead to an electrical failure. This type of crack propagation was not seen in the alloys with higher Bi content, Violet and Orchid, as shown in Figure 31 and Figure 32.

Figure 29: SAC305 after ATC (QFP crack formation)

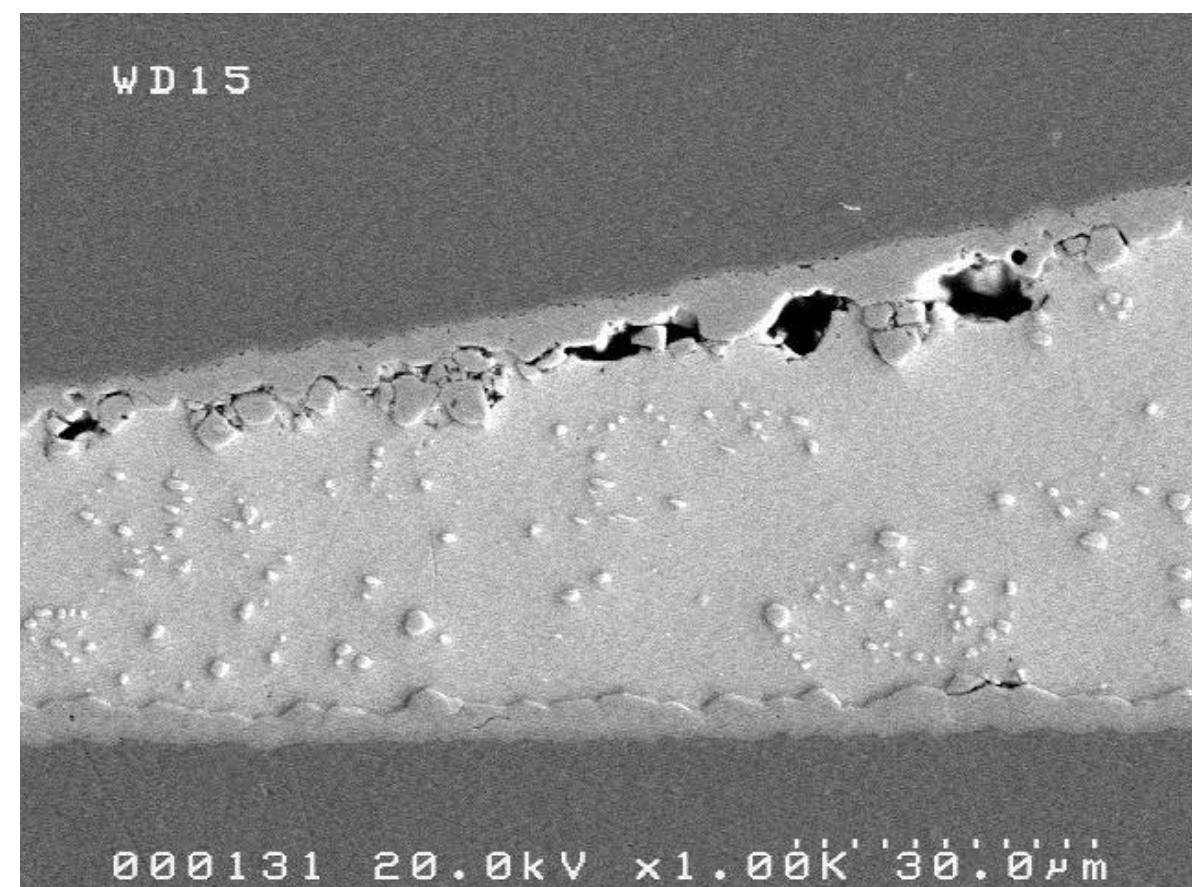
Figure 30: Paul after ATC (QFP crack formation)

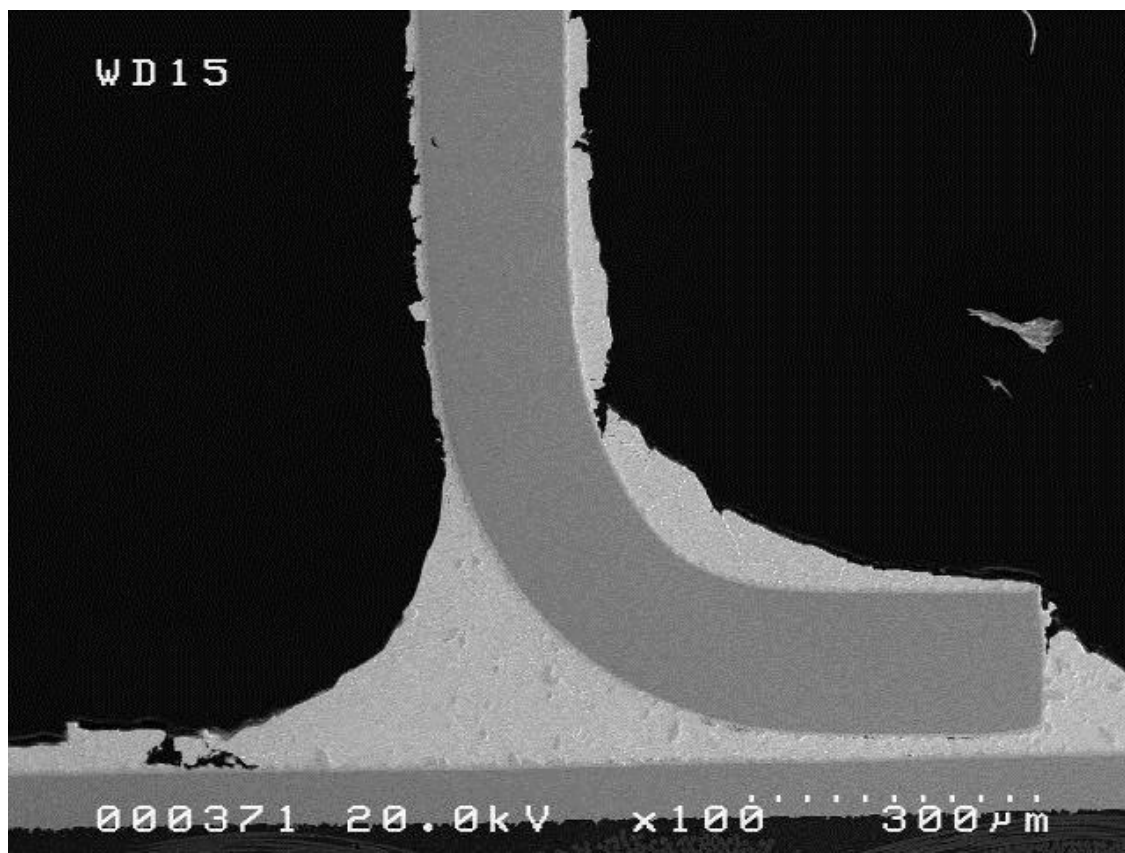
Figure 31: Violet after ATC (no major crack)

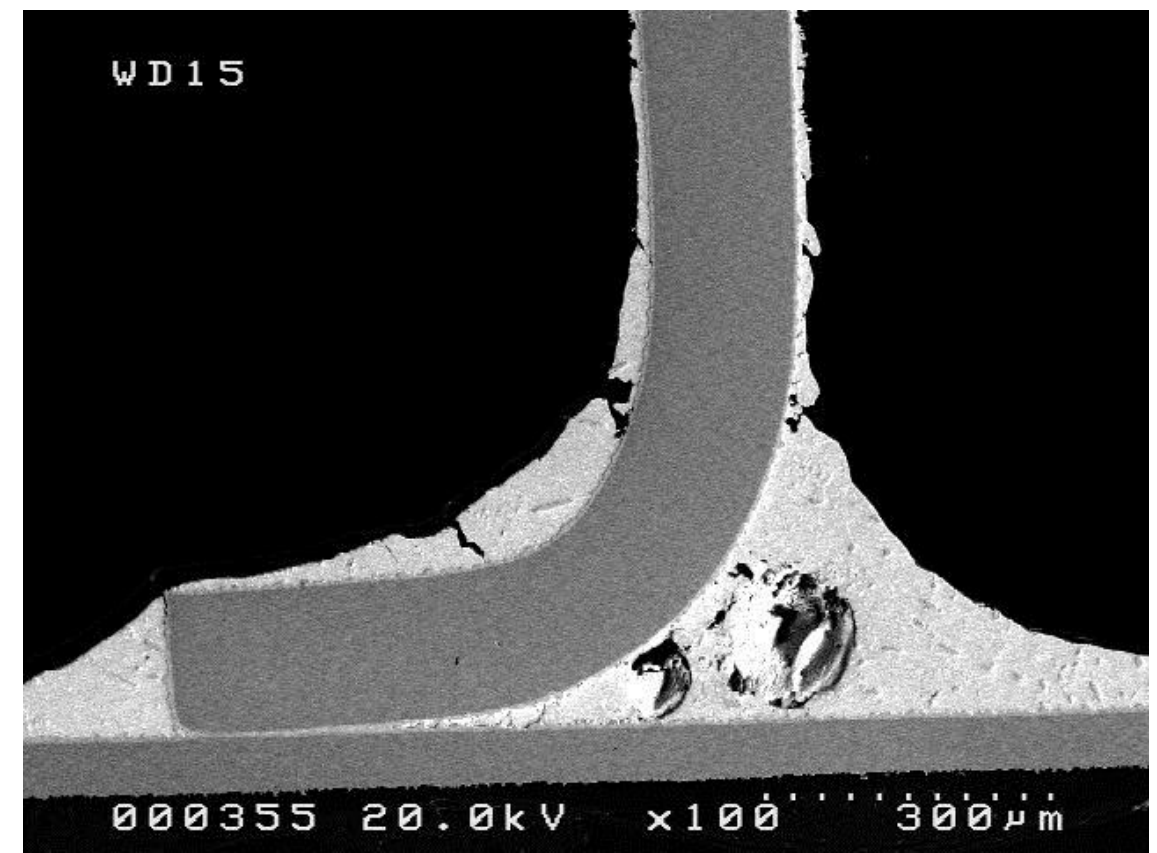
Figure 32: Orchid after ATC (no major crack)

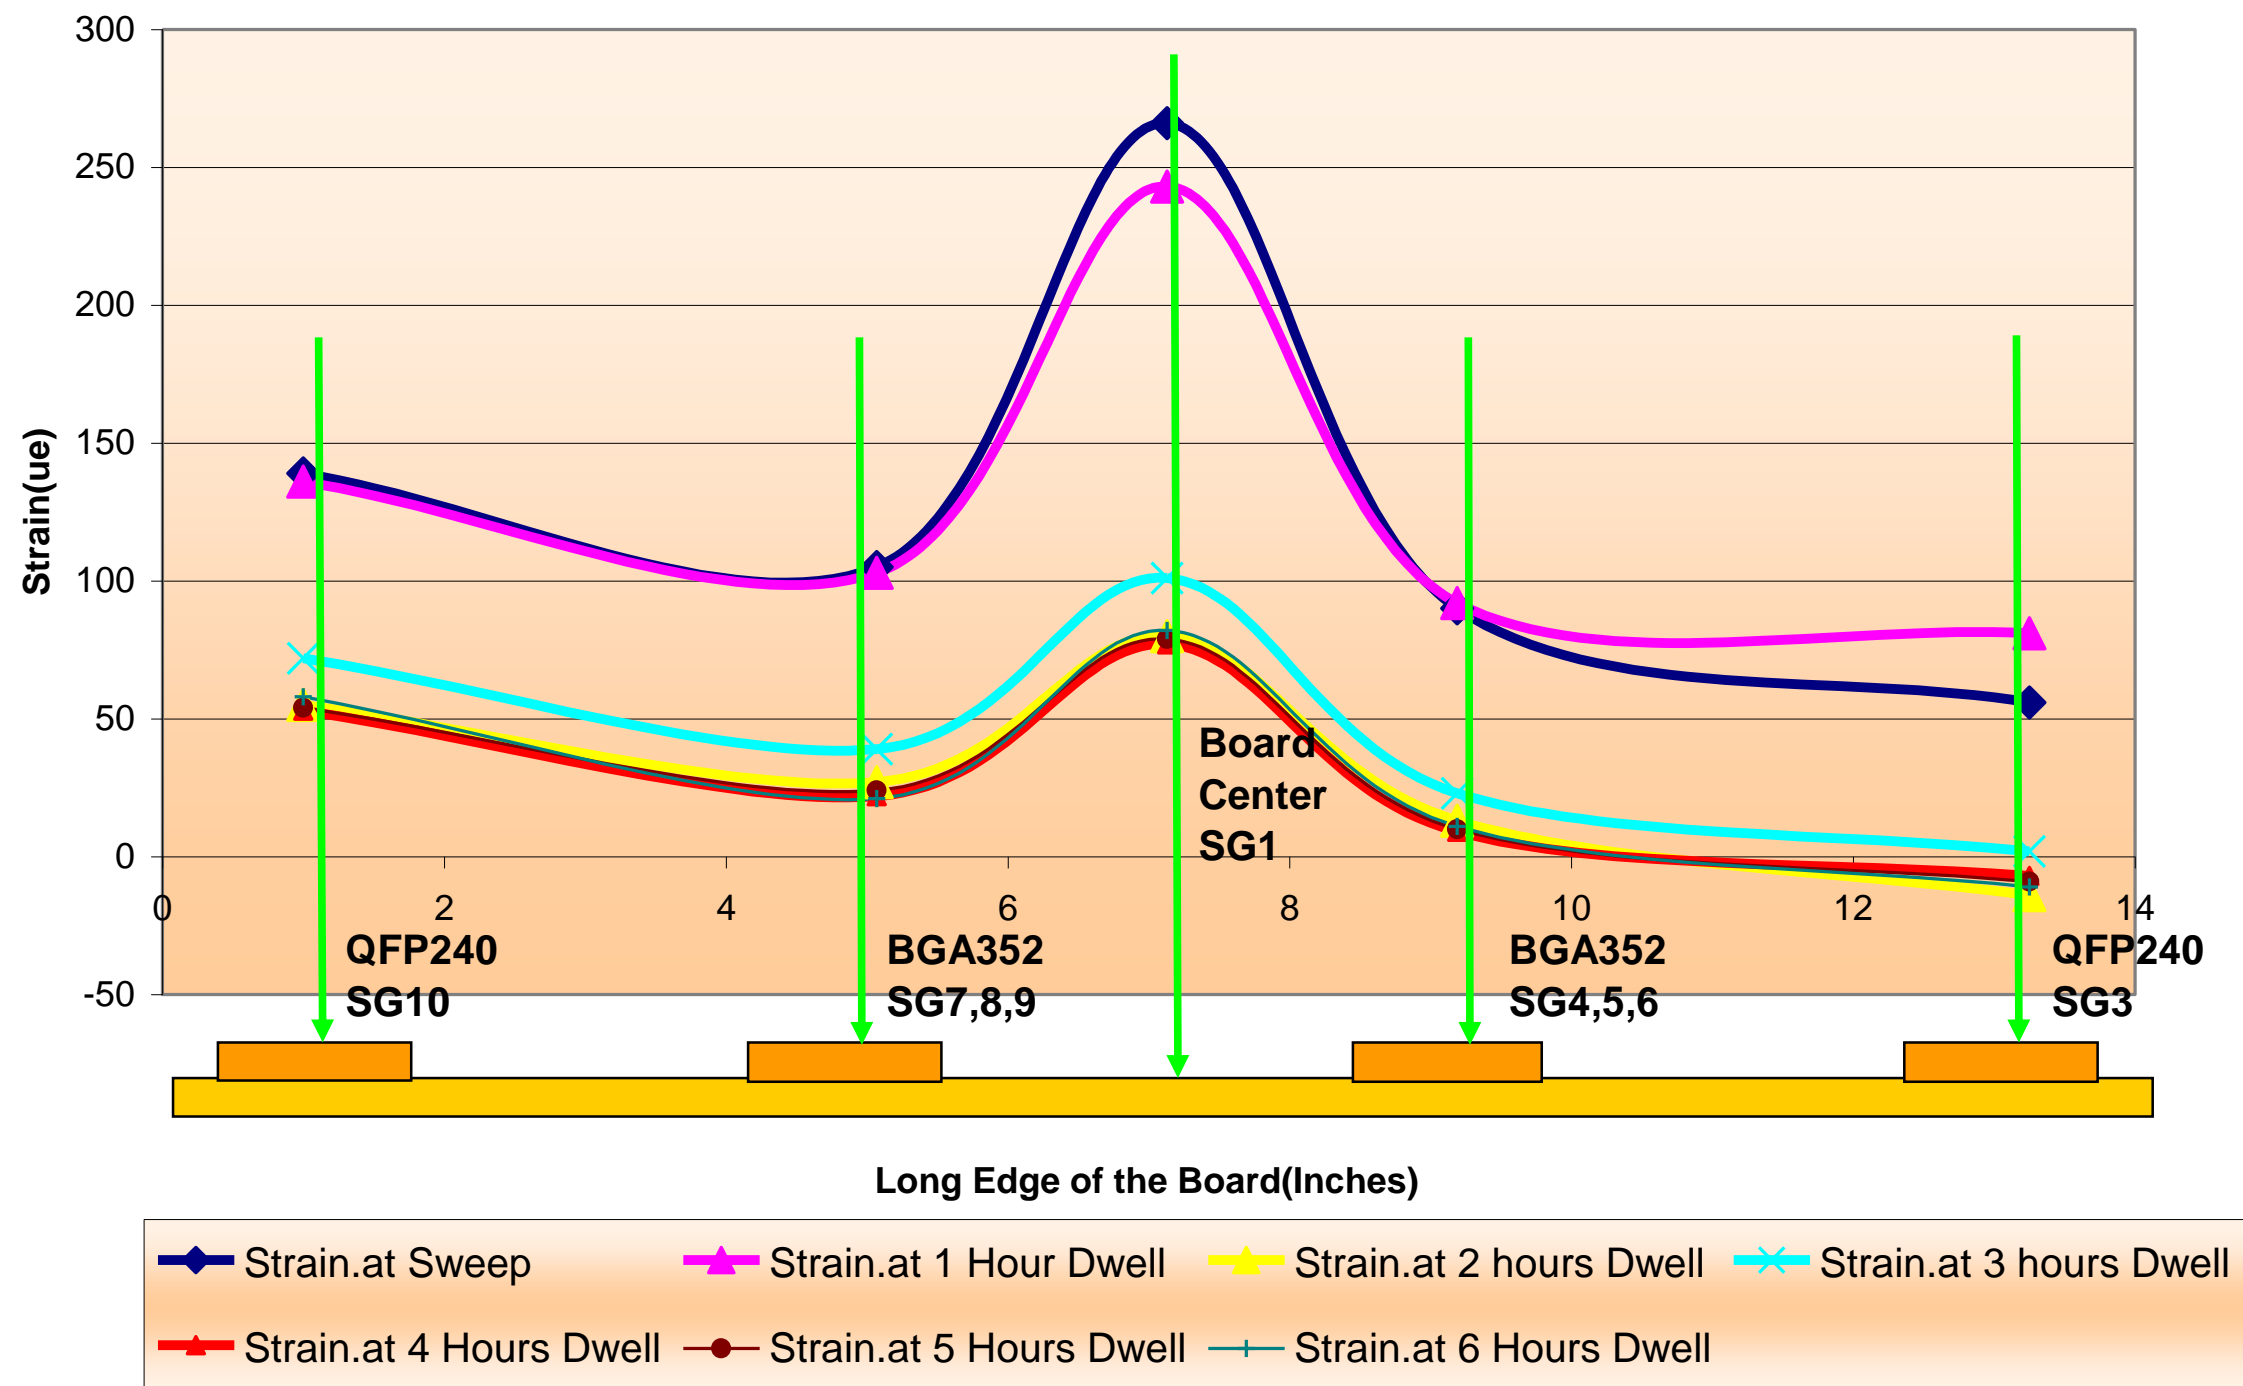
A general strain value behavior noted was that the strain value was at its maximum when the dwell started, then it decreased with dwell time. The cards' deflections are high at the beginning of the dwell, since the dwell frequency is very close to the cards' resonance frequency at that stage. The formation and accumulation of laminate and / or solder defects is changing the stiffness, therefore changing the resonance of the test sample. The dwell frequency was maintained consistent throughout the 6 hour dwell, so the card deflection must have decreased over the dwell time and resulted in a decrease in strain as seen in Figure 35.

Figure 35: Strain Distribution Change on Components during 6 Hours Dwell

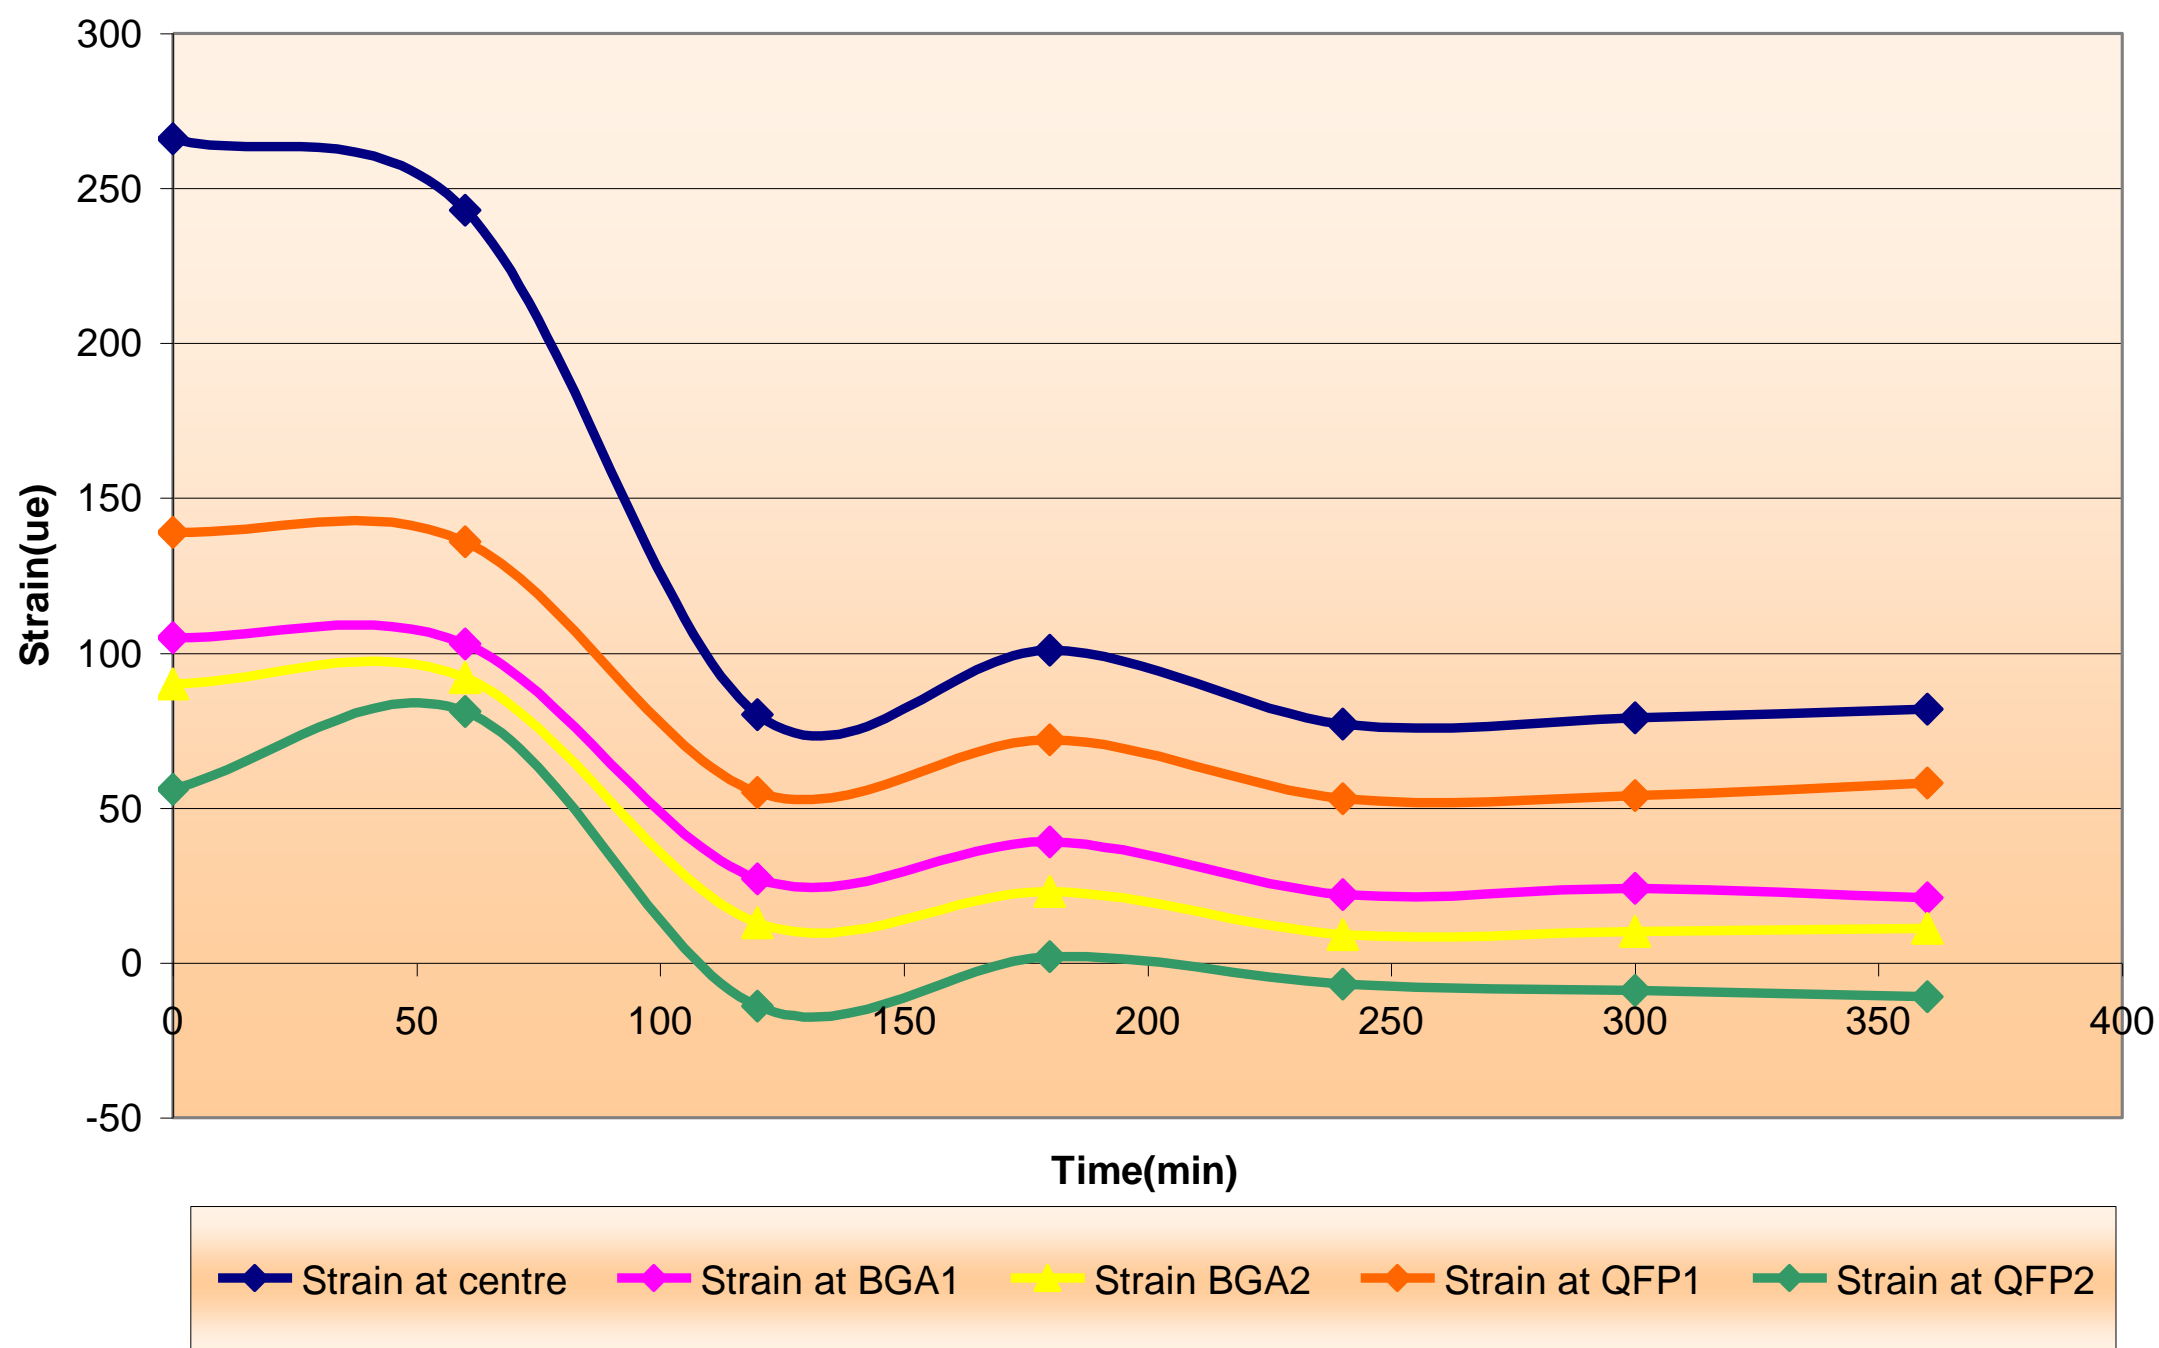
As Figure 36 indicates, all components' strain values follow a steep downward pattern from the start of the test to just before the two hour mark. From this point forward, strain values appear to remain fairly consistent on a flat line.

Figure 36: Typical Strain versus Time Graph during Sine Sweep on Components

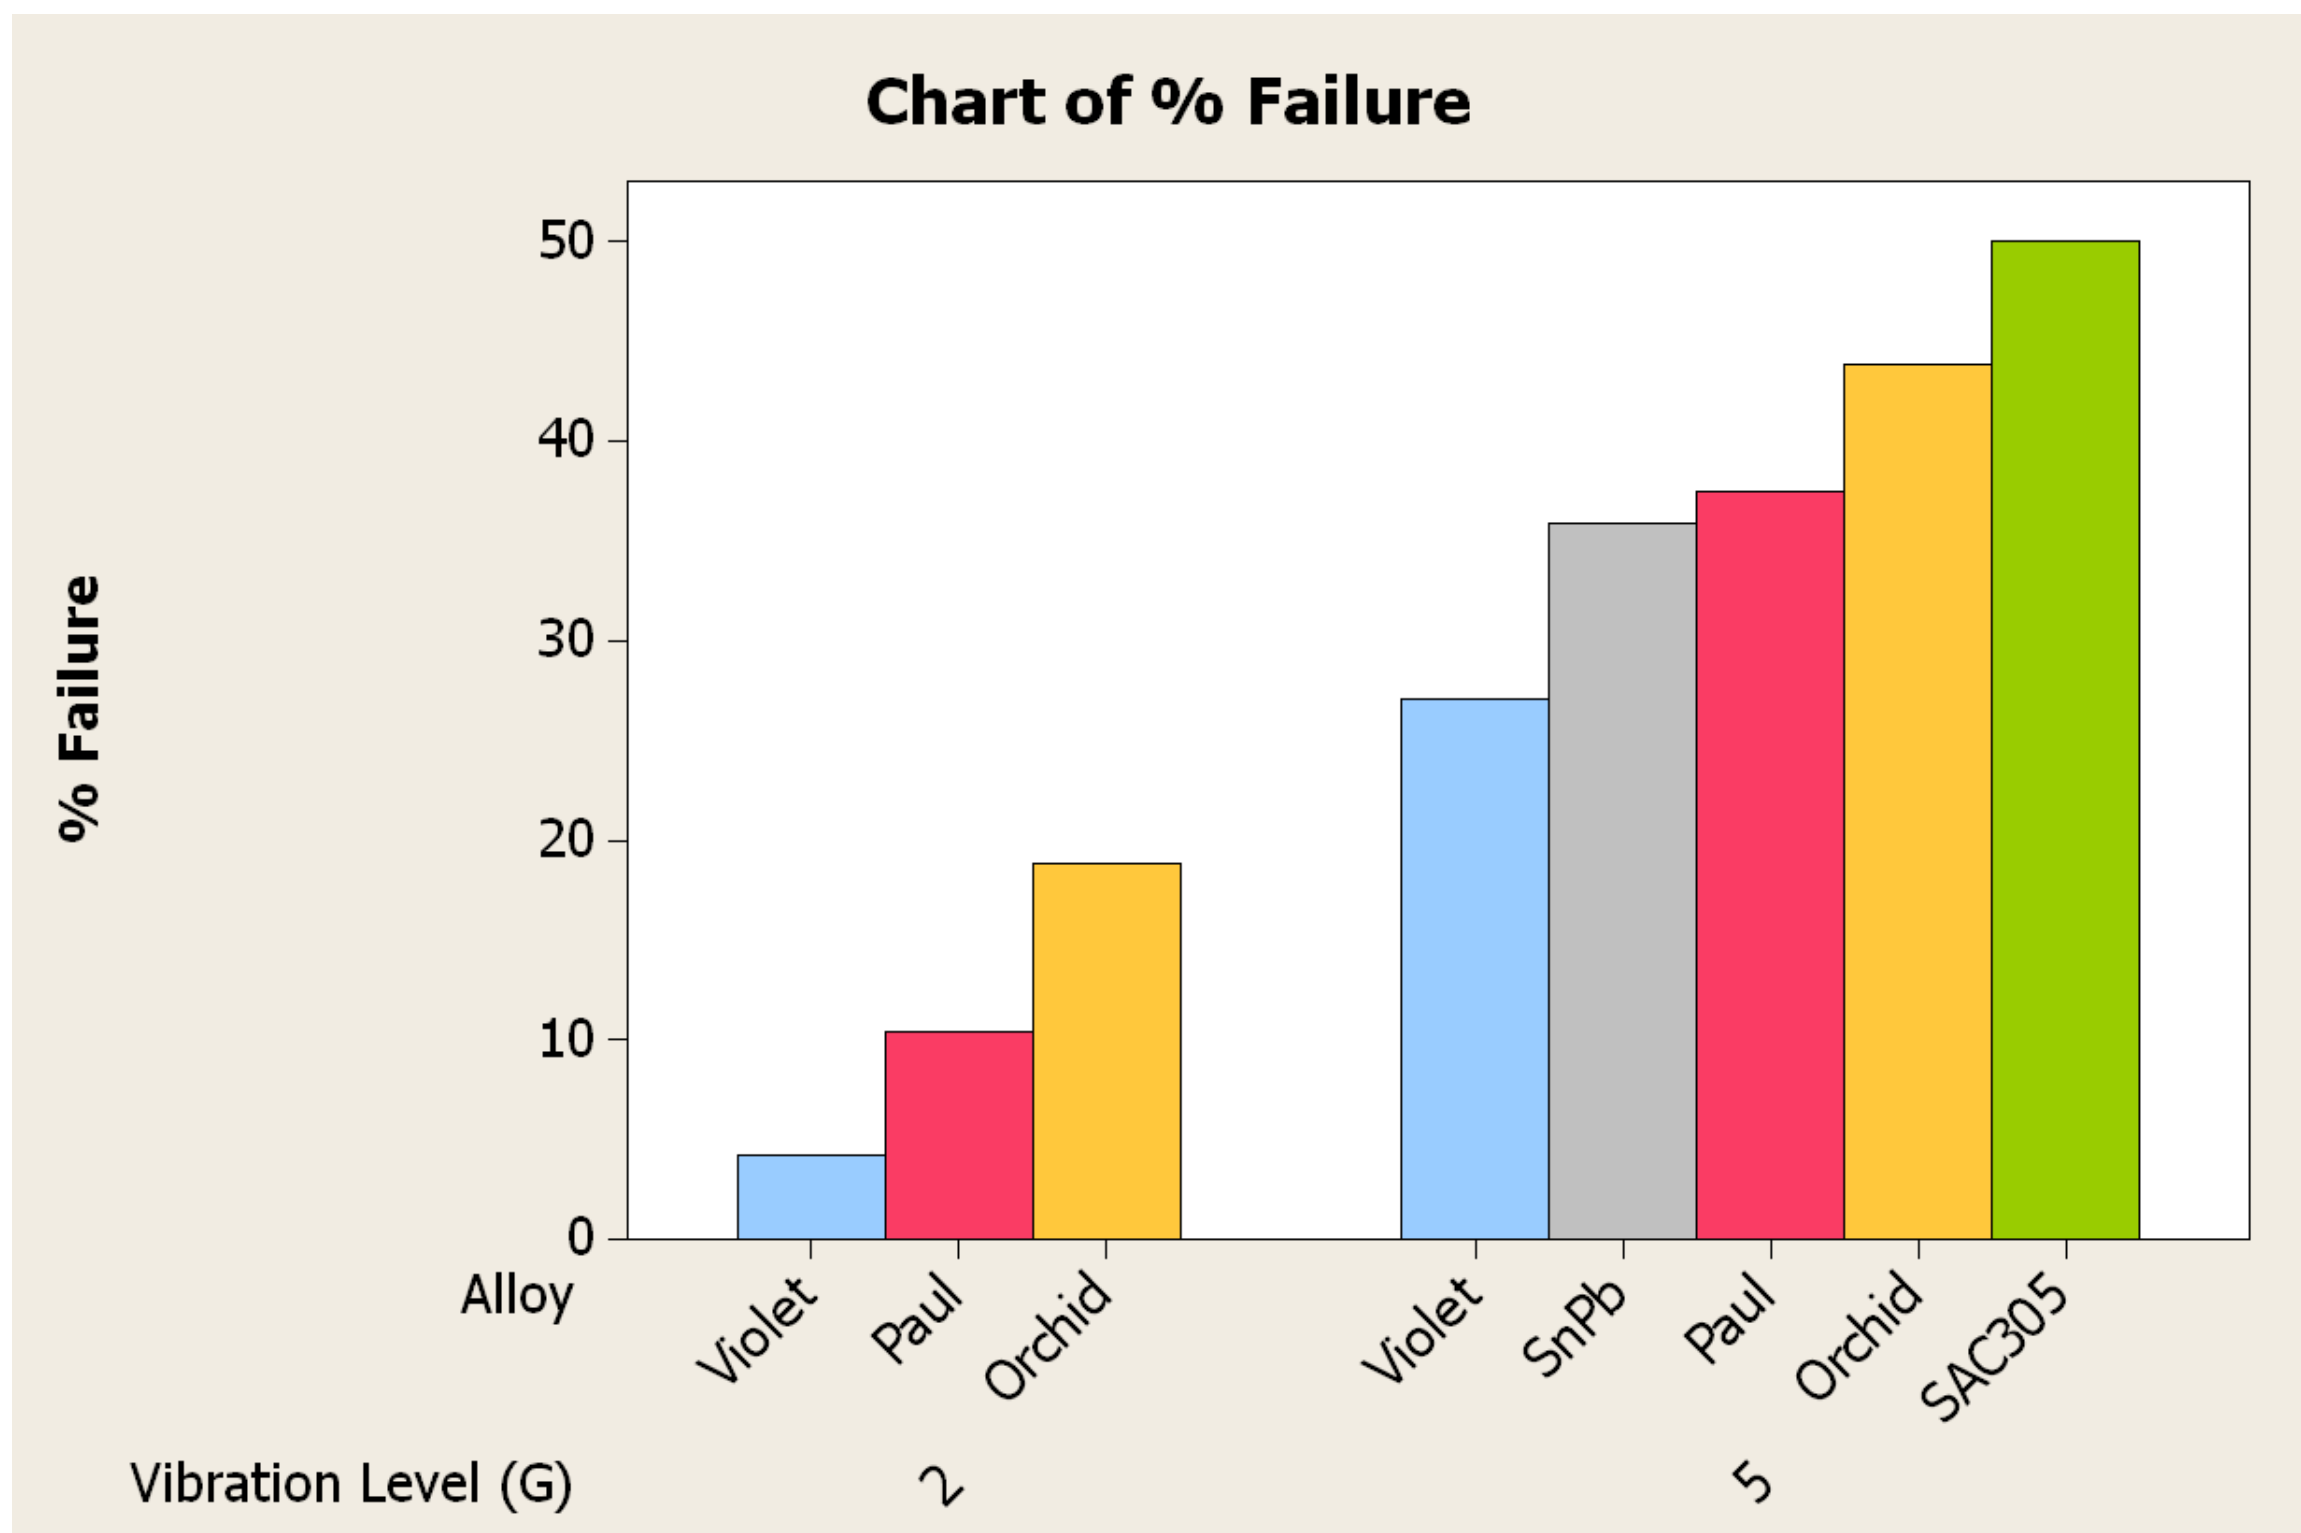
Figure 41: Percent Failed Components - 352 BGA, 240 QFP, SSOP 48 and PLCC 84 - After 6 Hours of Dwell at 2G and 5G Vibration

There was no BGA failure after 2G vibration. 20% of BGAs assembled on 155°C T_g boards and 82.2% of BGAs assembled on 170°C T_g boards failed after 5G vibration. Typically, the BGAs failed through the solder either at the component side as illustrated in Figure 42, or closer to the board side in which case the copper pad was also damaged as illustrated in Figure 43.

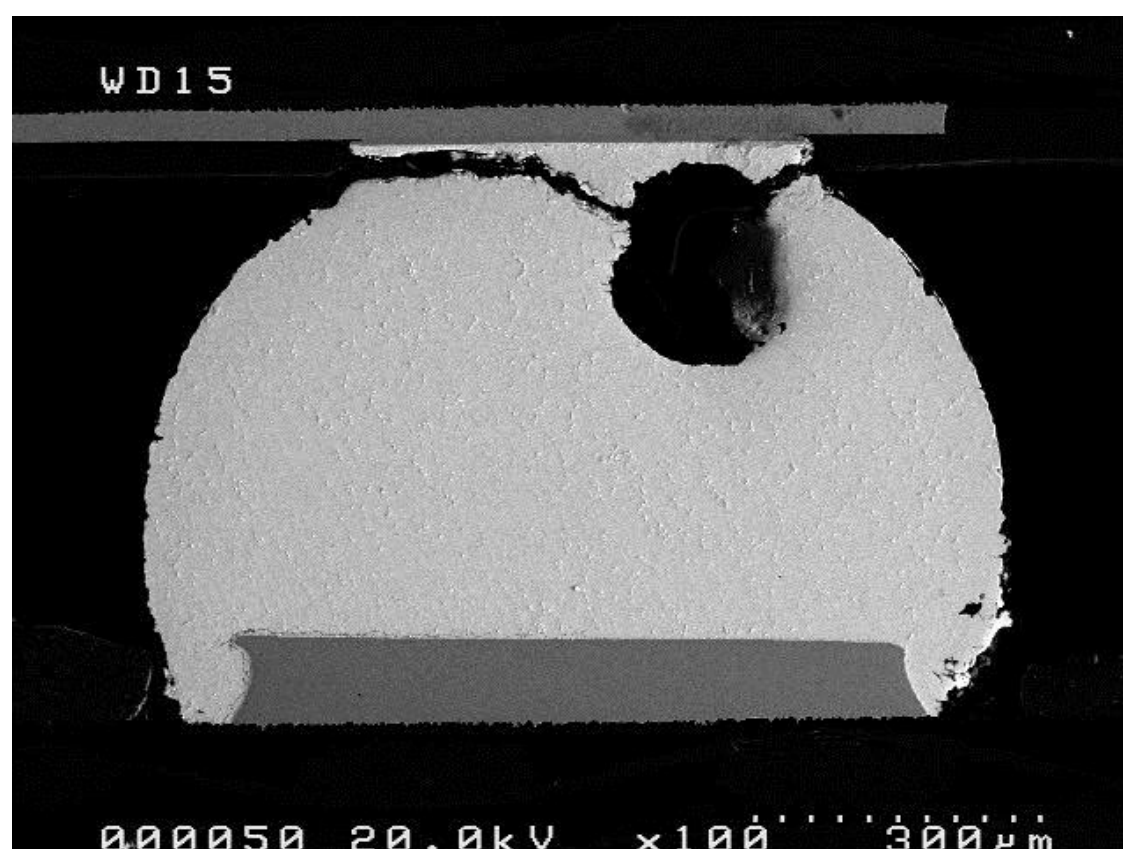
Figure 42: BGA with SAC305 on ENEPIG finish, 170 T_g board

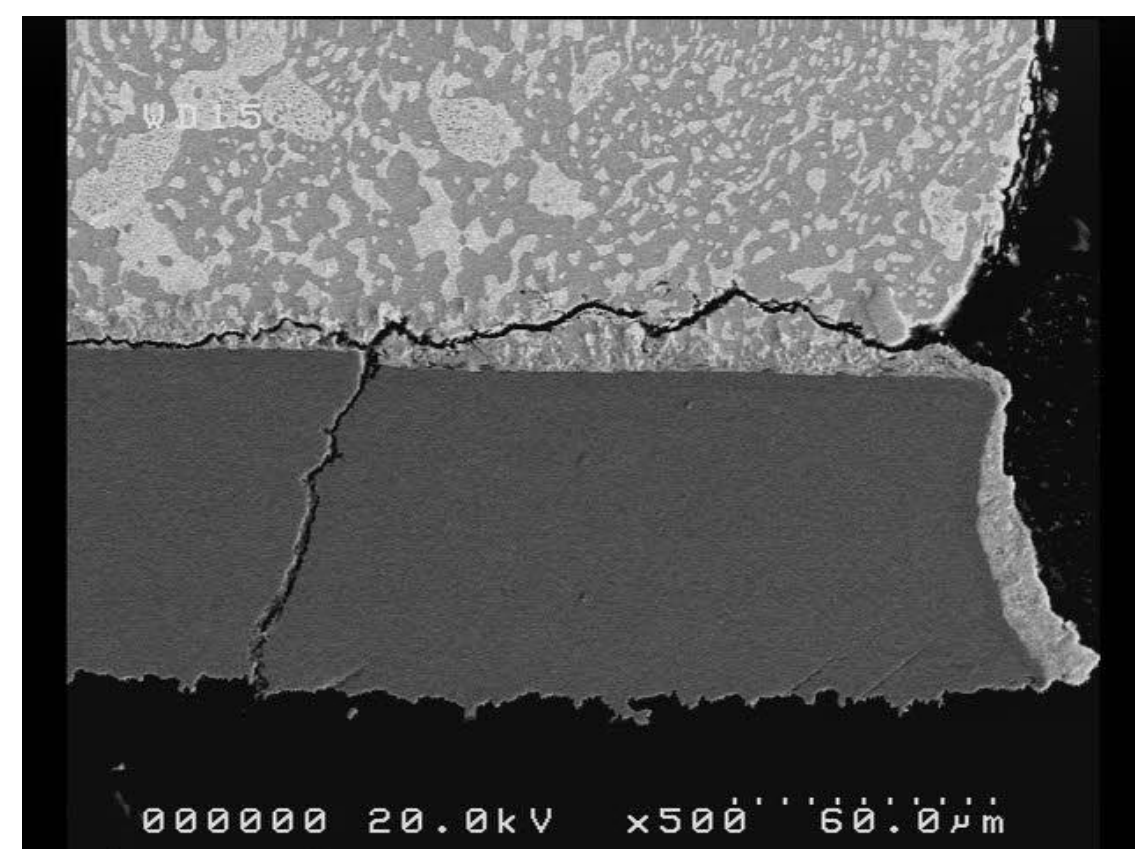
Figure 43: BGA with SnPb on ENEPIG finish, 170 T_g board
