Reliability Screening of Lower Melting Point Pb-Free Alloys Containing Bi

Joseph M. Juarez, Jr., Michael Robinson, Joel Heebink
Honeywell
AZ, US
mike.robinson6@honeywell.com
joseph.juarez@honeywell.com

Polina Snugovsky, Eva Kosiba, Jeffrey Kennedy, Zohreh Bagheri, Subramaniam Suthakaran, Marianne Romansky
Celestica Inc.
Toronto, ON, Canada
polina@celestica.com

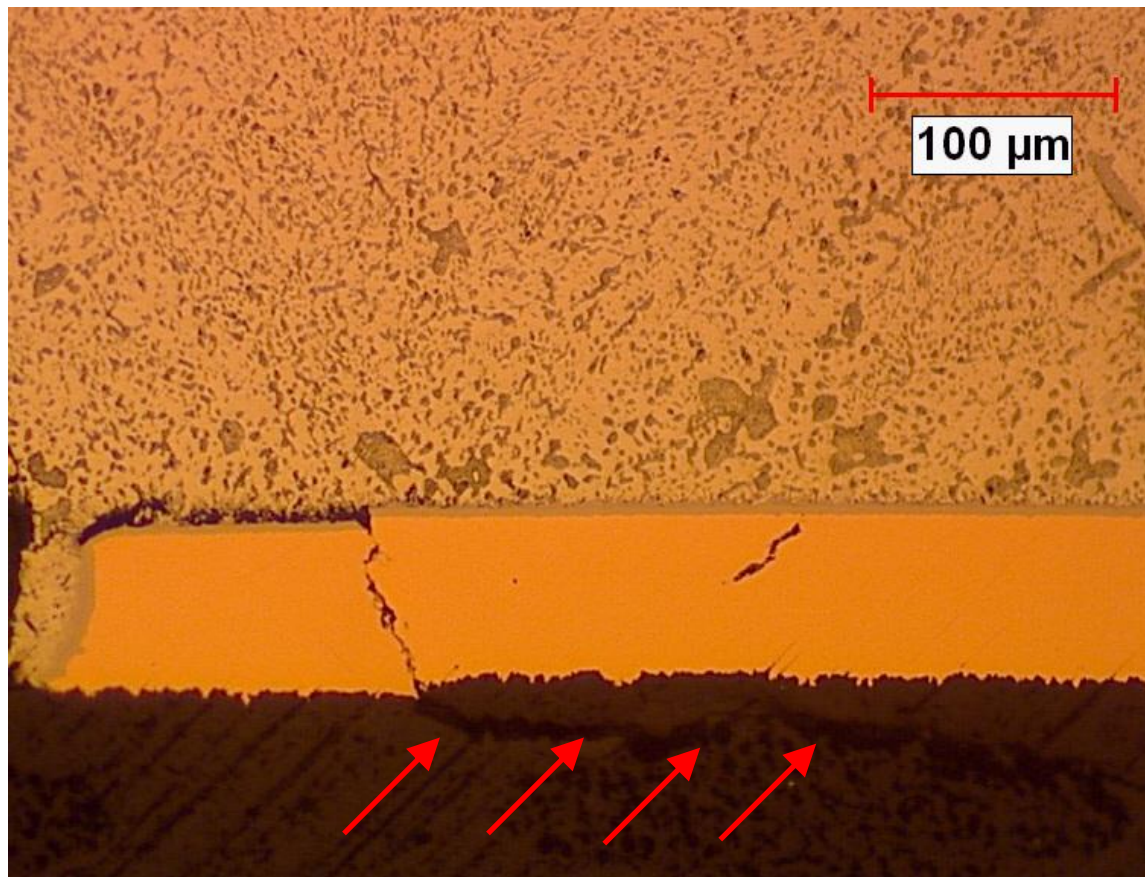
Board material had noticeable impact on the failure modes; 170°C T_g and in some cases 155°C board materials experienced failure via pad cratering as seen in Figure 44. This failure occurs at locations where the copper pad has cracked through. 155°C T_g boards where observed to have failures in the vias in the form of barrel cracks.

Figure 44: Board Side Failure (with Pad Crater) of BGA with SnPb Solder on ENEPIG Finish, 170 T_g Board

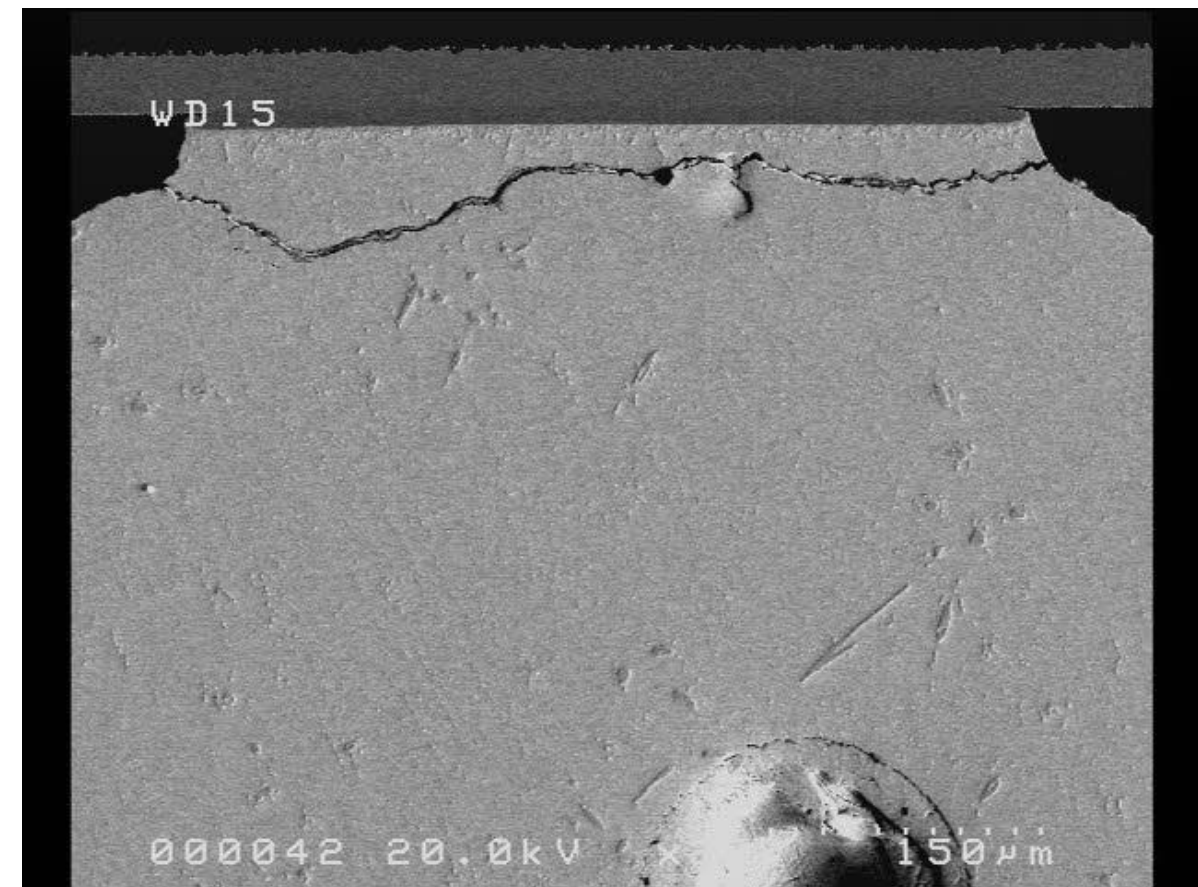
Surface finish also had an impact on the failure mode: All BGA failures on boards with OSP finish occurred through the solder as illustrated in Figure 45. ENEPIG failures occurred mainly in the same fashion, through the solder as shown in Figure 46 and Figure 47 with the exception of those failures which occurred with Orchid solder paste on ENEPIG finished boards. As shown in Figure 48, these failed through the brittle IMC layer formed between the solder and the board side copper pad with ENEPIG finish. All ENIG failures resulted from separation of the IMC from the board as shown in Figure 49.

Figure 45: Component Side Failure with SAC305 Solder on OSP Finish, 170 T_g Board

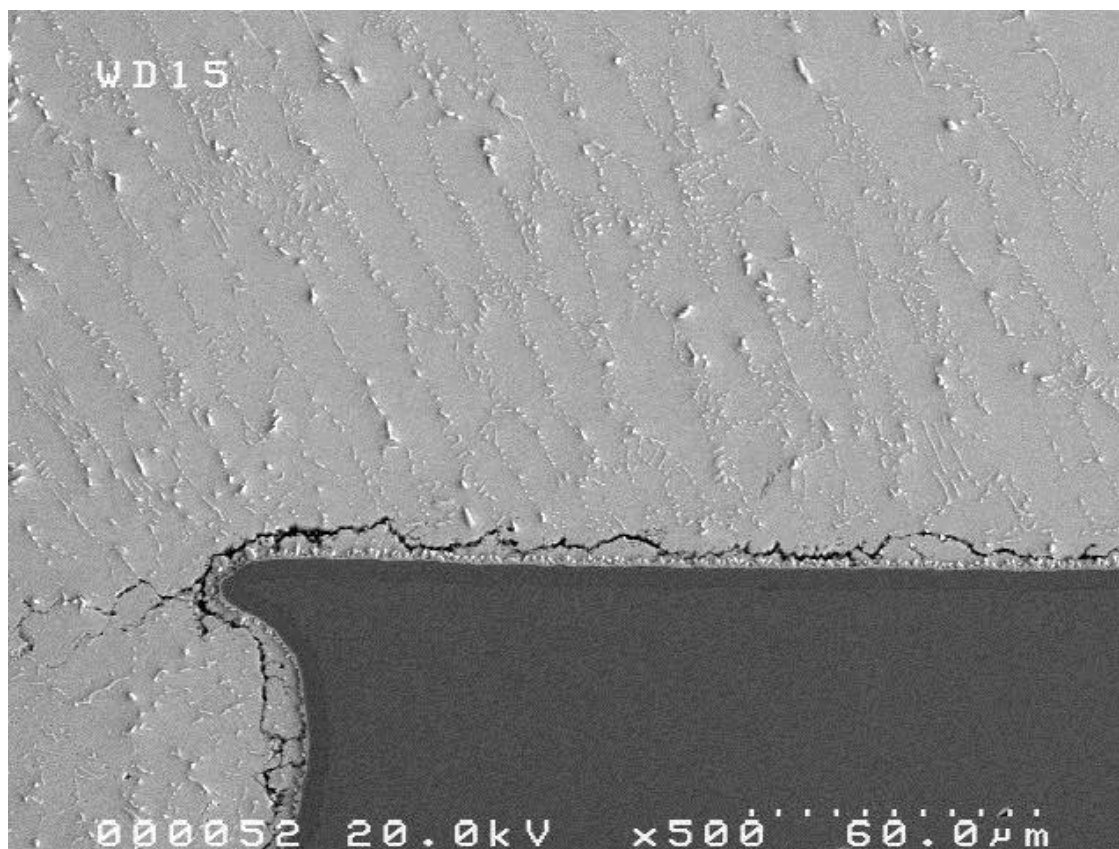
Figure 46: Board Side Failure of BGA with SAC305 Solder on ENEPIG Finish, 170 T_g Board

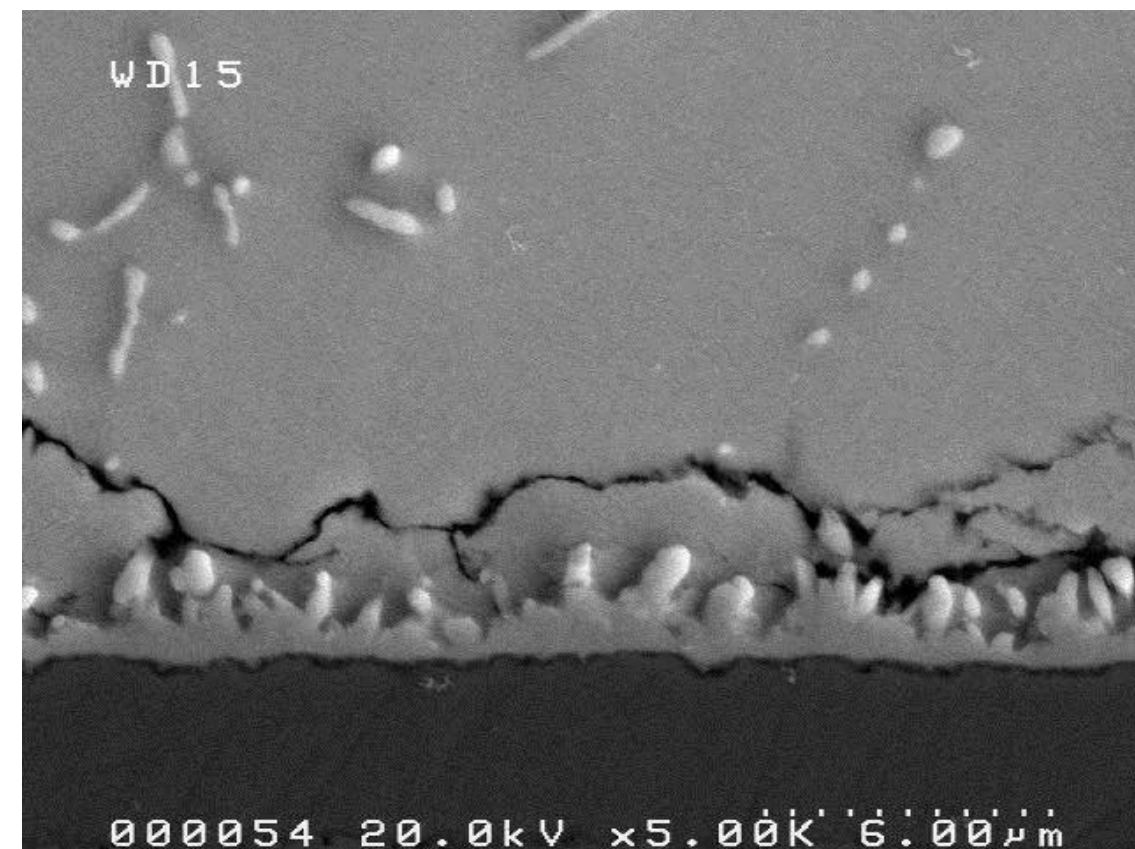
Figure 47: Board Side Failure of BGA with SAC305 Solder on ENEPIG Finish, 170 T_g Board

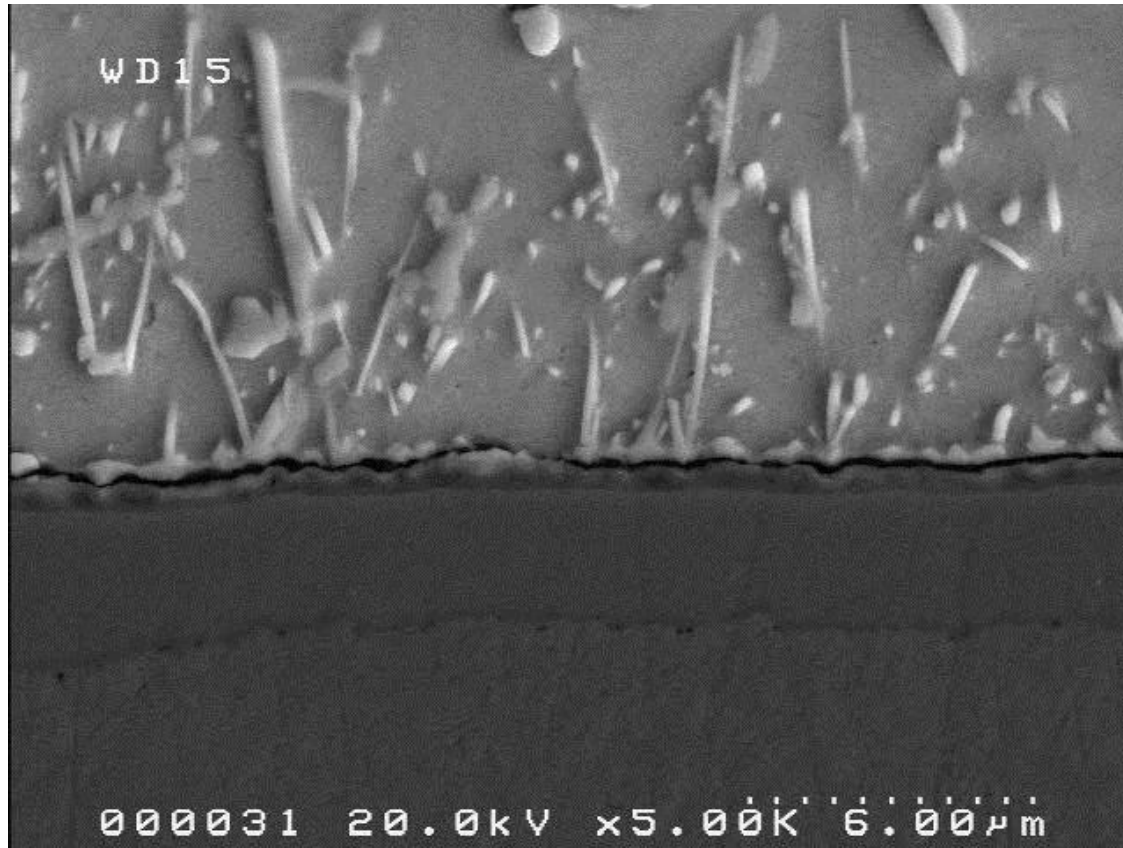
Figure 48: Board Side Failure of BGA with Orchid Solder on ENEPIG Finish, 170 T_g Board

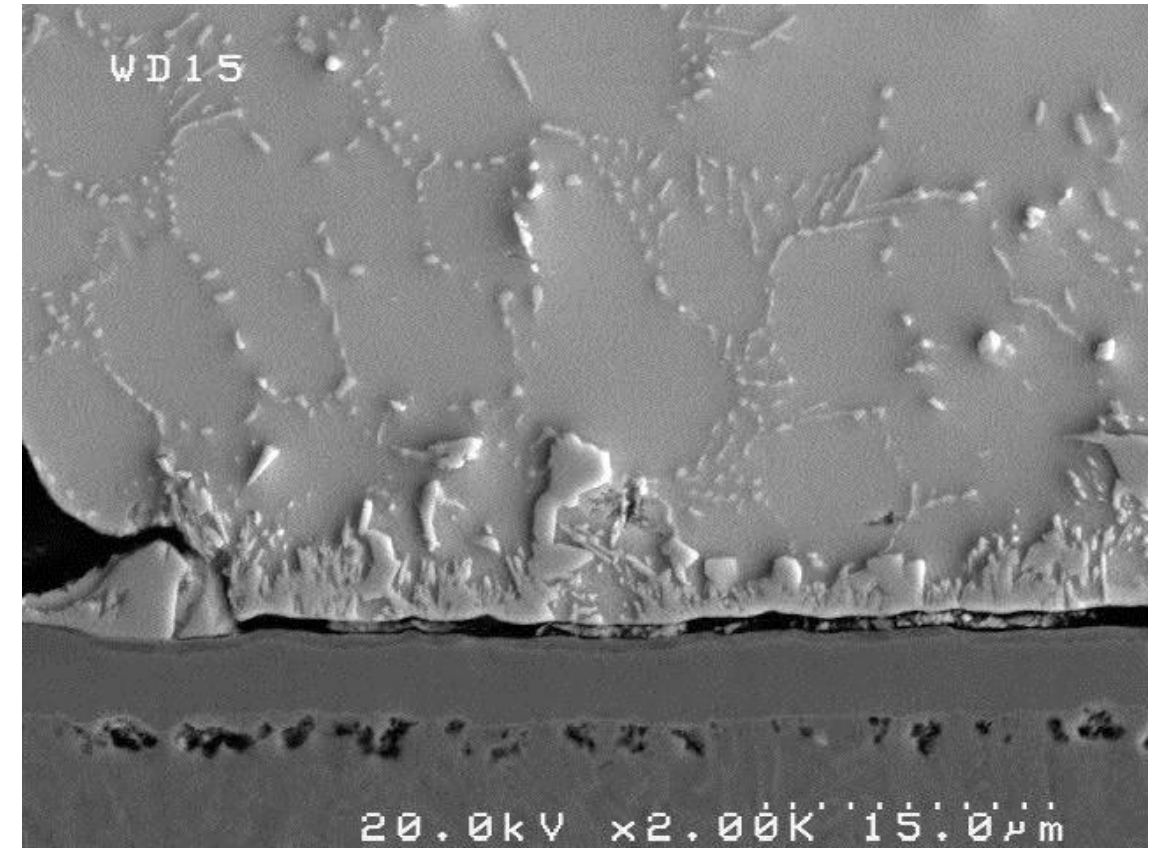
Figure 49: Board Side Failure of BGA with Paul Solder on ENIG Finish, 170T_g Board

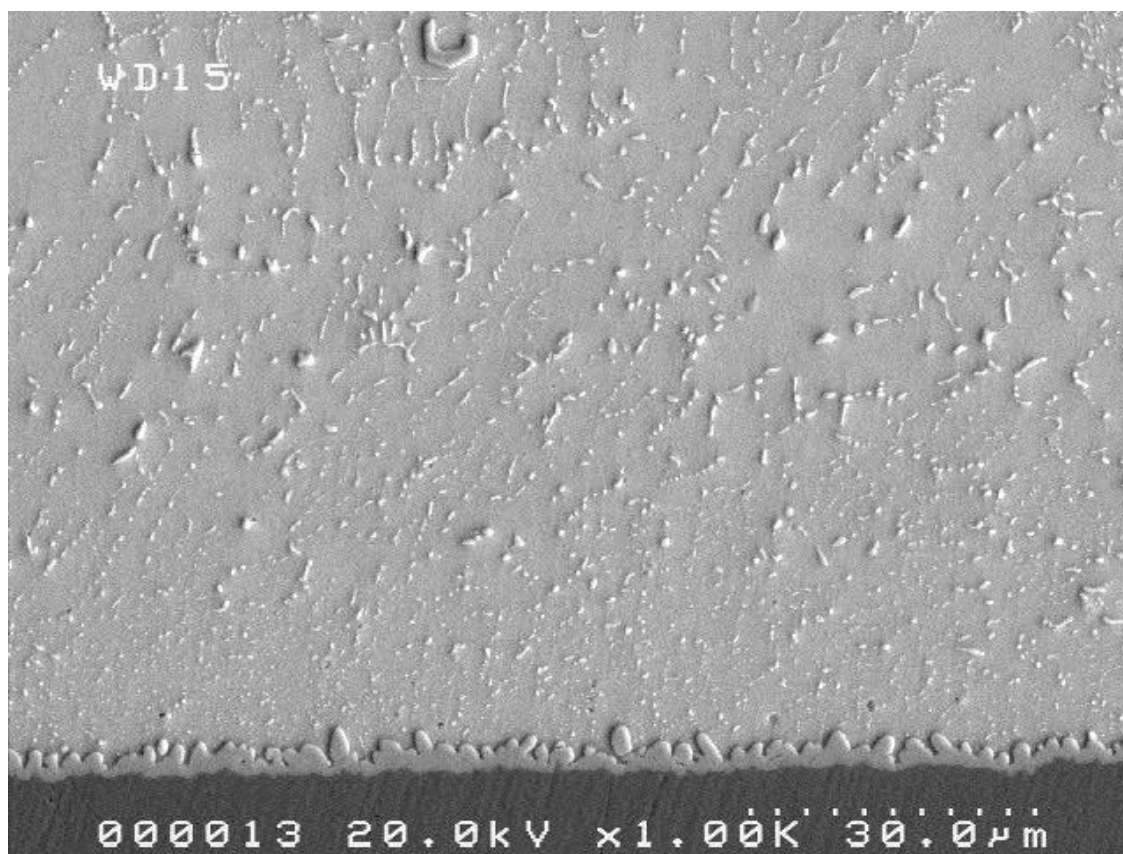
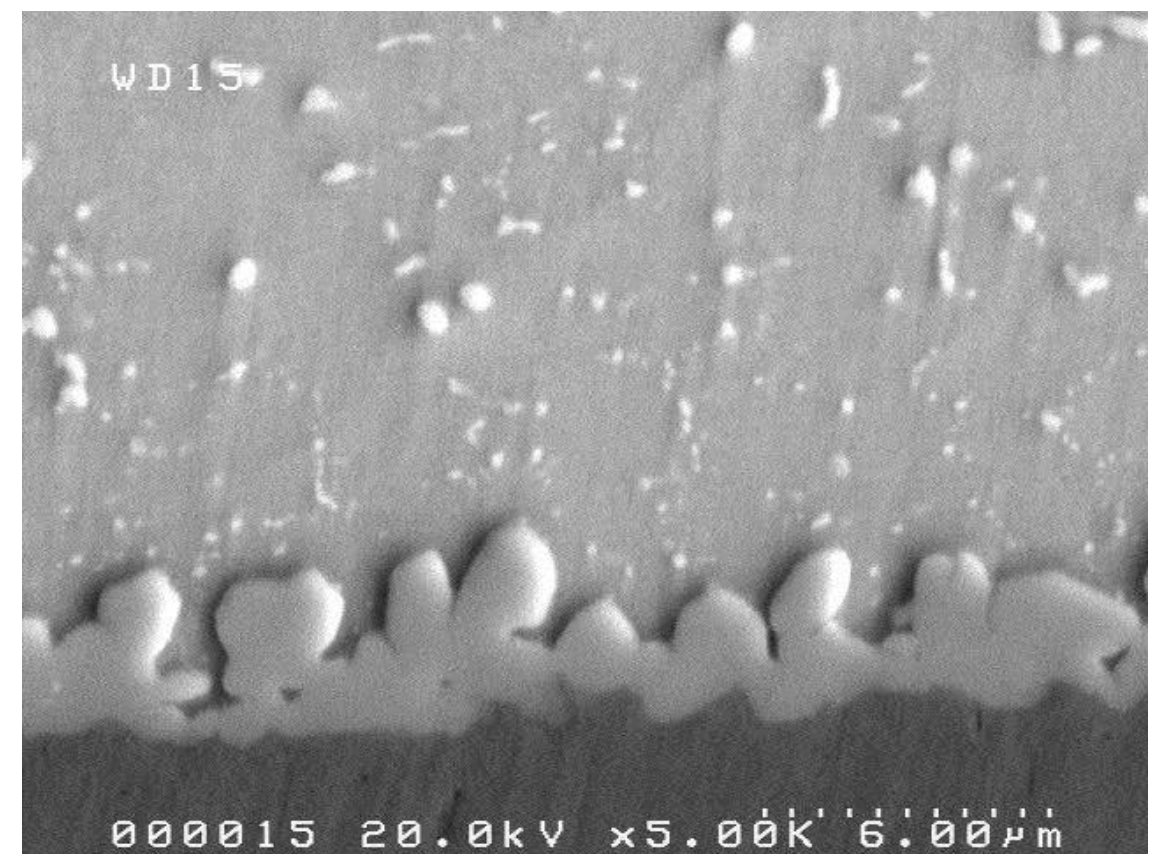
No failures occurred with Violet solder paste on OSP board finish. This solder-finish combination performed as well as SnPb on OSP and outperformed all other variations. Cross sections of this sample reveal good microstructural properties with a consistent, unbroken IMC layer as seen in Figure 50 and Figure 51.

Figure 50: BGA with Violet Solder Paste on OSP Finish

Figure 51: BGA with Violet Solder Paste on OSP Finish

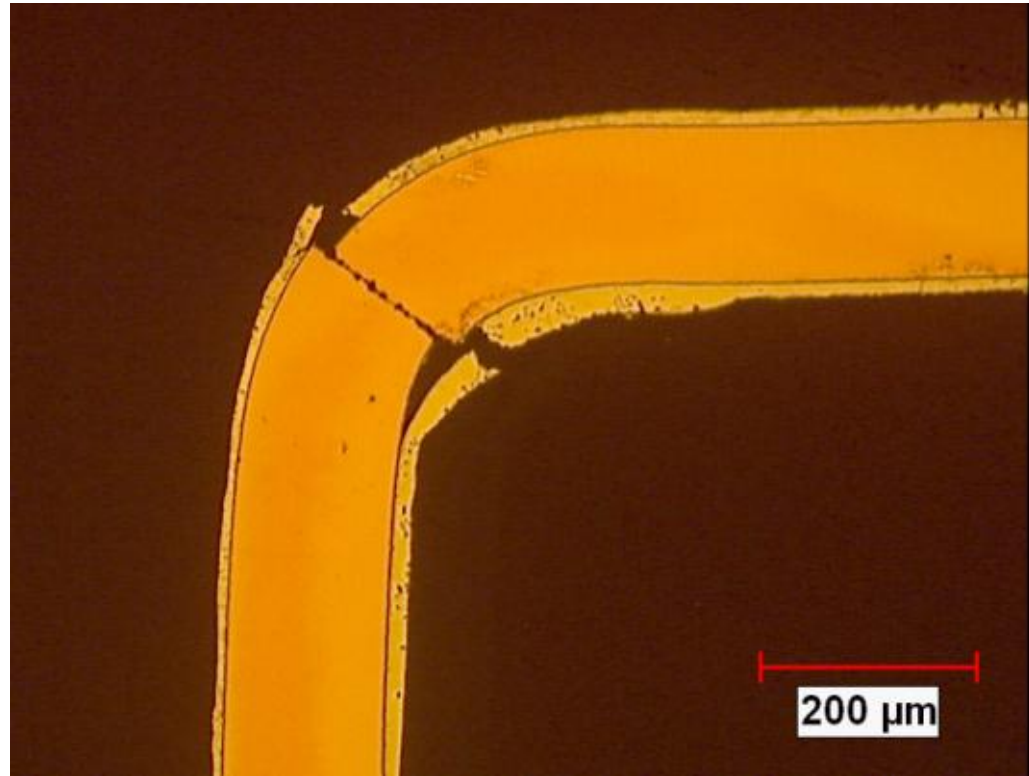
QFP failures can be attributed to full cracks and breaks of the lead as revealed in Figure 52. The solder however does appear to be a factor as the crack initiation appears to occur within the solder along the lead as shown in Figure 53. Only Violet and SnPb solders appeared to have survived. No pad crater mode was detected in QFP solder joints nether in 170°C nor 155°C T_g boards. There was no difference in survival rate of QFPs assembled on 170°C and 155°C T_g boards as well. The pad crater failure mode is very typical for BGAs. There was a significant difference in survival rate between the BGAs assembled on 170°C and 155°C T_g boards. 80**%** BGAs assembled on 155°C T_g boards using Paul, Violet, Orchid and SnPb (SAC305 was excluded because 155°C T_g boards cannot be used for 240°C assembly) survived 1,000,000 cycles at 5G. Only 18.8% of the BGAs assembled using the same solder pastes on 170°C T_g boards survived 1,000,000 cycles at 5G. This suggests that the 155°C T_g laminate demonstrates a trend to pad crater failure mode reduction.

Figure 52: QFP Failure by Broken Lead

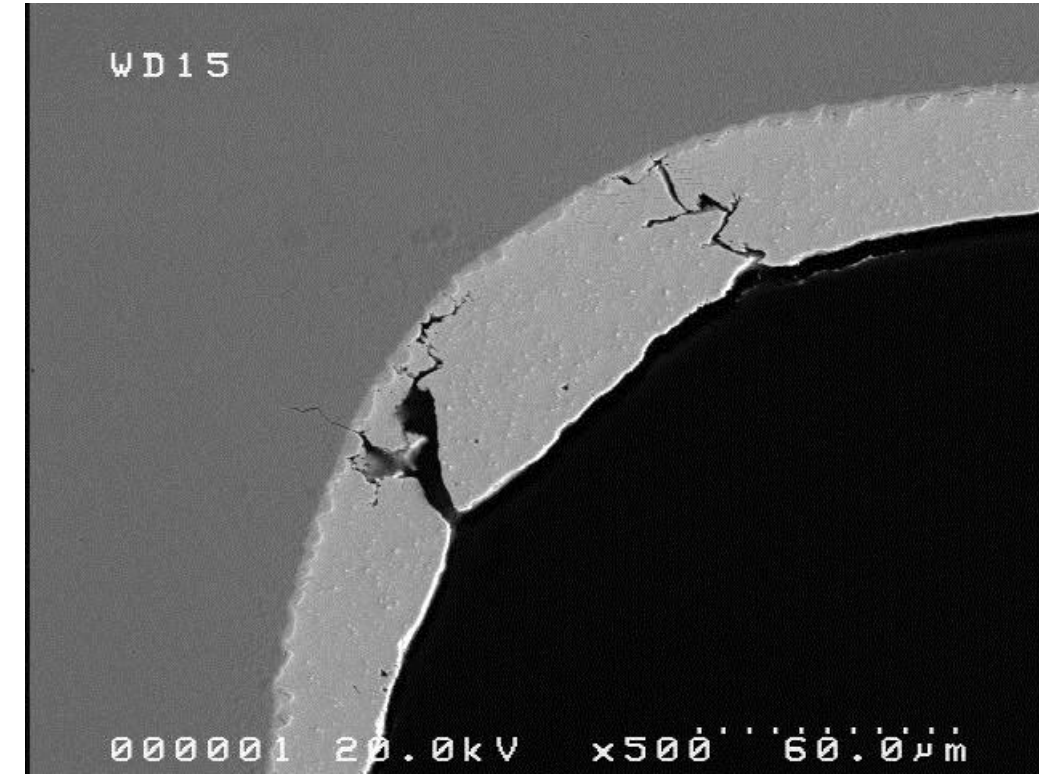
Figure 53: QFP Failure Initiating in Solder

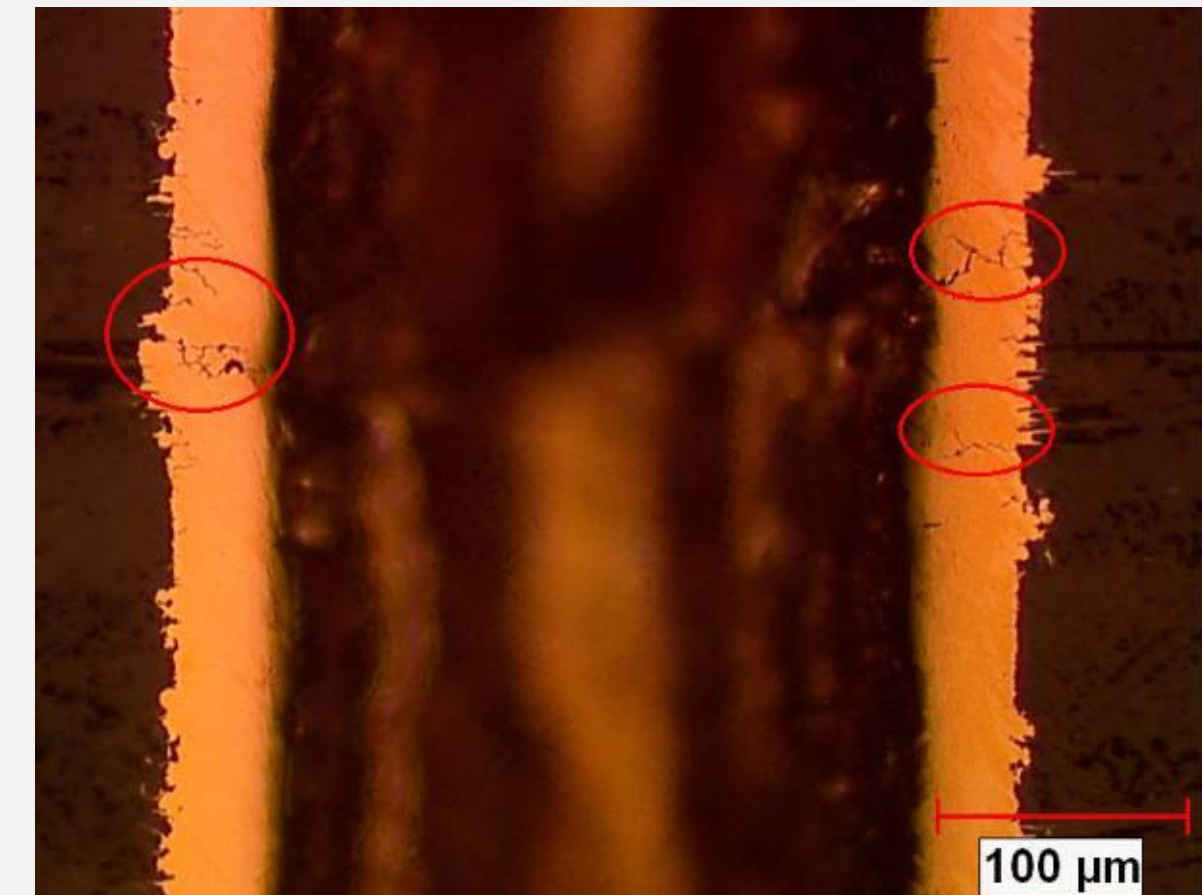
Cross Section showing barrel crack in via beneath SnPb/OSP/170°C T_g solder joint after 1734 cycles

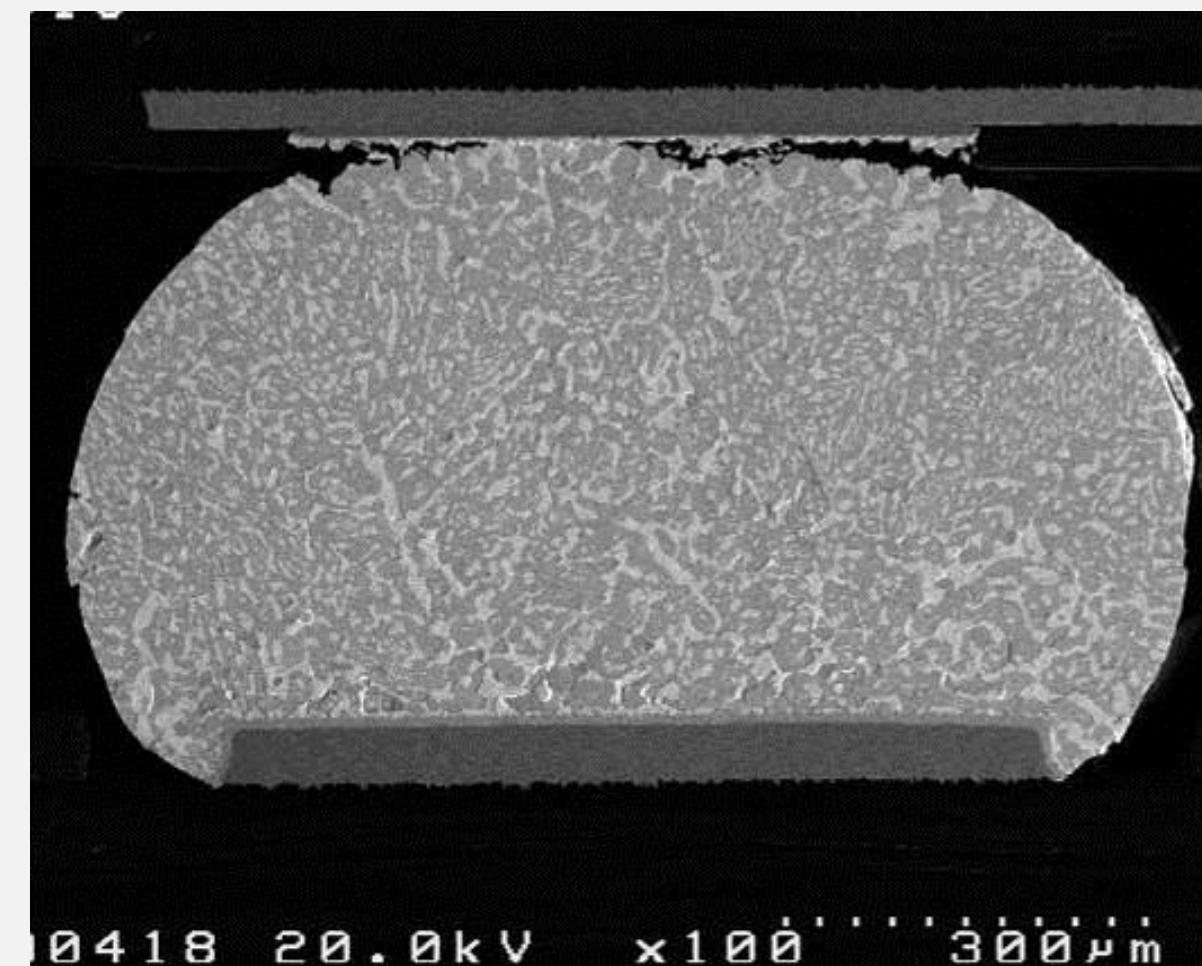
Cross Section of SnPb BGA Solder joint showing near complete fatigue cracking after 1734 cycles

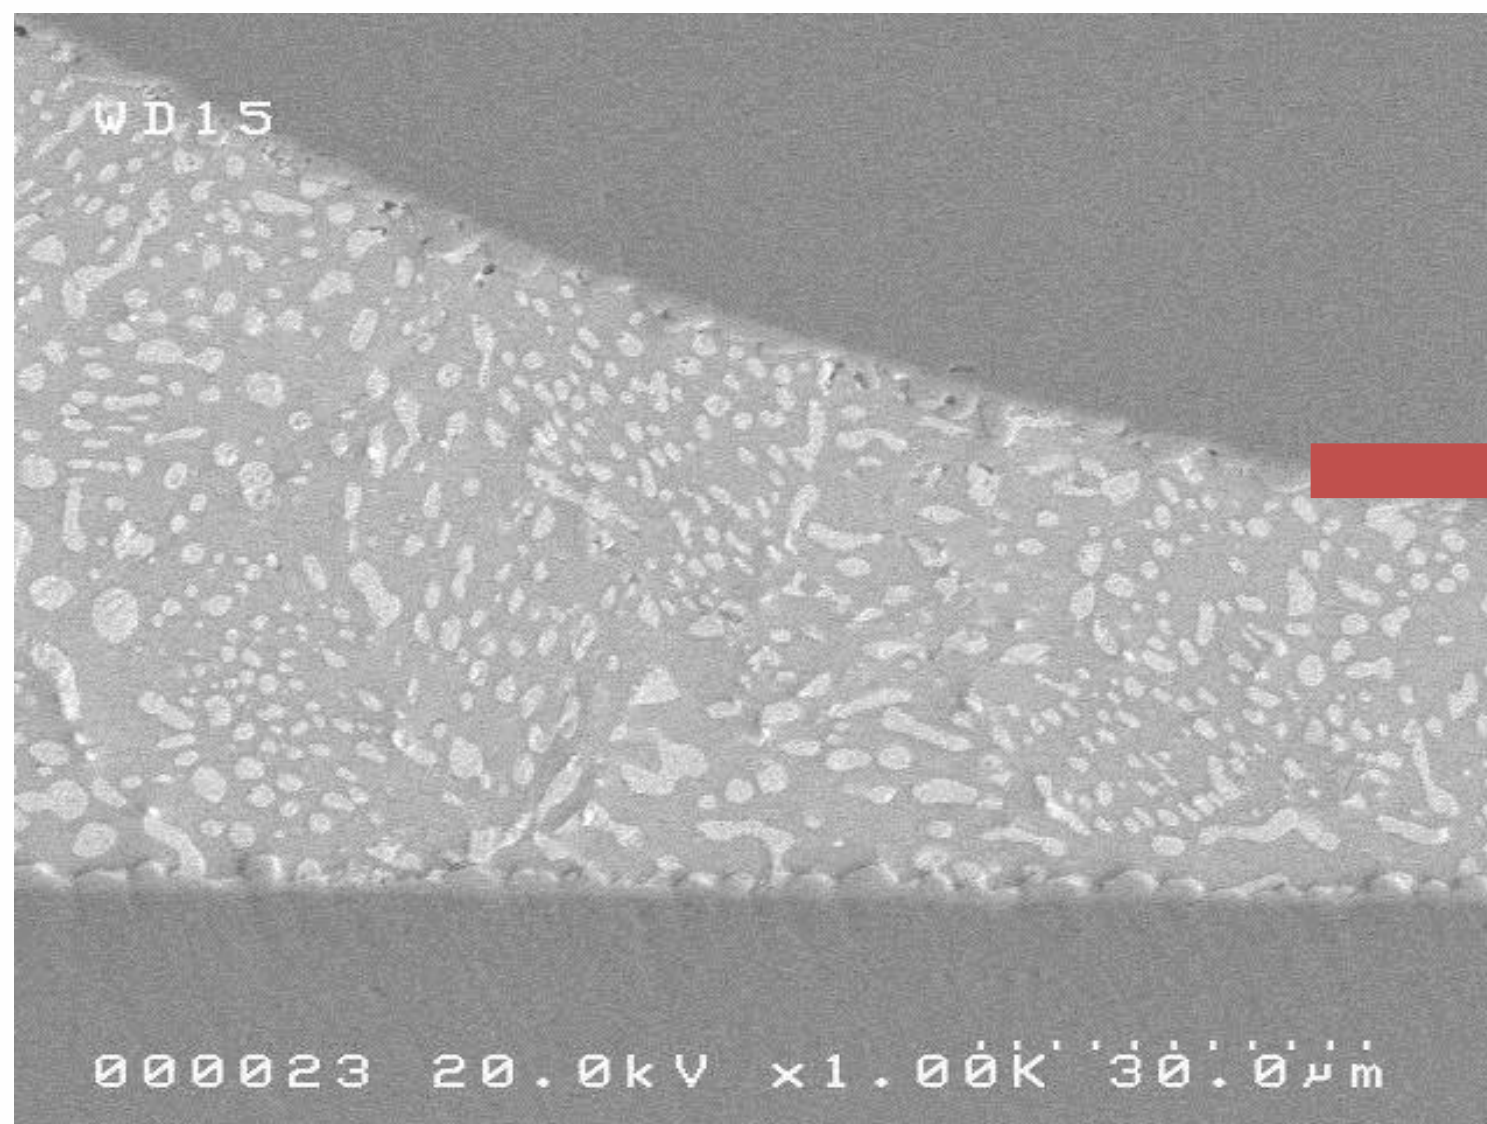
SnPb microstructural change after 3010 cycles ATC (seen on QFP)

- Recrystallization and Grain Growth
- IMC layer growth, Cu_3Sn phase now visible
- Pb (brittle phase) pooling at IMC layer

Cross Section showing SnPb microstructure after assembly

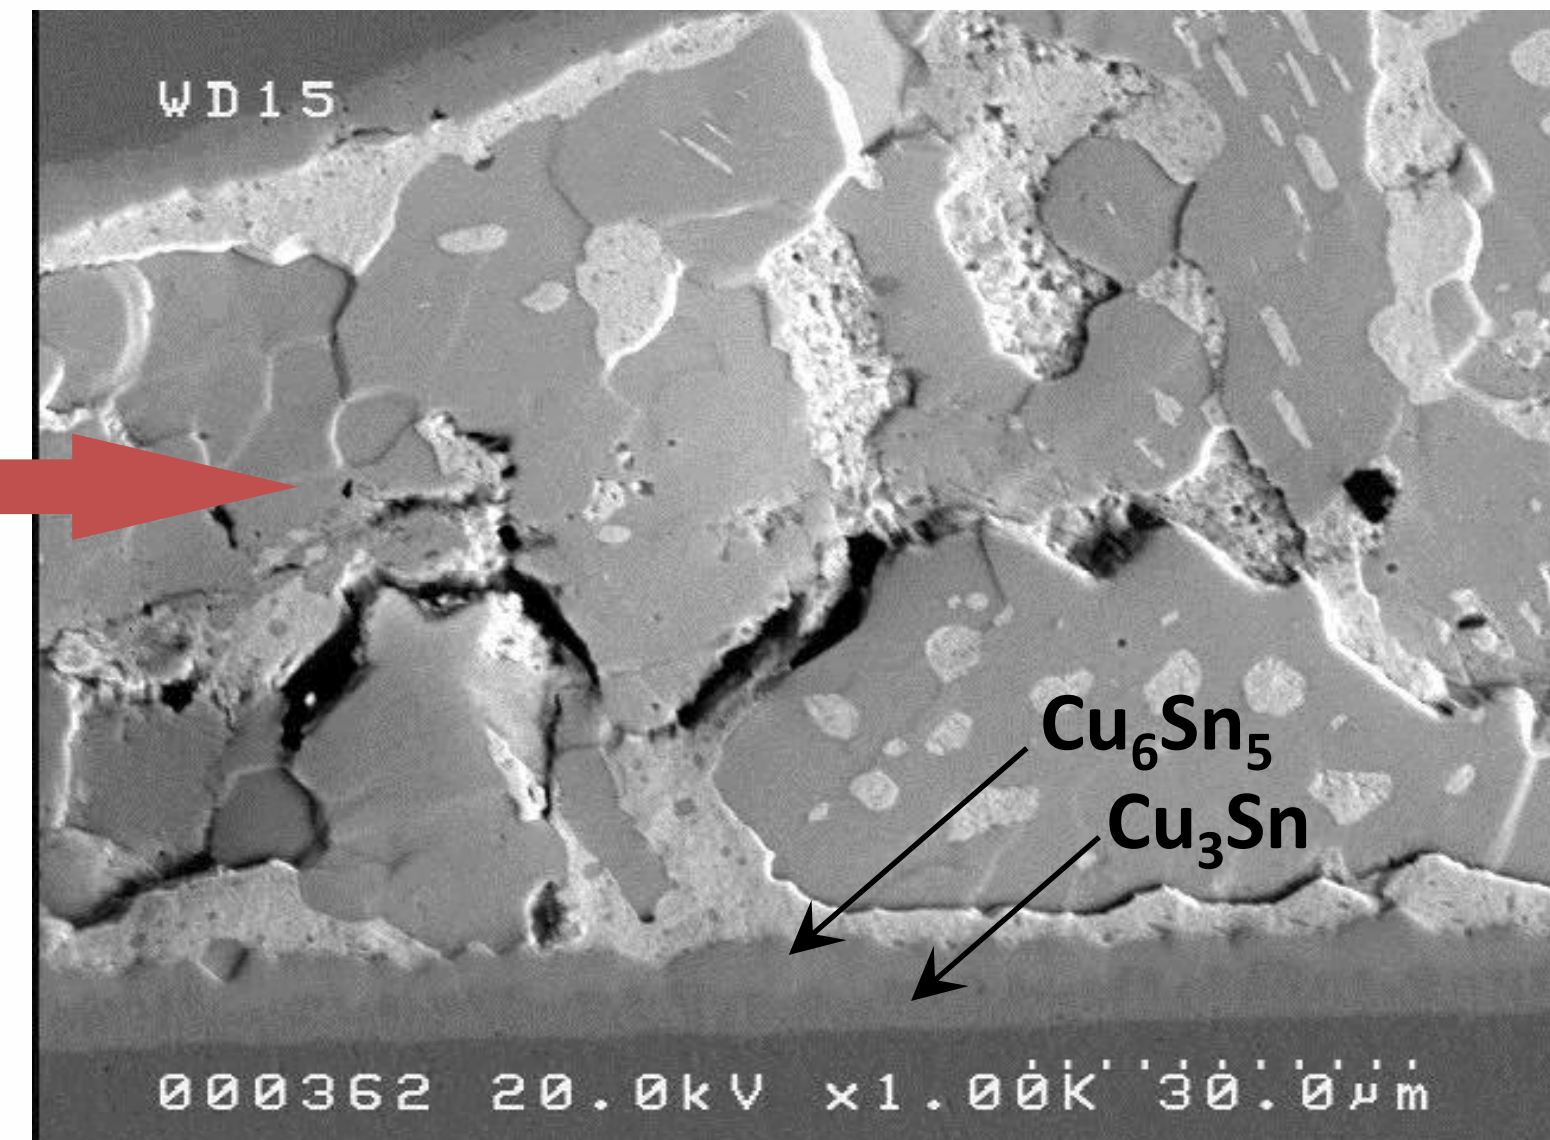
Cross Section showing SnPb microstructure after 3010 cycles of harsh environment ATC

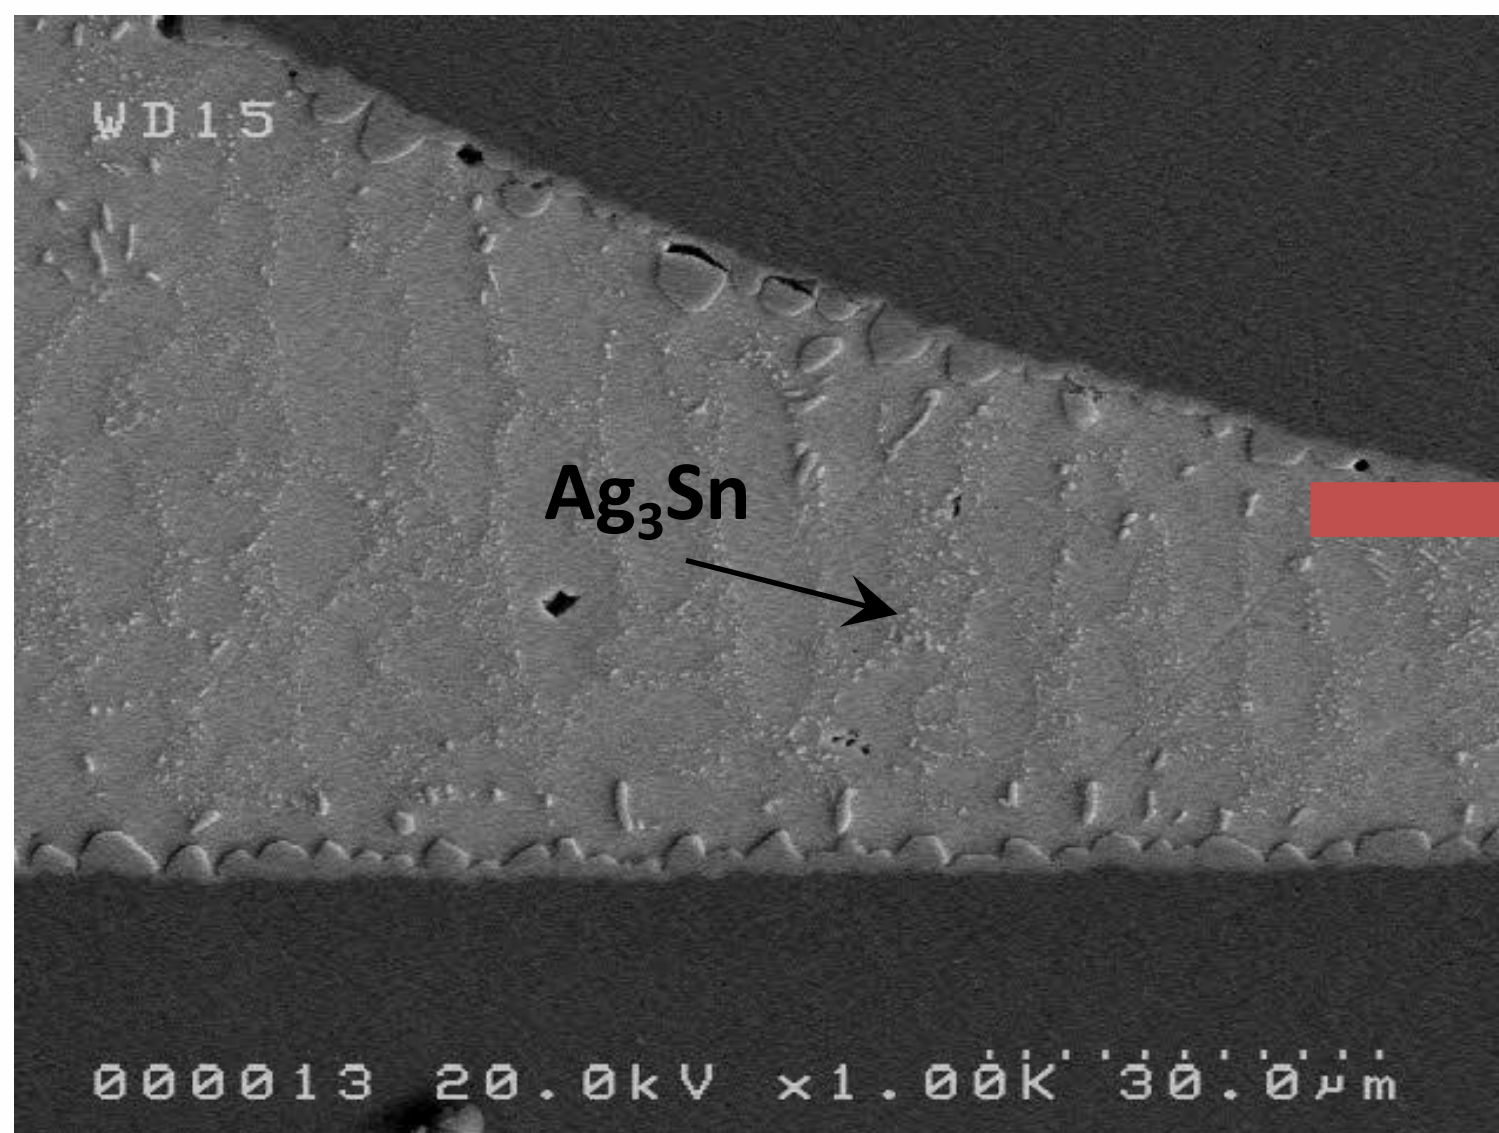
SAC305 microstructural change after 3010 cycles ATC (seen on QFP)

- grain growth, IMC layer growth
- Distinct Cu_3Sn layer in IMC after 3000 cycles
- Ag_3Sn particles coalesced into fewer, larger particles
- Incomplete crack propagating along the lead

Cross Section showing SAC305 microstructure after assembly

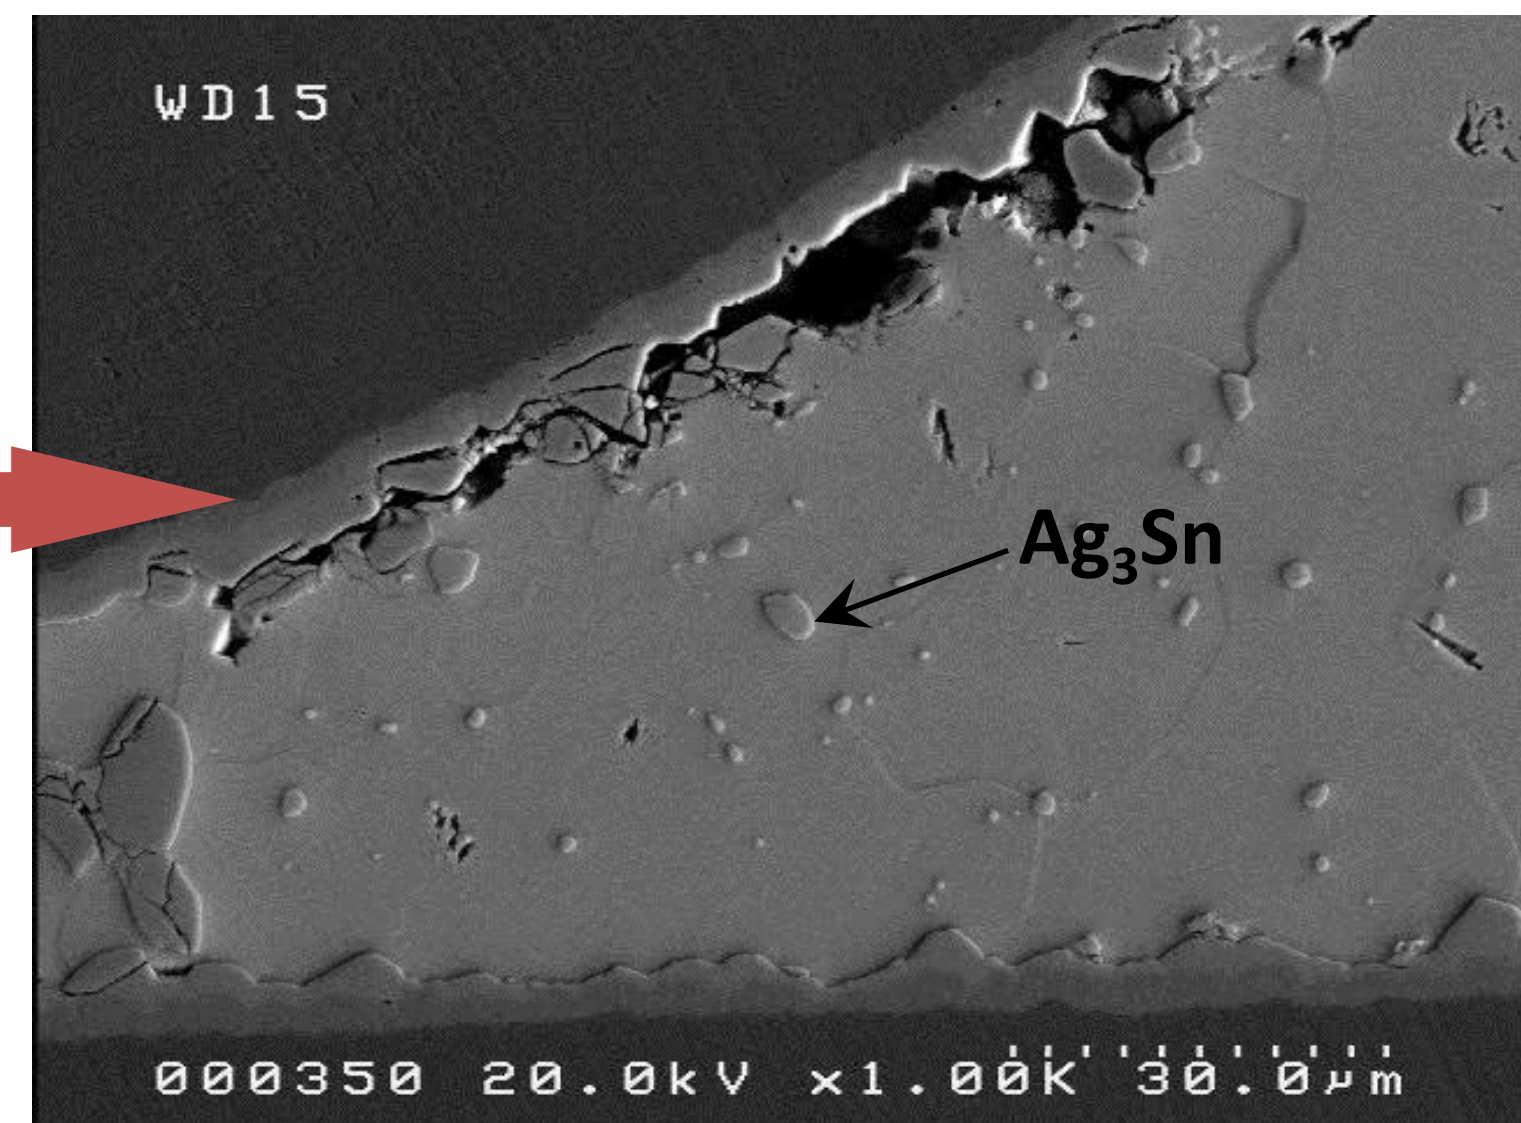
Cross Section showing SAC305 microstructure after 3010 cycles of harsh environment ATC

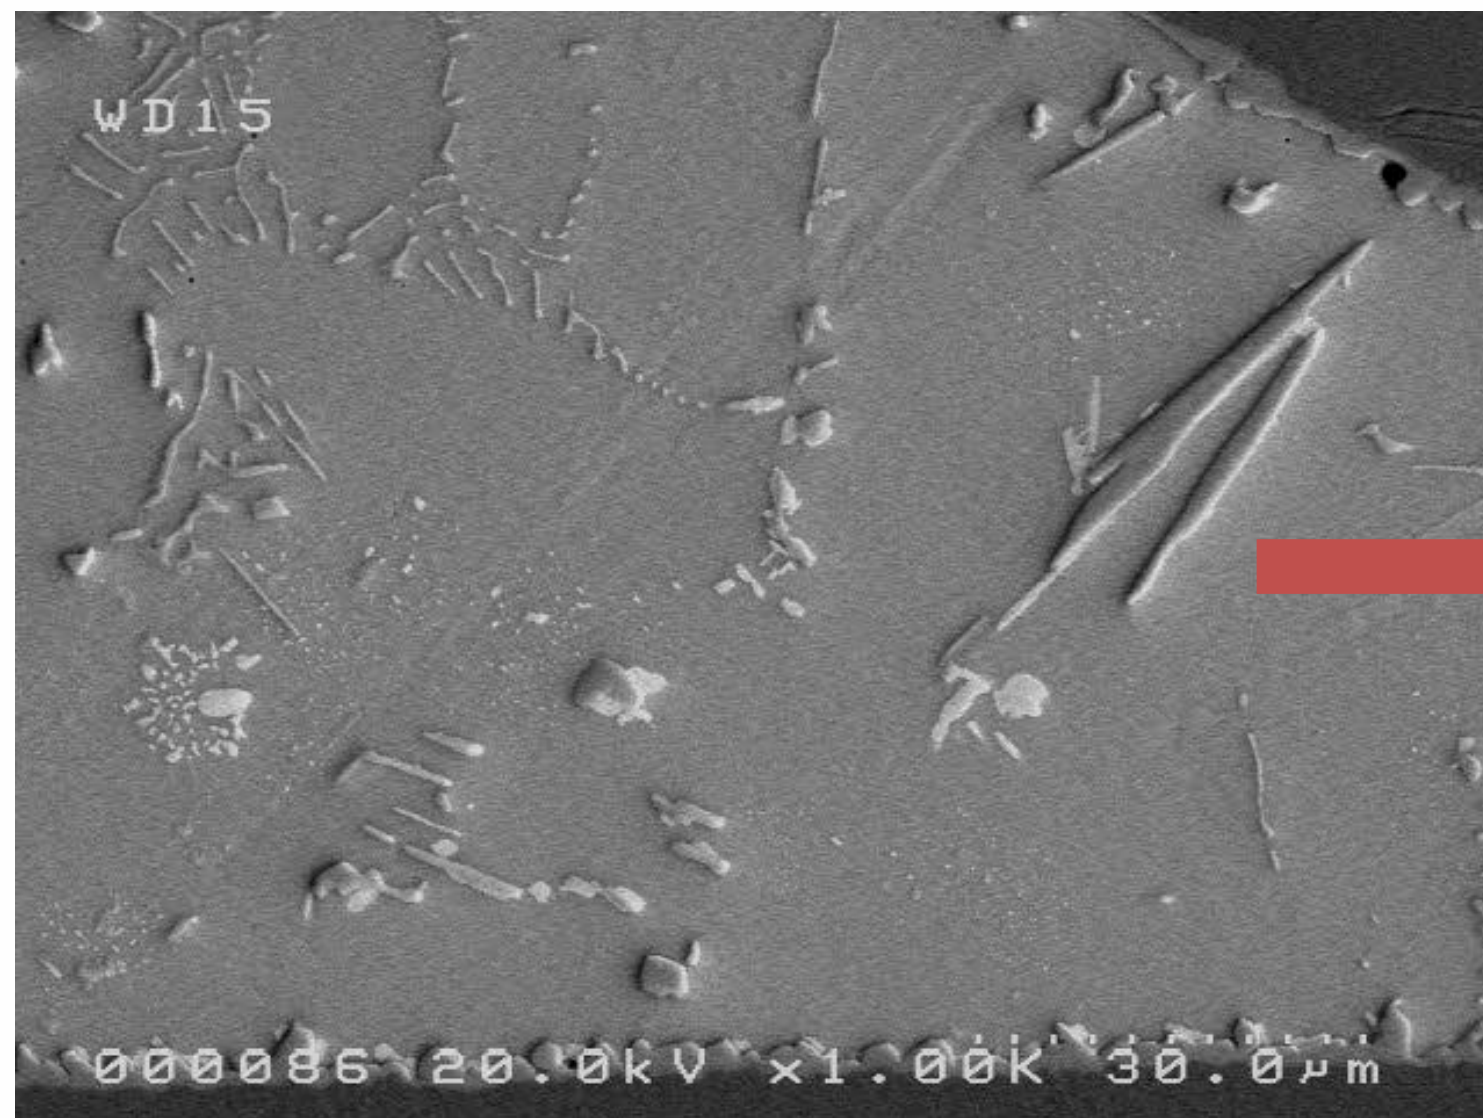
Violet microsturtural change after 3010 cycles ATC (seen on QFP)

- IMC layer growth, Distinct Cu_3Sn layer in IMC
- Grains did not appear to grow
- Bi, present in solid solution in Sn at assembly, precipitated out of solution after 3010 cycles ATC

Cross Section showing Violet microstructure after assembly

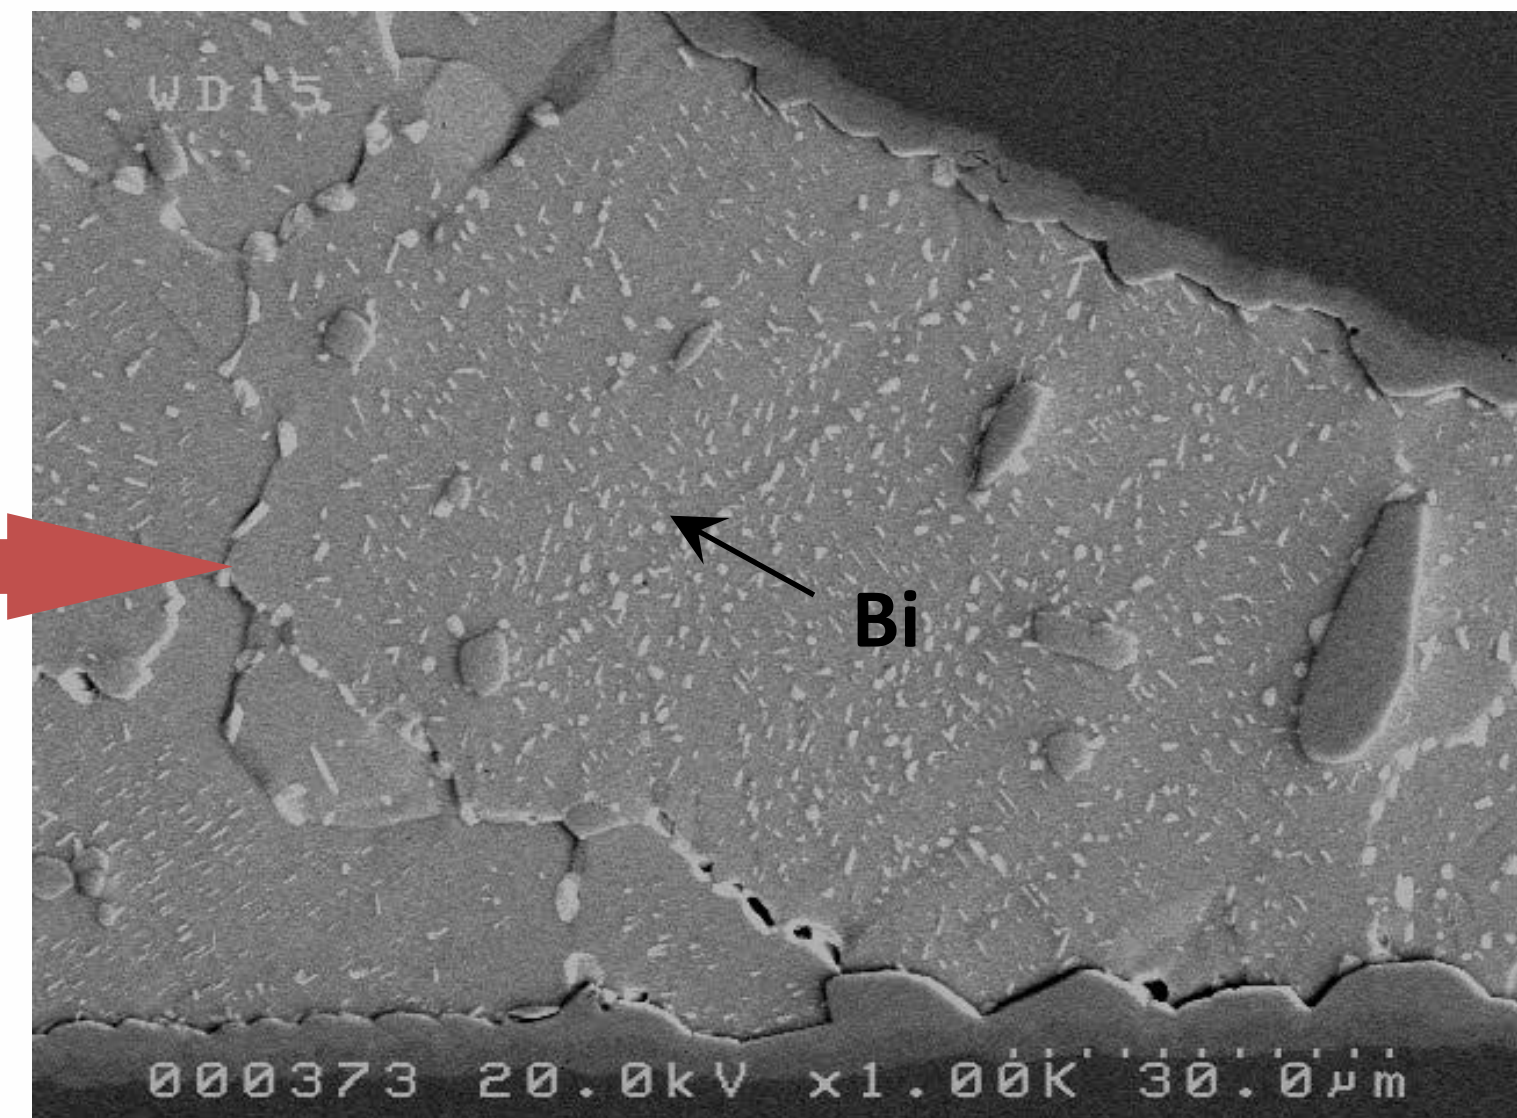
Cross Section showing Violet microstructure after 3010 cycles of harsh environment ATC
