Reliability Screening of Lower Melting Point Pb-Free Alloys Containing Bi

Joseph M. Juarez, Jr., Michael Robinson, Joel Heebink
Honeywell
AZ, US
mike.robinson6@honeywell.com
joseph.juarez@honeywell.com

Polina Snugovsky, Eva Kosiba, Jeffrey Kennedy, Zohreh Bagheri, Subramaniam Suthakaran, Marianne Romansky
Celestica Inc.
Toronto, ON, Canada
polina@celestica.com

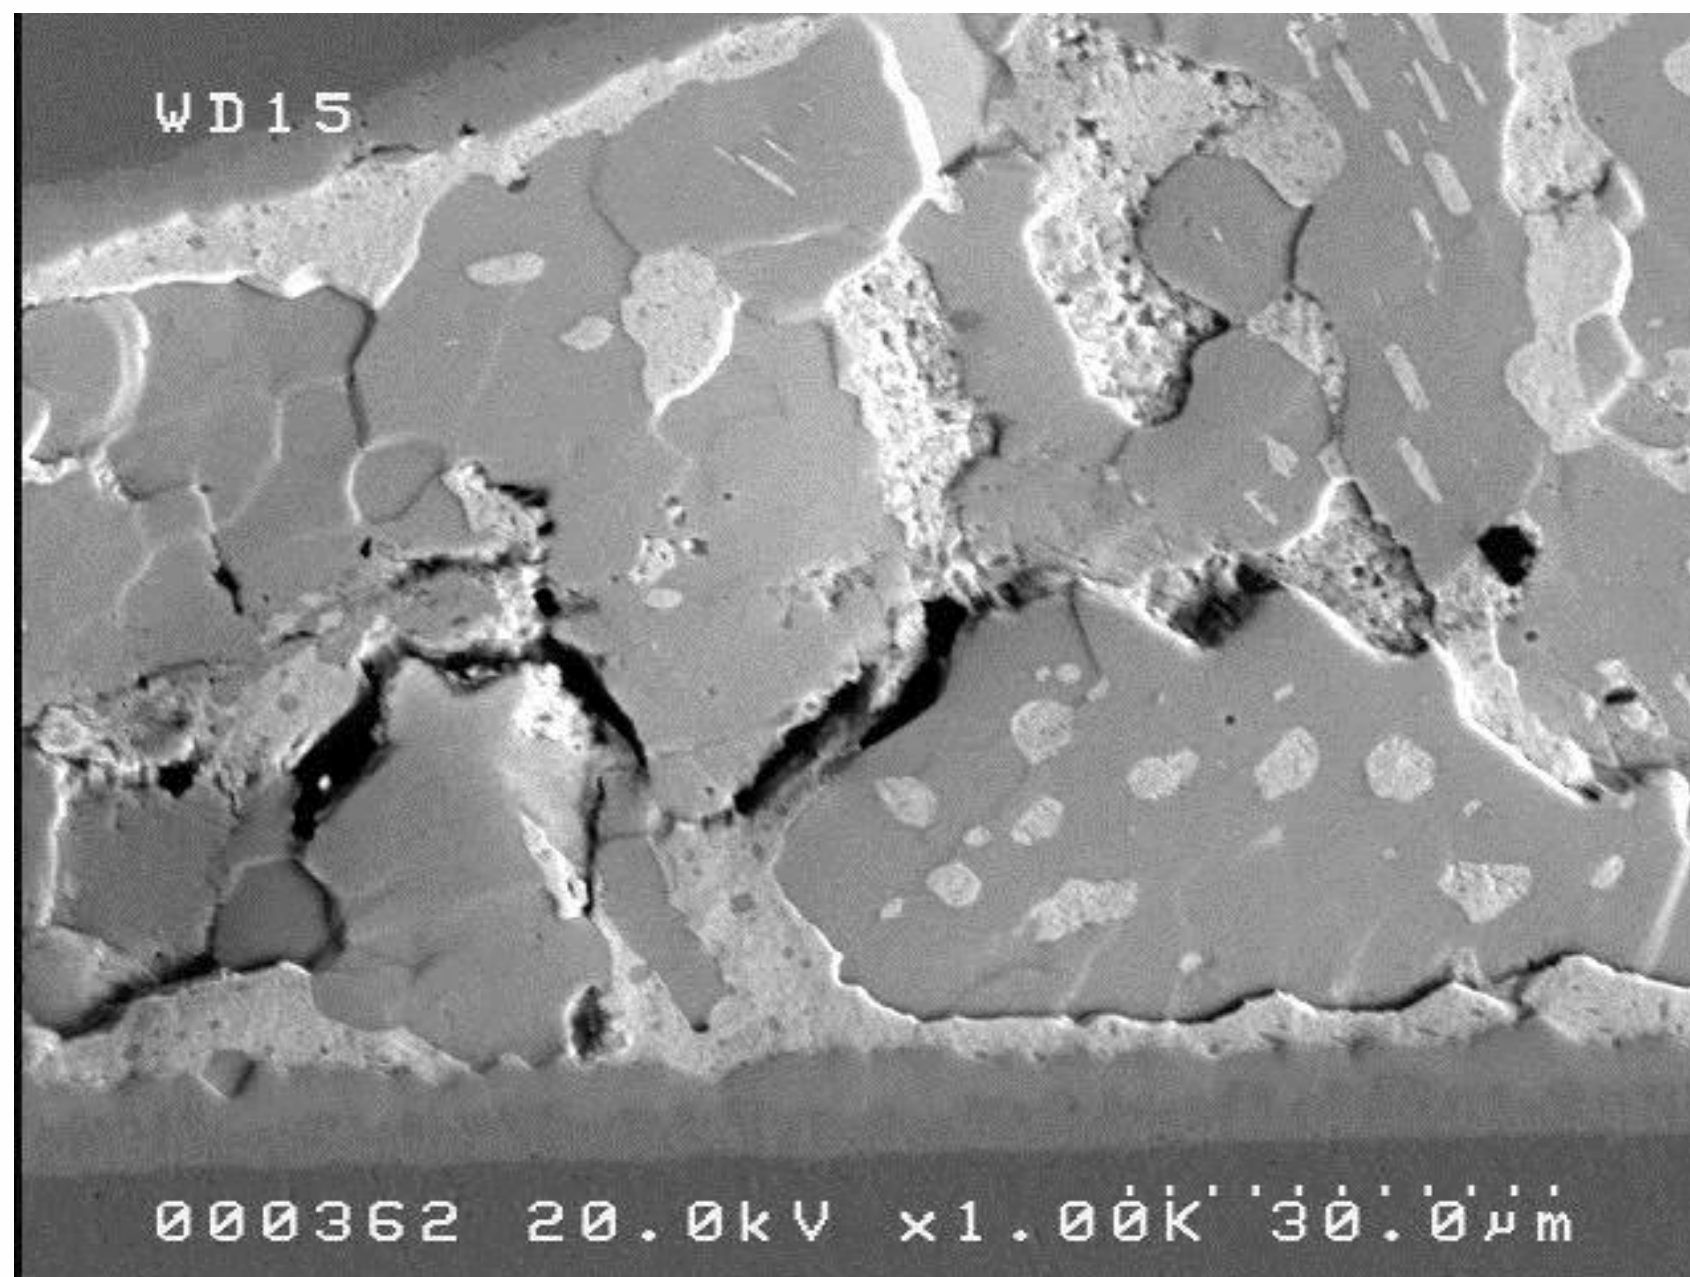
Cross Section showing SnPb microstructure after 3010 cycles of harsh environment ATC

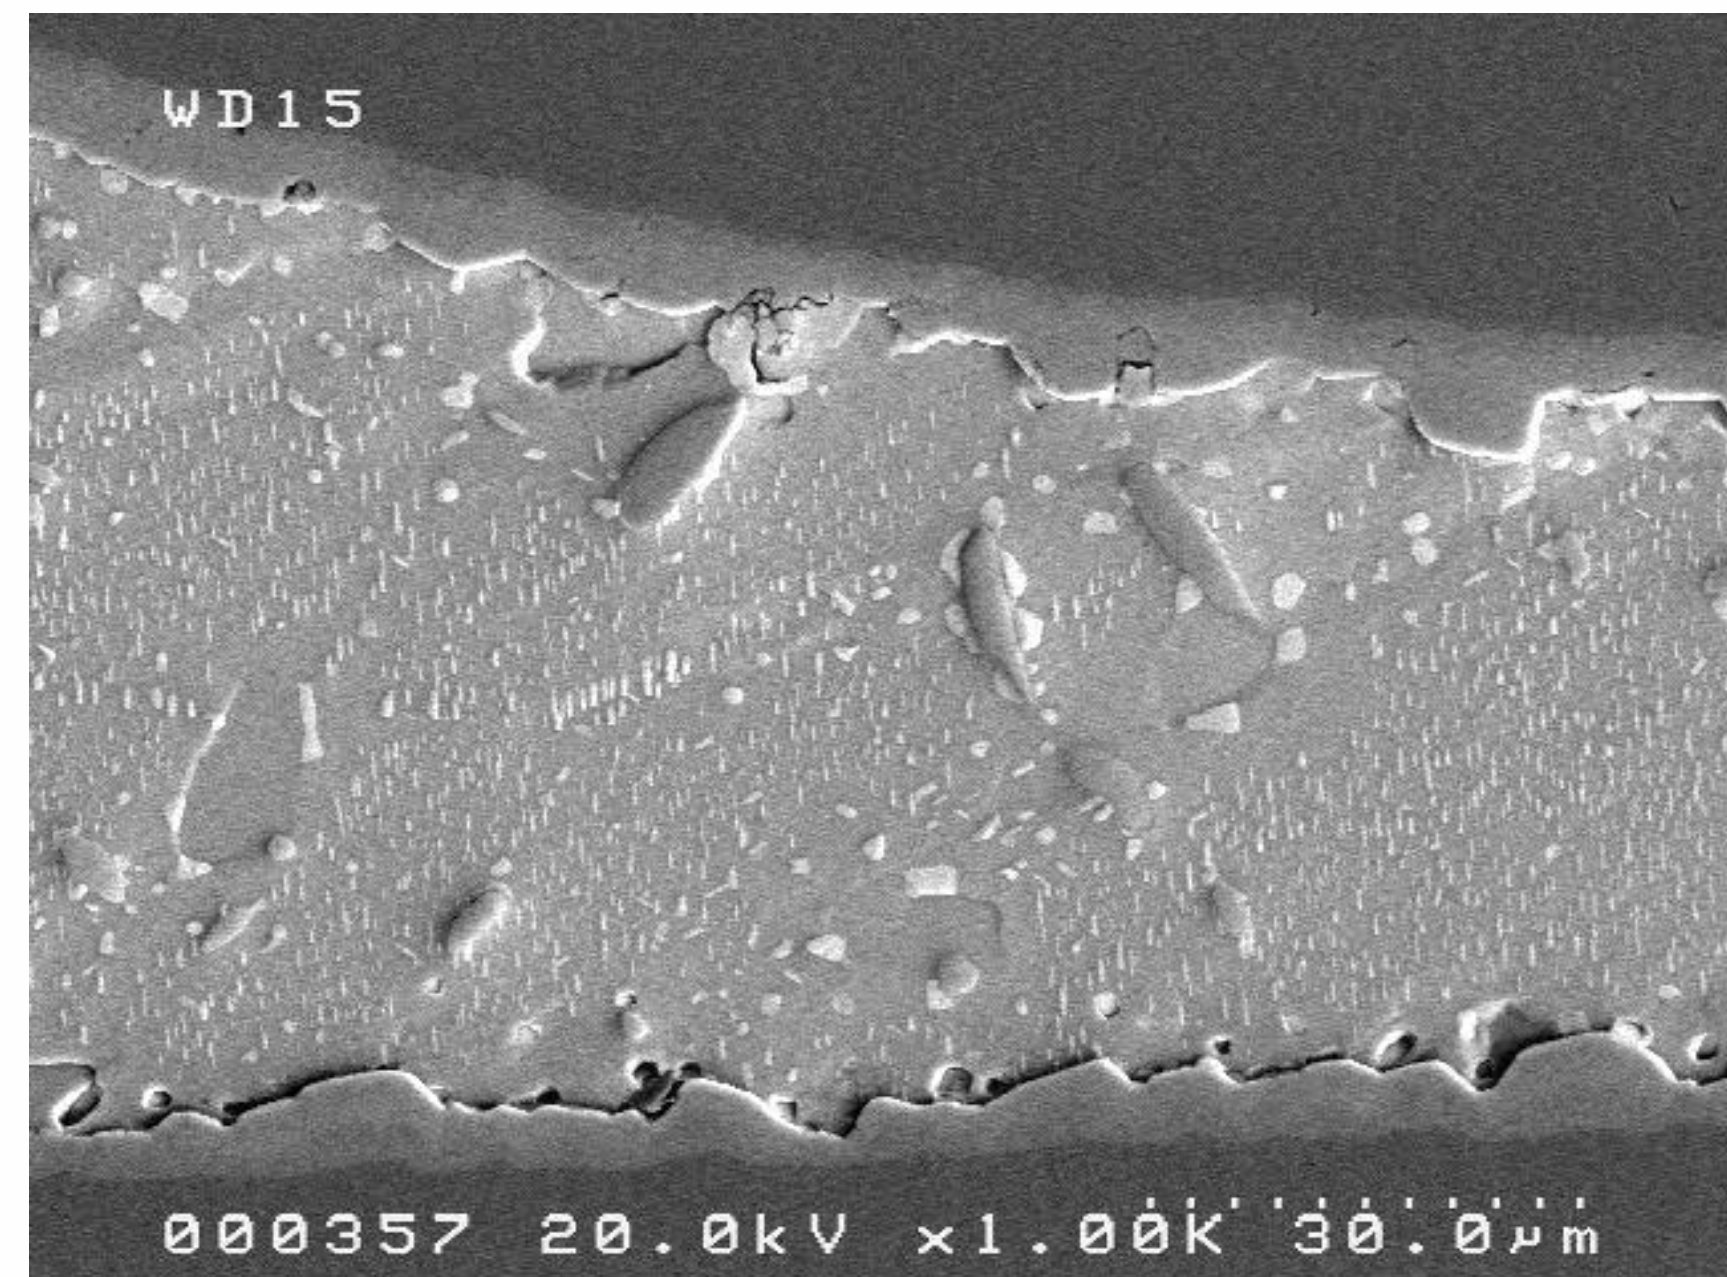
Bi containing lead free alloys show improved microstructure after Harsh Environment Accelerated Thermal Cycling – definite improvement compared to SnPb solder exposed to the same conditions

Cross Section showing Orchid microstructure after 3010 cycles of harsh environment ATC

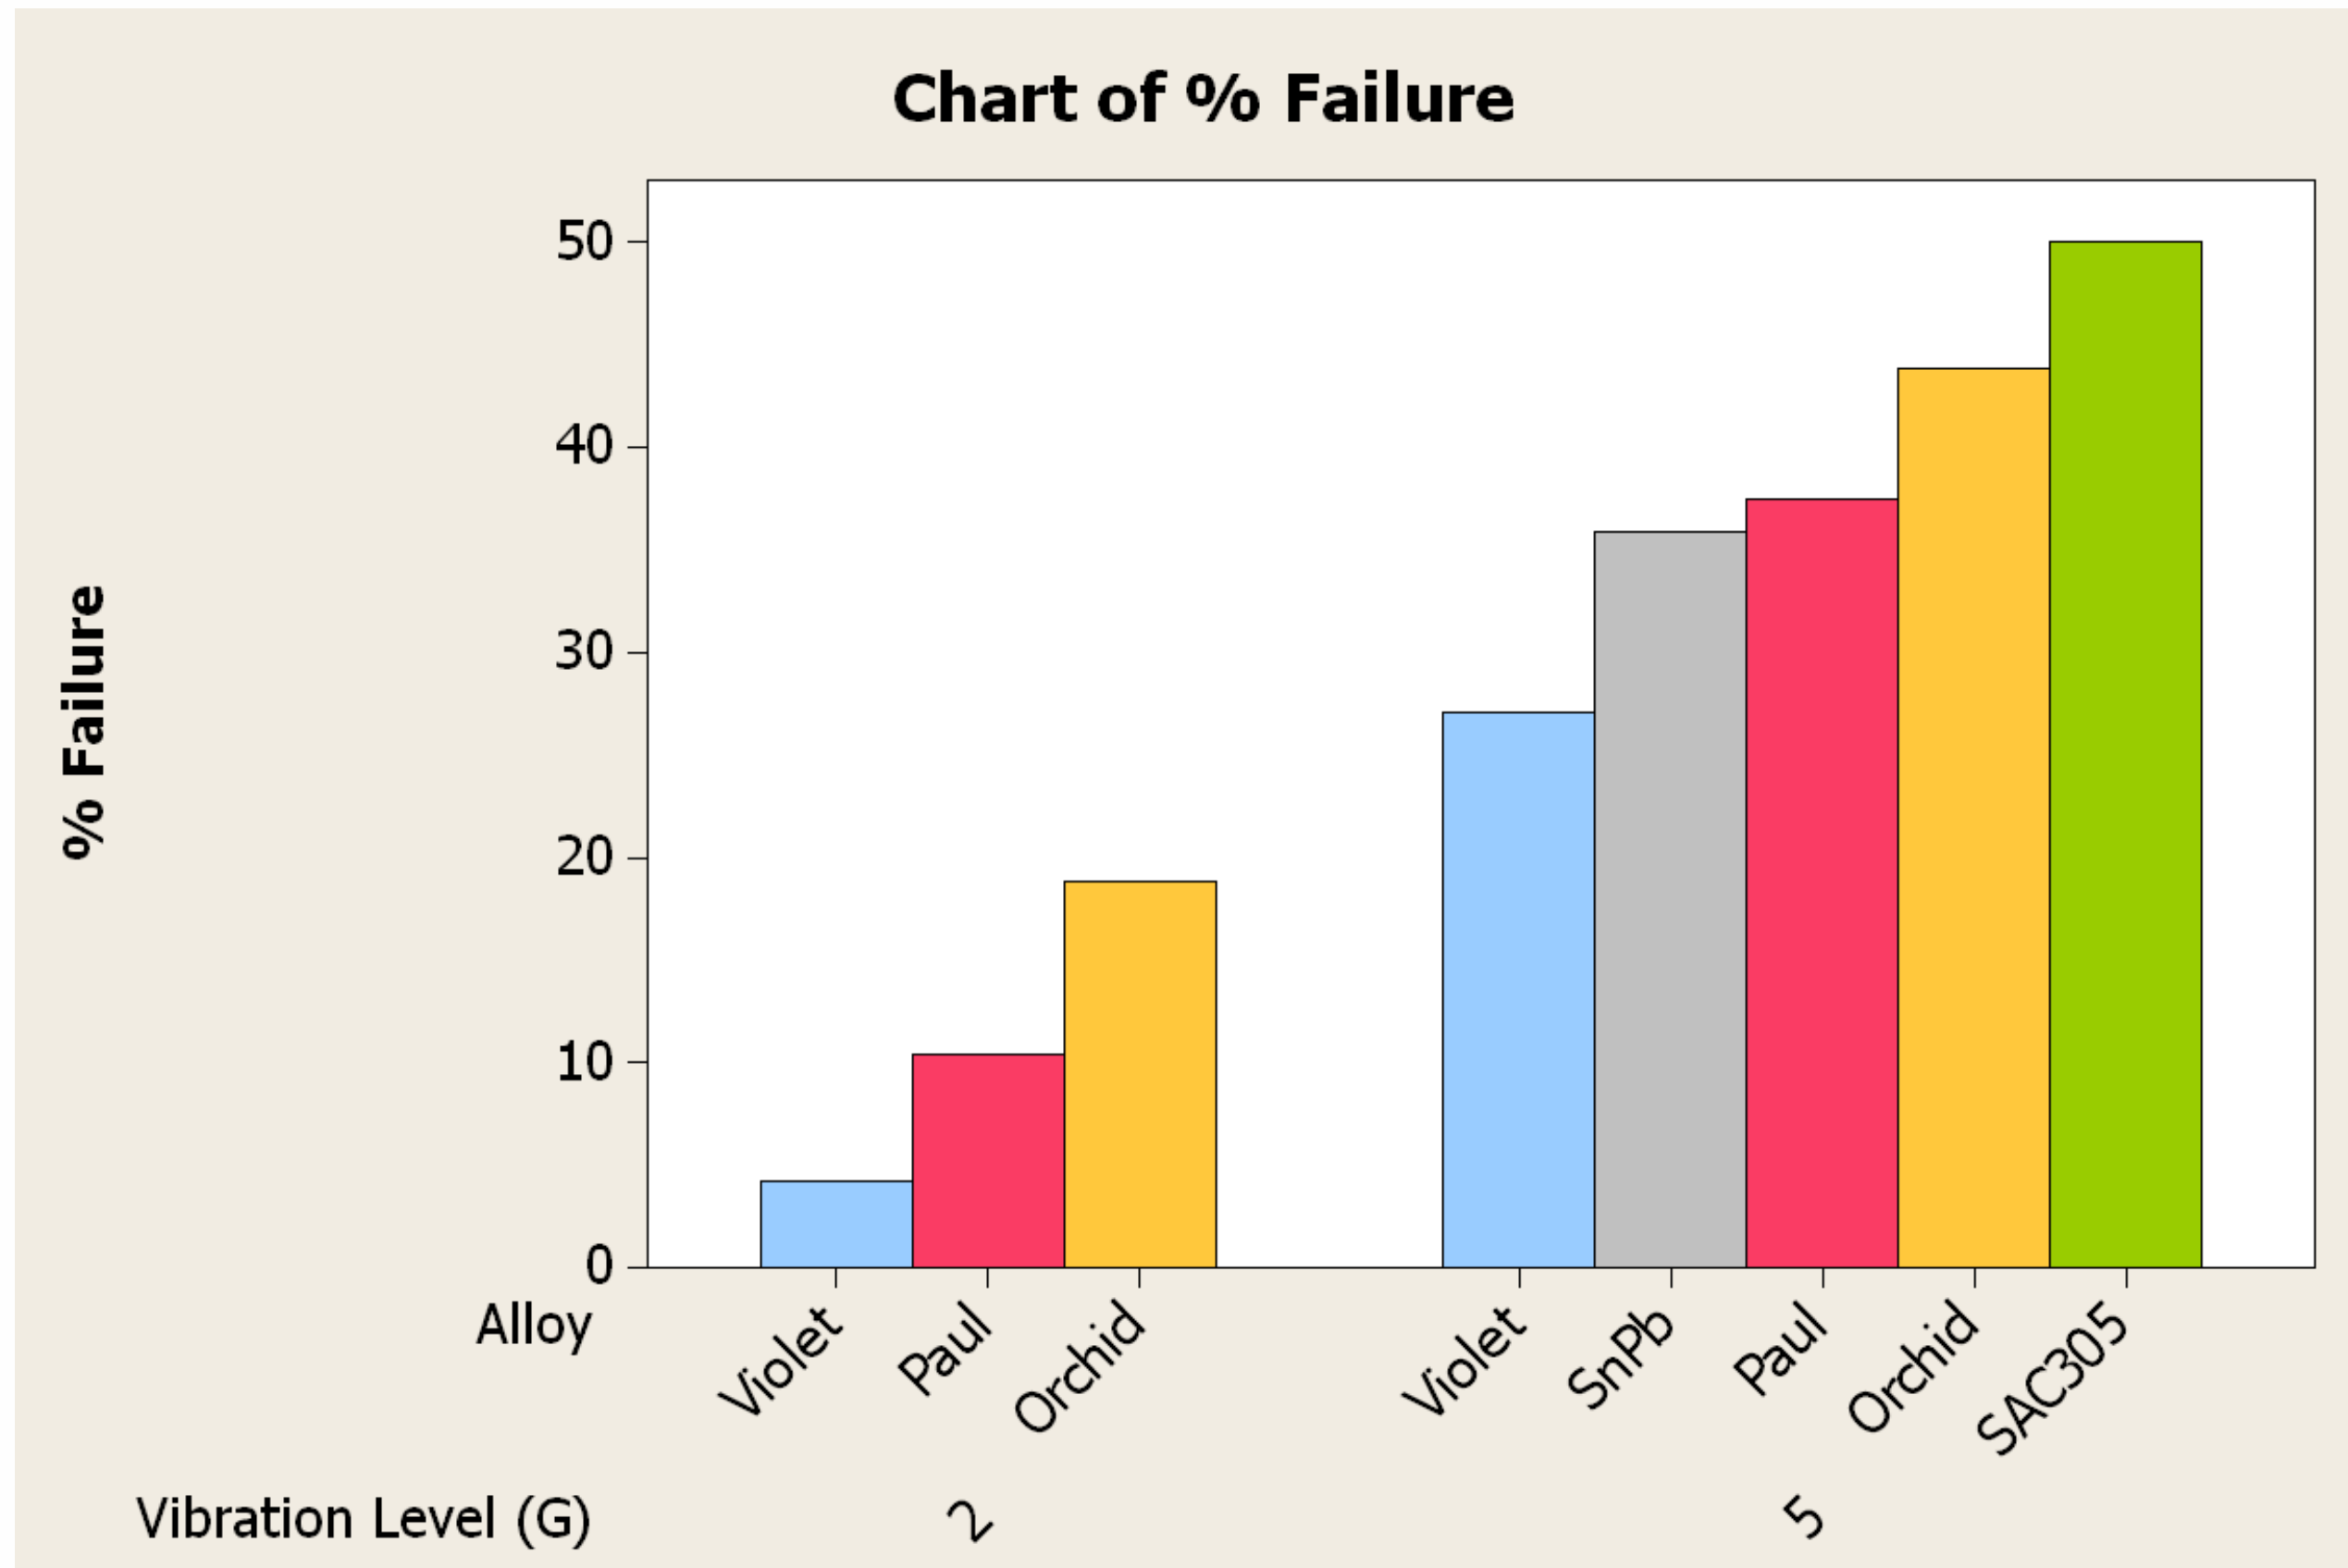
Vibration Resistance Measurements Details

Same failure trend between 2G and 5G with Violet, Paul, and Orchid

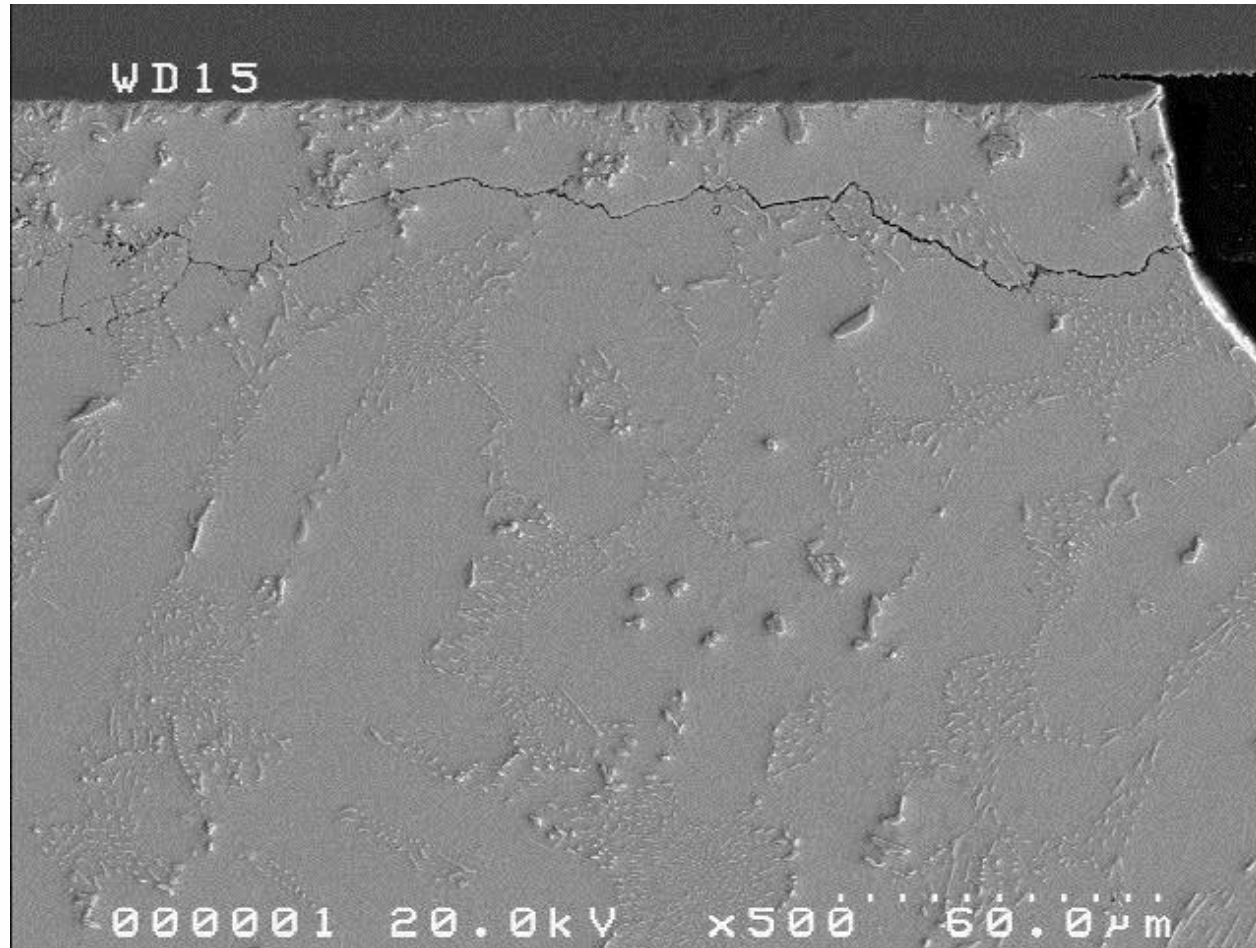
Partial fracture near component side IMC on BGA of Violet and SAC305 with an ENIG finish, 155°C T_g board

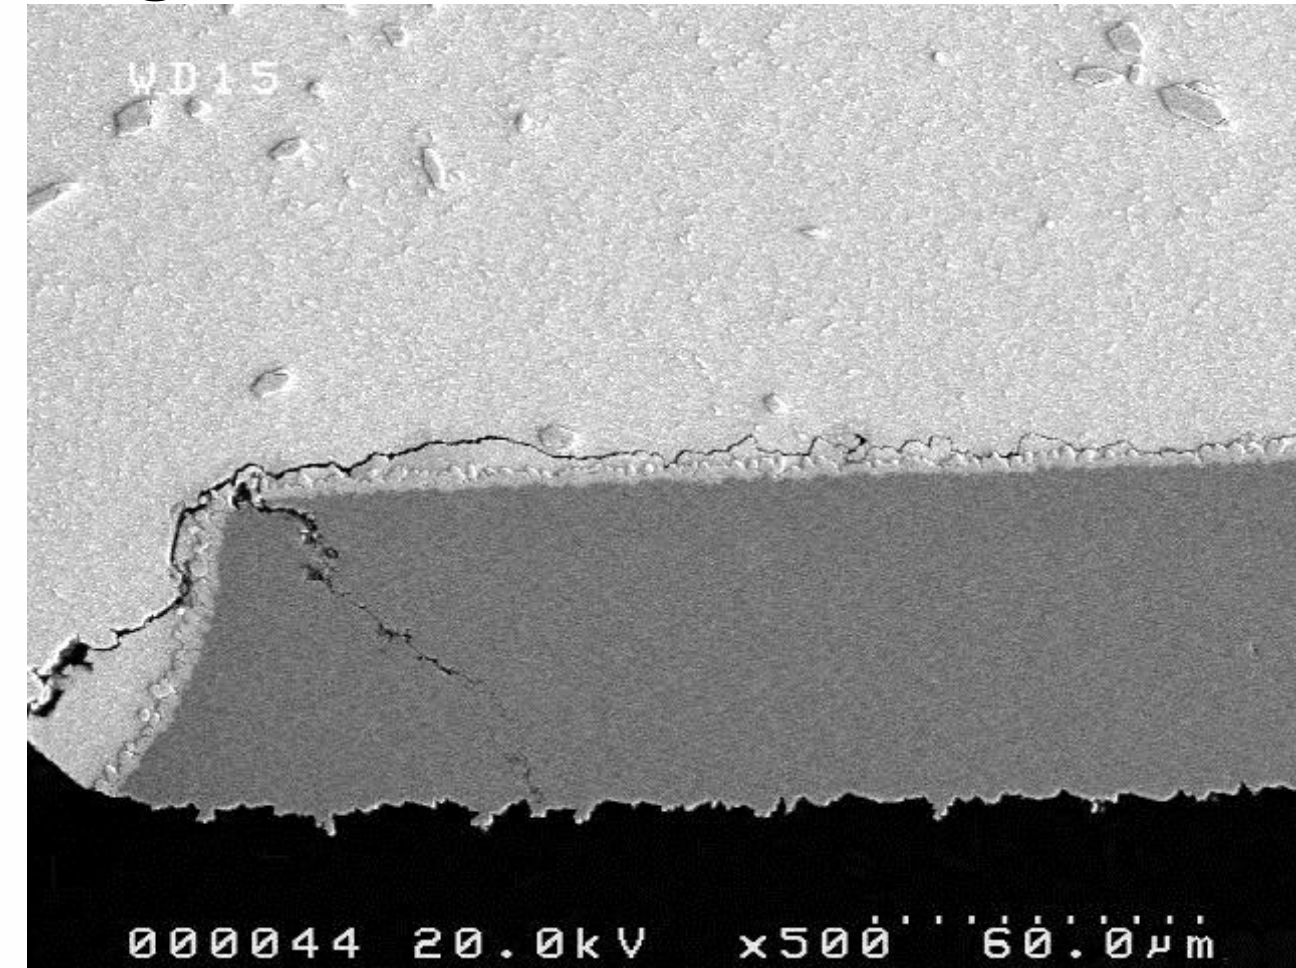
Fracture near board side IMC on BGA of SAC305 with an OSP finish, 155°C T_g board

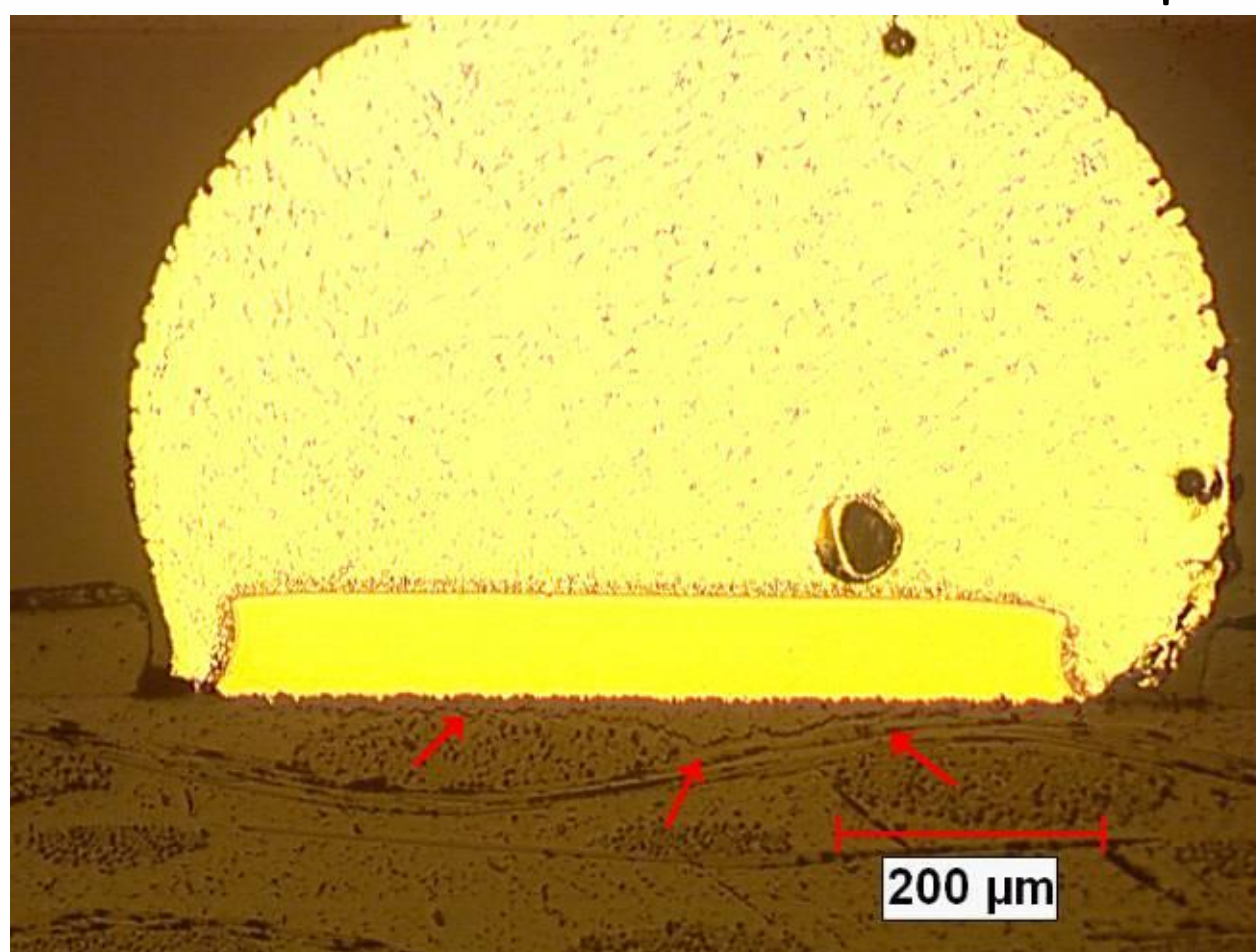
Pad crater beneath Orchid and SAC305 solder joint on ENEPIG finish, 155°C T_g board

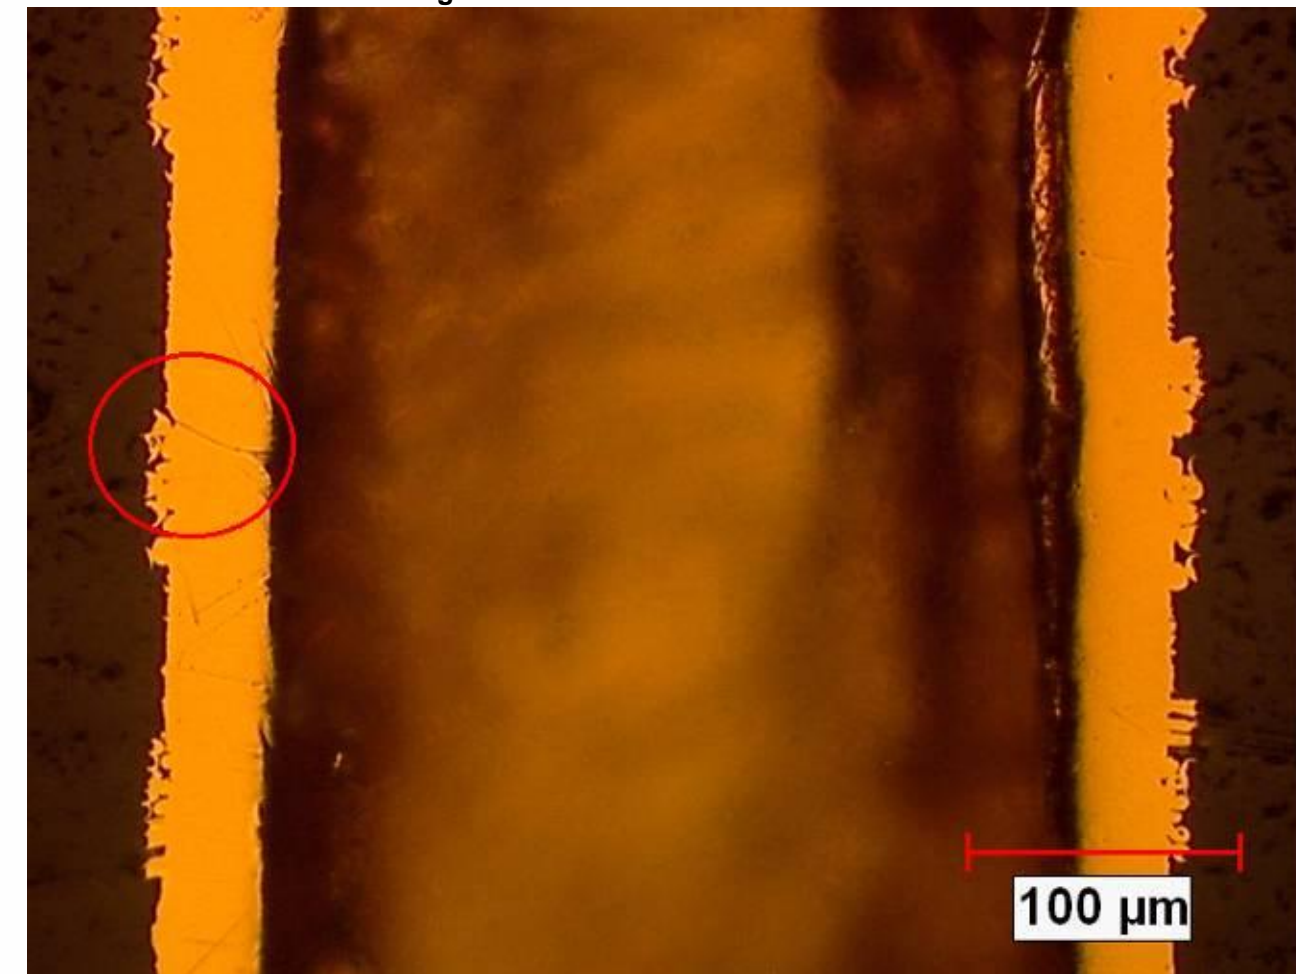
Barrel Crack in Via beneath SAC305 solder joint on OSP finish, 155°C T_g board

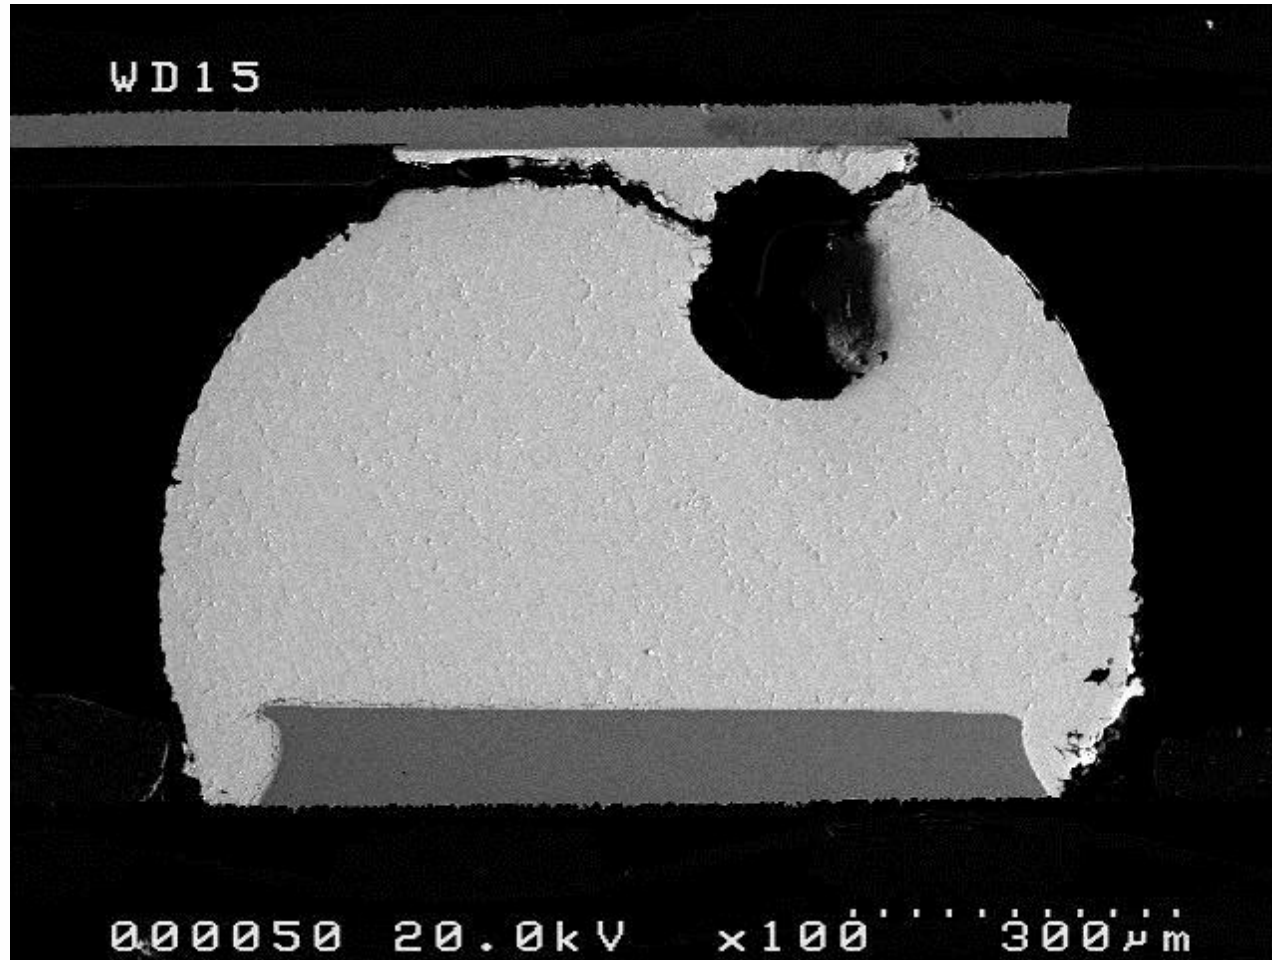
Complete fracture near component side IMC on BGA of SAC305 with an ENEPIG finish, 170°C T_g board

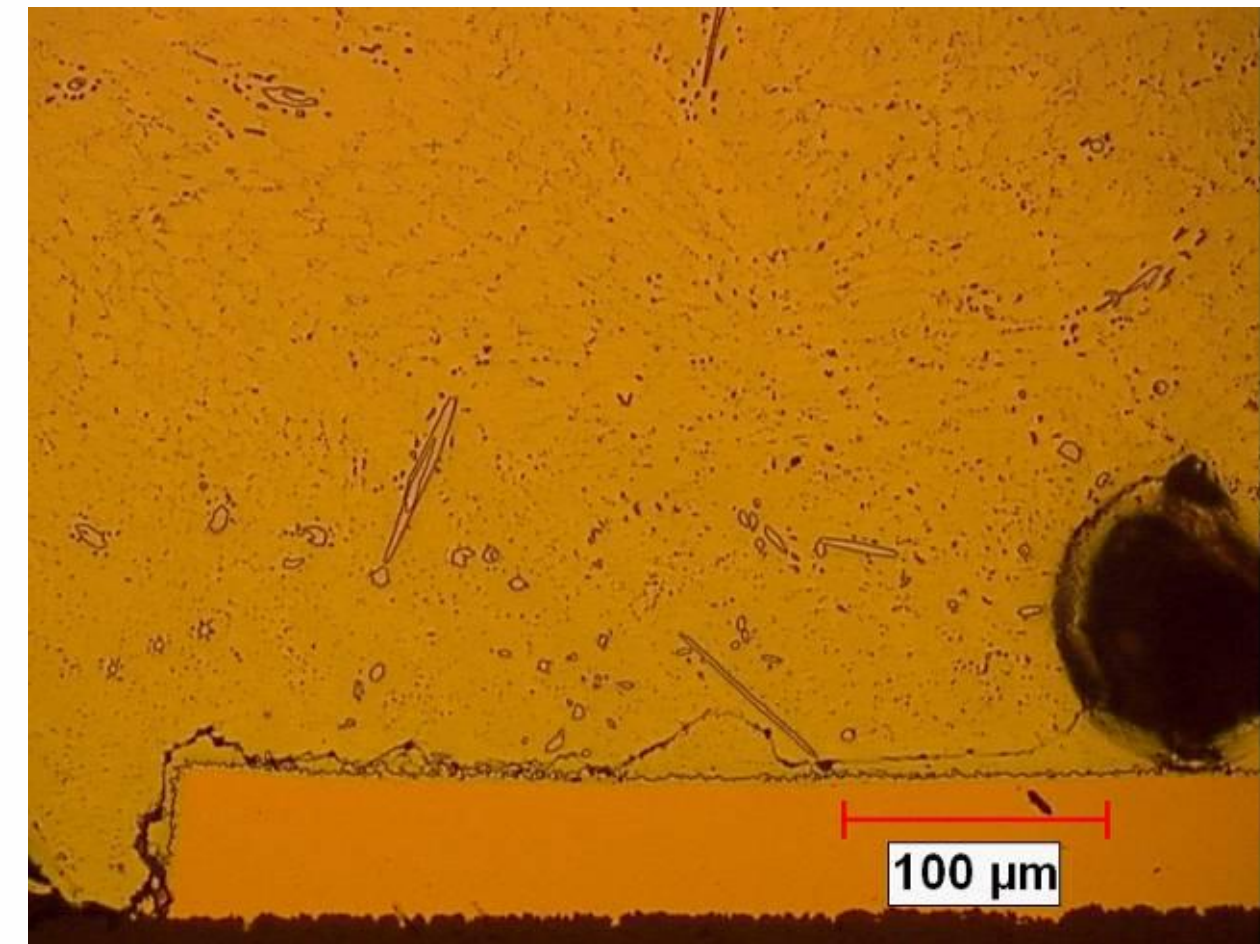
Fracture near board side IMC on BGA of SAC305 with an OSP finish, 170°C T_g board

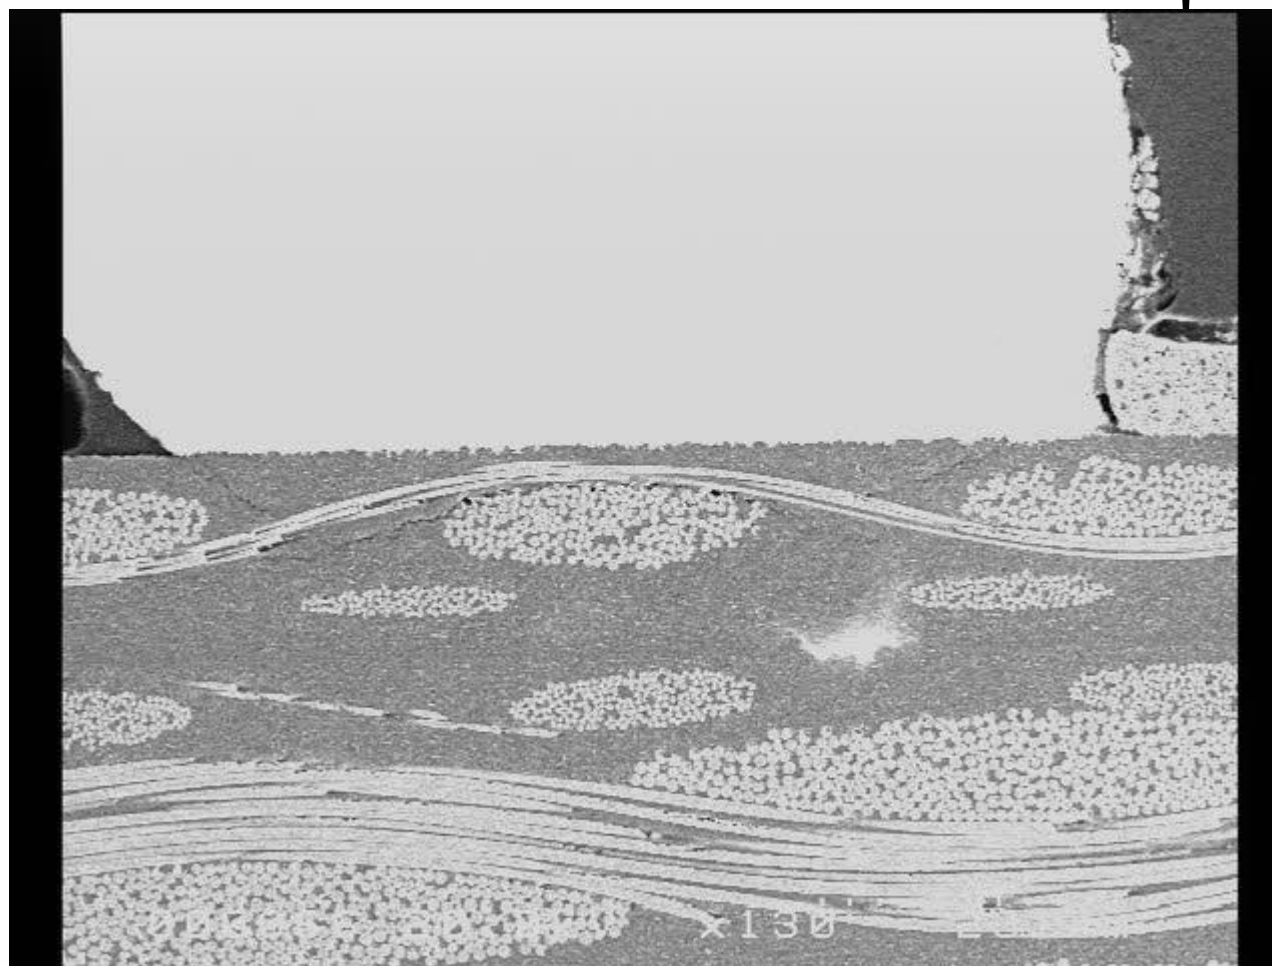
Pad crater beneath Violet and SAC305 solder joint on ENEPIG finish, 170°C T_g board

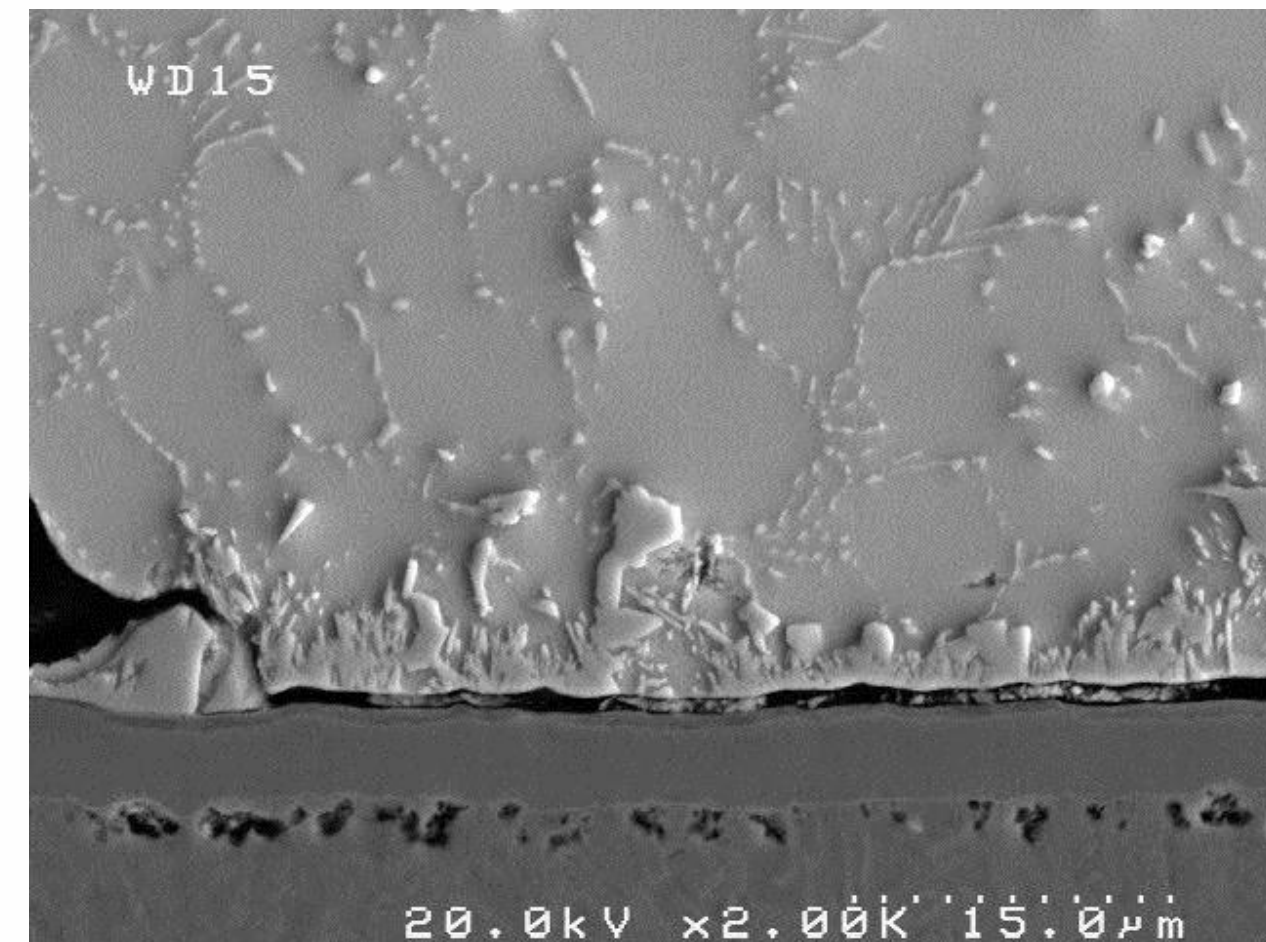
Fracture between IMC and copper pad of Paul and SAC305 solder joint on ENIG finish, 170°C T_g board

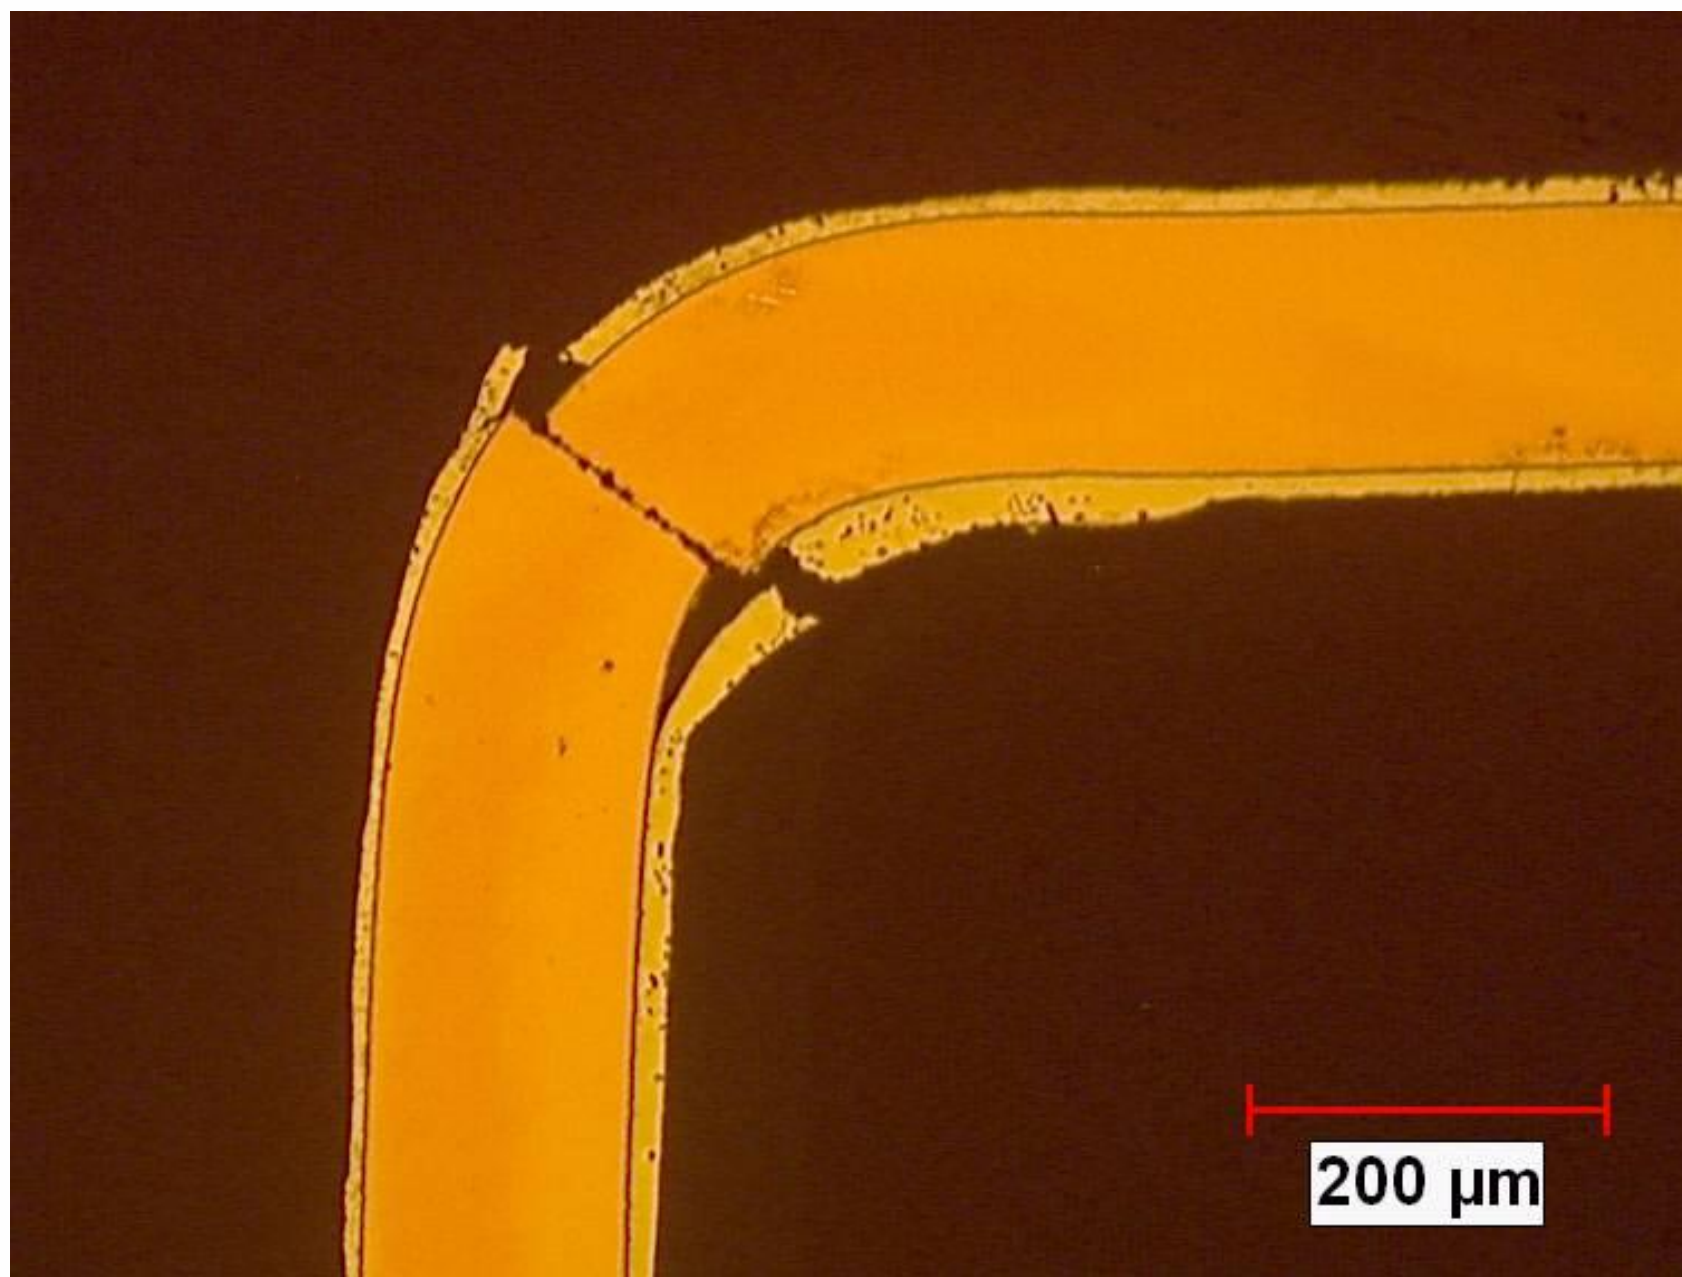
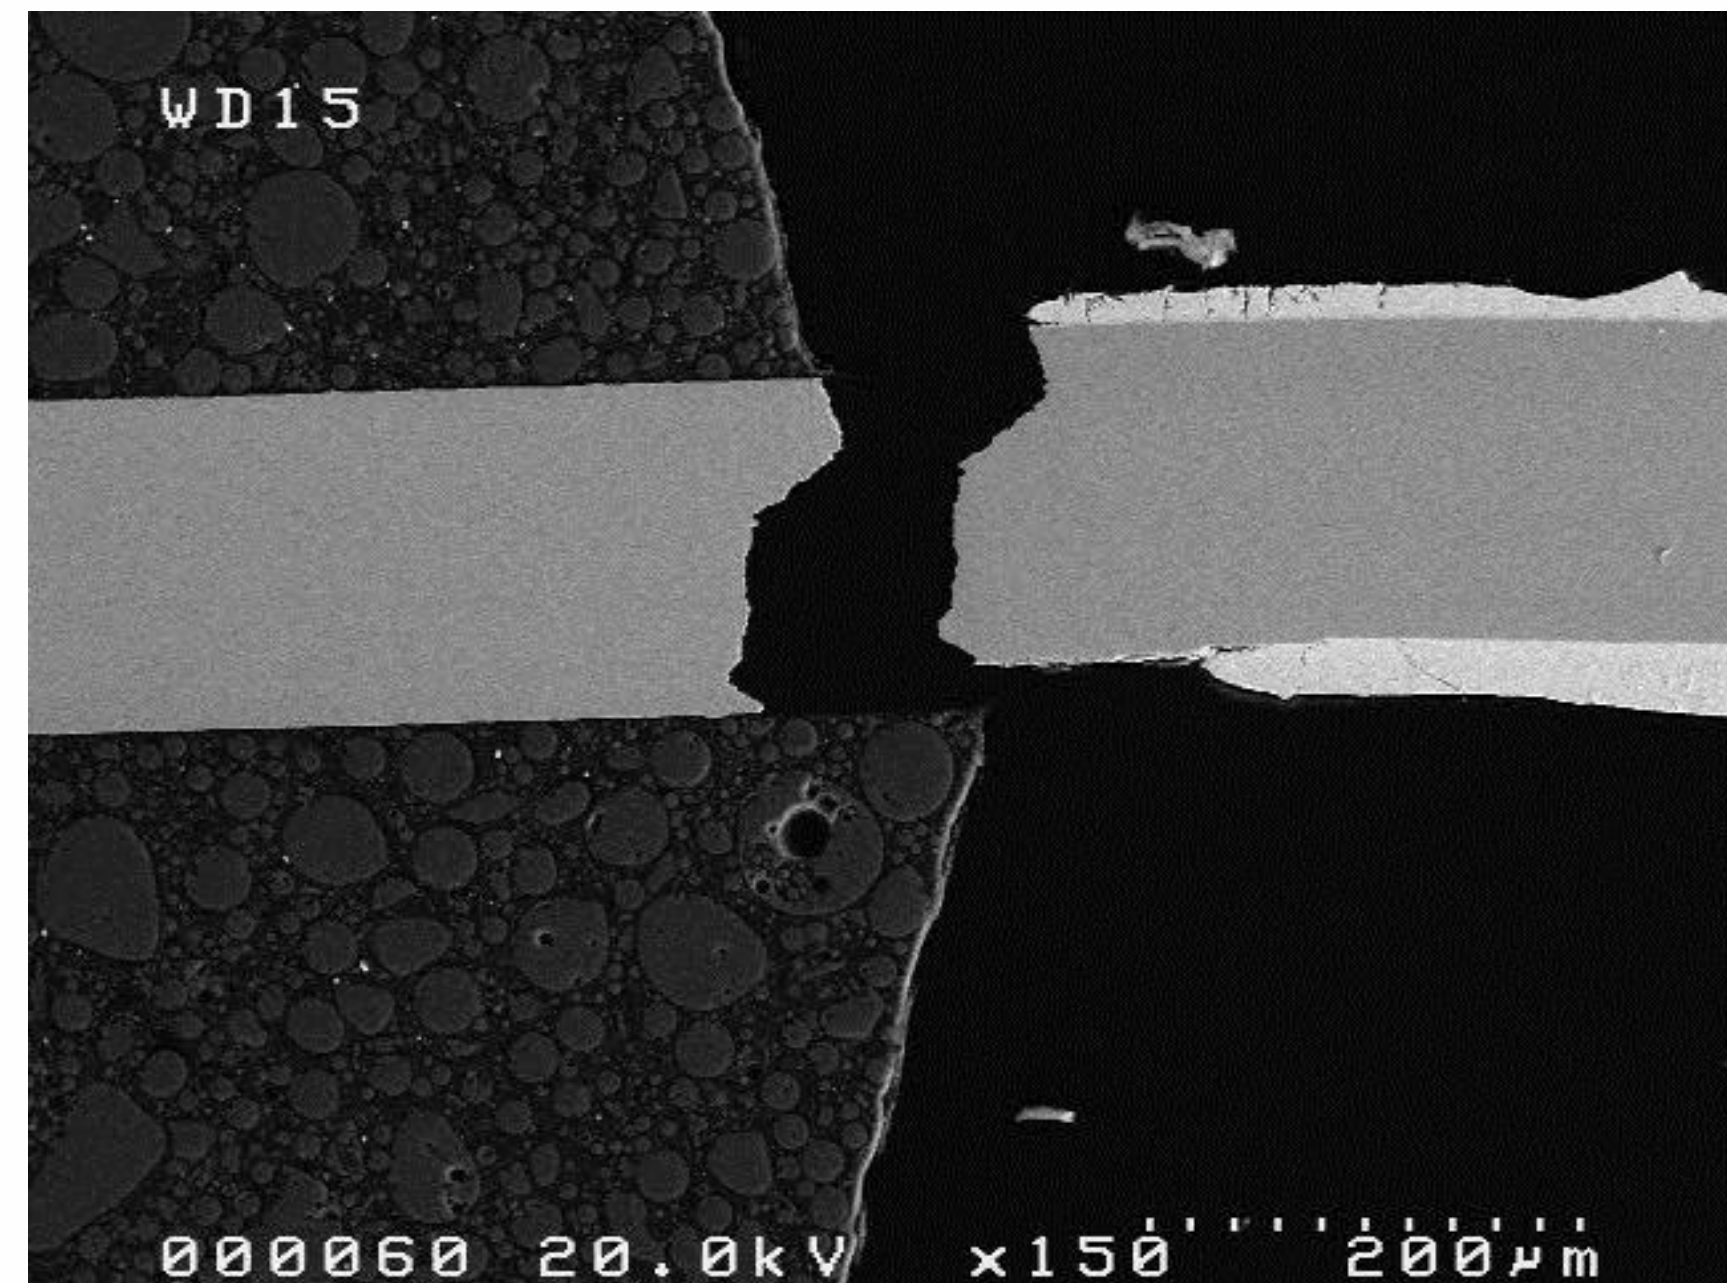
Vibration: Failure Analysis of QFPs

- QFPs failed at the leads
- The lead either broke at the knee or was ripped from the component
- No pad cratering occurred
