Reliability Screening of Lower Melting Point Pb-Free Alloys Containing Bi

Joseph M. Juarez, Jr., Michael Robinson, Joel Heebink
Honeywell
AZ, US
mike.robinson6@honeywell.com
joseph.juarez@honeywell.com

Polina Snugovsky, Eva Kosiba, Jeffrey Kennedy, Zohreh Bagheri, Subramaniam Suthakaran, Marianne Romansky
Celestica Inc.
Toronto, ON, Canada
polina@celestica.com

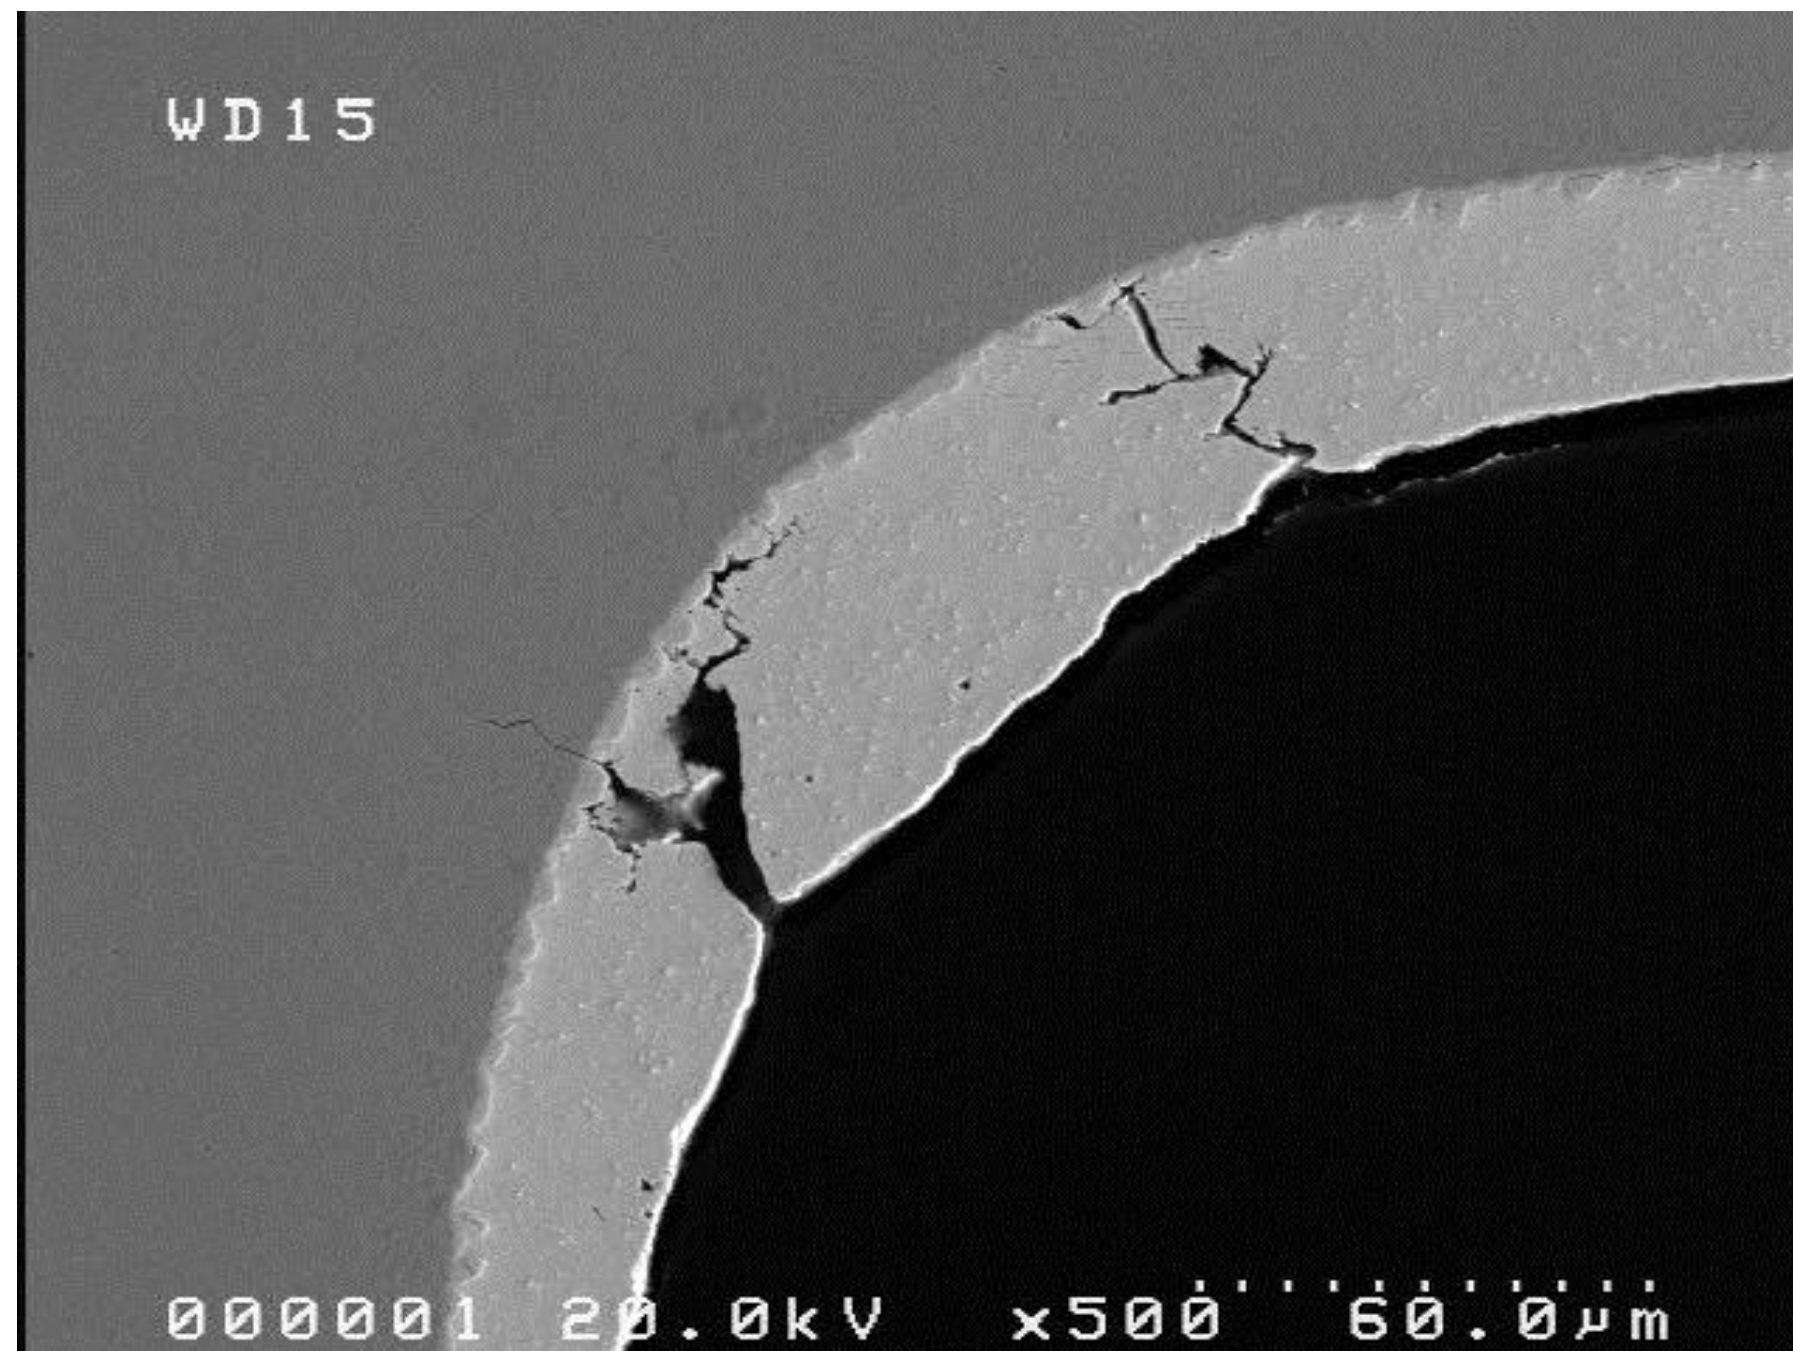
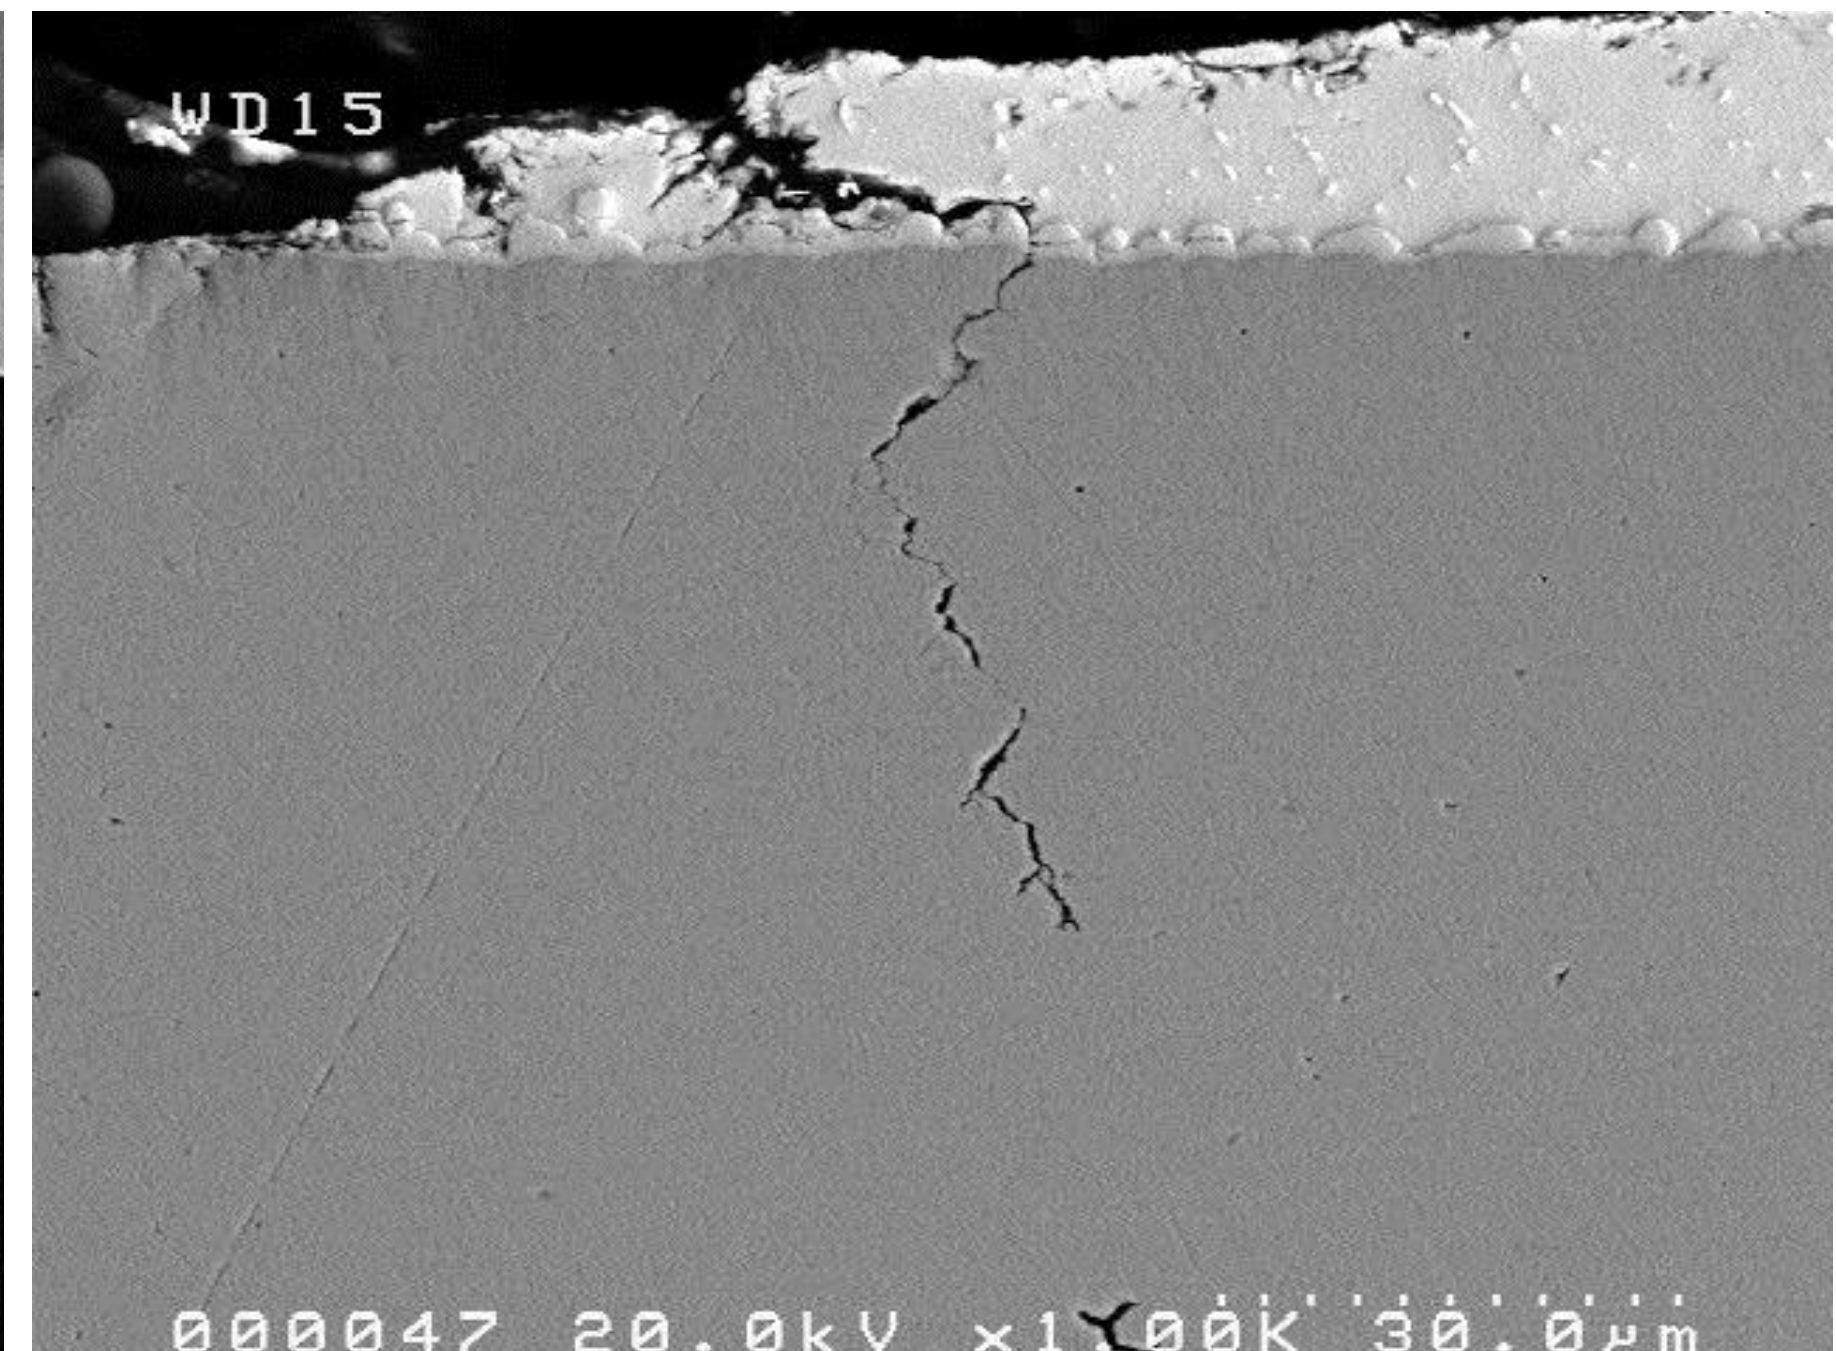
Vibration: Failure Analysis of QFPs

- Cracks were seen to form within the solder and propagate to the lead material
- Therefore, this QFP lead failures showed some alloy dependence in vibration testing
- Only Violet and SnPb solder joints survived completely after vibration testing
