## Troubleshooting the STM32F429 board and restoring its operation

Let's look at how the troubleshooting was carried out using such a system on the STM32F429 board.

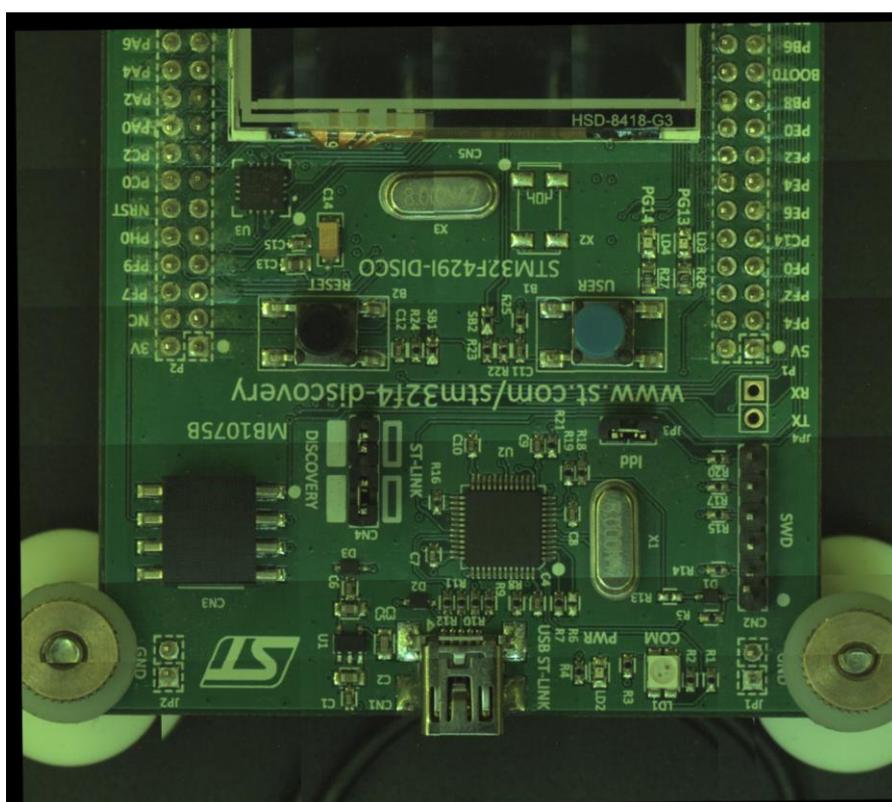
When connected to a PC, the board should be identified as ST-Link, but this didn't happen, the board was recognized as an Unknown device. Also, when connected, the U1 microcircuit was heated. Based on this, it was assumed that the problem lies in the part of the ST-Link
