Liquid Tin Corrosion and Lead Free Wave Soldering

Jim Morris

Speedline Technologies, Inc., Camdenton, MO

Abstract

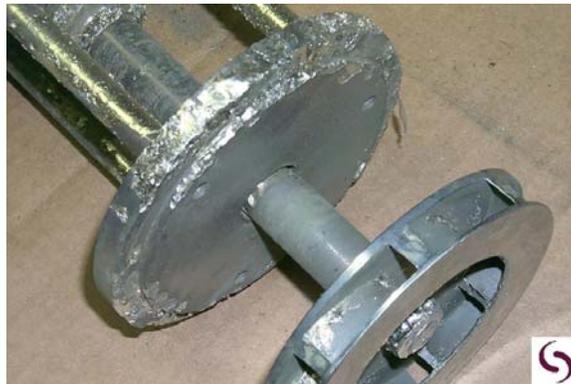
Figure 1 – Unprotected Stainless Steel

The initial conversion to lead free in mainstream electronic assemblies began in the late 1990's. Early adopters discovered that the Sn/Cu and Sn/Ag solders caused severe corrosion of the solder pot components. Stainless steels used for soldering equipment at that time would quickly degrade with high tin (Sn) lead free alloys. Figure 1 shows the result of unprotected stainless steel running in Sn/Ag solder for approximately six months.

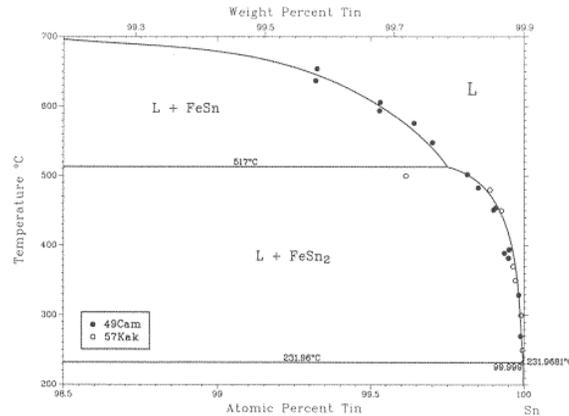
Figure 2 - Sn Rich Part of Fe-Sn Phase Diagram²

Gray Cast Iron – Gray cast iron has proven to be a material that resists tin corrosion and is a preferred material for solder pot construction. One way to estimate the dissolution of one material to another is through use of phase diagrams. The more soluble one material is to another (as indicated by the phase diagram), the more likely erosion or corrosion will occur. Figure 2 below shows the Sn/Fe phase diagram in the range of 99.5% to 100.0% Sn.

Per the phase diagram, Sn can only hold a maximum of 0.001% Fe in solution at 265°C (510°F). This very low amount of Fe that can be held by the molten tin is a good indicator that Fe would not be easily dissolved by molten Sn at soldering temperatures.

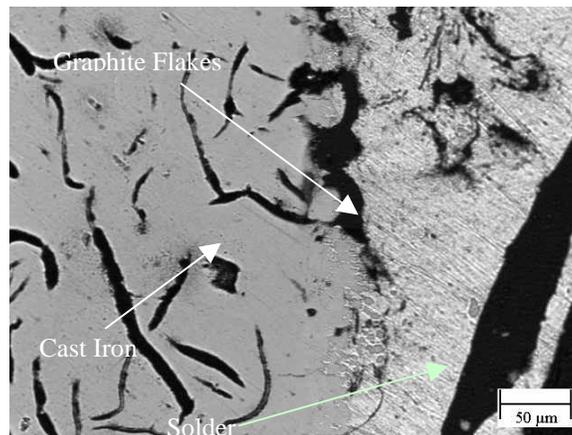
Figure 3 - Cast Iron Cross Section

Graphite (carbon) flakes, found in gray cast iron, are insoluble in molten Sn. These flakes act as a barrier and reduce the possibility of erosion. Figure 3 below shows a cross section of a gray cast iron solder pot after exposure to Sn/Ag solder.³

Seven years of field data for cast iron operating in Sn/Ag and SAC solder indicate no noticeable erosion of the cast iron solder pot or detrimental changes to the soldering process. Advantages of gray cast iron include good corrosion resistance, an economical material, and homogeneous (non-welded) construction. A disadvantage is that it is impractical for internal solder pot components due to the tooling costs involved.

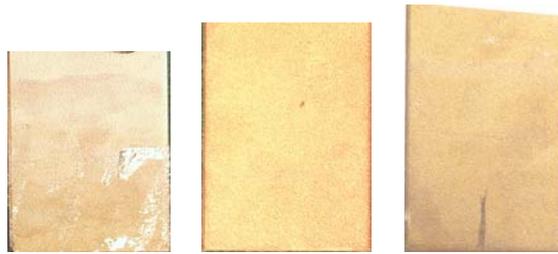
Figure 4 -Titanium SamplesAfter Sn/Ag Exposure

Figure 4 shows titanium coupons, exposed to Sn/Ag solder for 8 weeks at 250°C (482°F). No evidence of liquid metal corrosion of the titanium material is exhibited³. In comparison, type 304 stainless steel showed evidence of wetting after two weeks exposure under these same conditions.

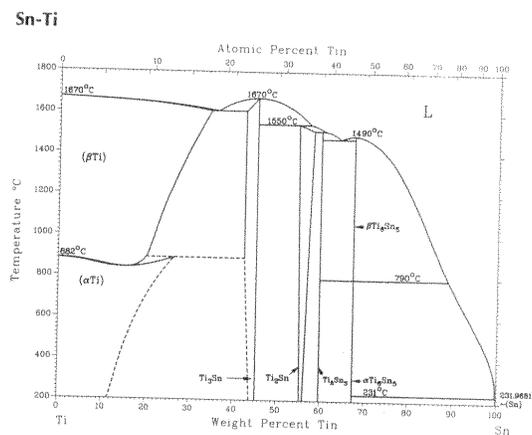
Figure 5 – Sn-Ti phase diagram⁴

Phase diagram analysis supports the field experience for titanium components. At the common soldering temperature of 265°C (510°F), less than 0.001% Ti can be held in solution with Sn. Figure 5 shows the Sn-Ti phase diagram.

As temperature increases, the amount of Ti that can be dissolved into Sn increases at faster rate than does cast iron. Utilization of titanium in solder pots for high temperature tinning applications 436°C (800°F) is not recommended. At these elevated temperatures, corrosion rates for titanium are given in the ASM Handbook of Corrosion Data⁵ as 1.0 mm per year versus 0.25mm per year for cast iron.

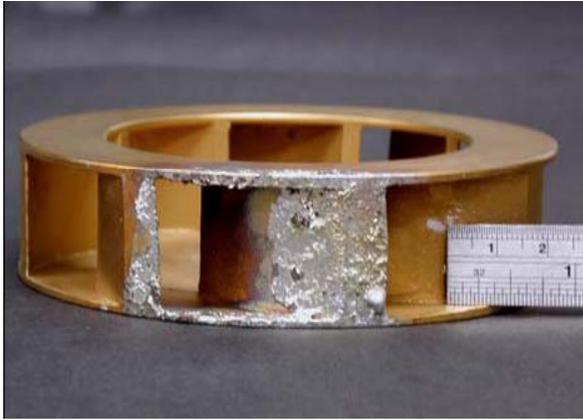
Figure 6 – TiN coated 316 stainless steel impellor

Evaluation of TiN coated samples in Pb-free solders has been conducted⁷. To determine suitability for use in lead free solder, a sample solder pump impeller was coated with titanium nitride and exposed to SAC solder for six weeks at 316°C (600°F). At the conclusion of the exposure the sample was subjected to a tape adhesion test. The solder easily peeled away from the coated sample, indicating no signs of wetting to the TiN coated sample. The sample was then sectioned, polished, and examined by metallography, X-ray diffraction, Auger analysis, electron microscopy, and chemical analysis⁷. Figure 6 below shows the test sample after exposure to SAC solder.

Conclusions from the TiN testing indicate that this coating withstands the corrosive effects of molten Sn extremely well. Advantages of TiN are its corrosion resistance, hardness, and low coefficient of friction. Disadvantages are cost and interior resistance and coating ability.

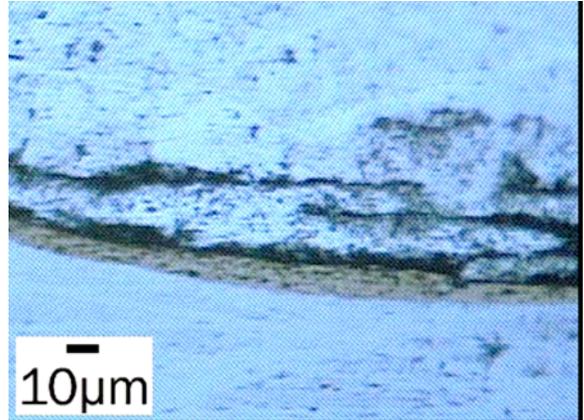
Figure 7 – Digital micrographs of areas of Titanium nitride coating on sample 1, (400X)

No TiN/Sn reaction products were observed in the digital micrographs (Figure. 7). The gold color is characteristic of TiN and X-ray diffraction indicated that the coating was TiN and not Ti_2N or other phase.

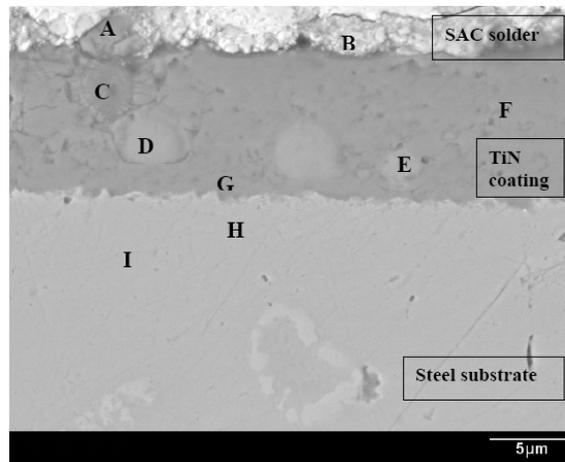
Figure 8 - Designations of areas analyzed with EDS. (3000X) EDS results in Table 1.

Chemical analysis was performed in a scanning electron microscope (SEM) using energy dispersive spectroscopy (EDS), with the results given in Figure 8 and Table 1.

Area	Label	Major elements (>10%)	Minor elements (<10%)
SAC Solder	A	Sn, Ti	
	B	Sn	
TiN coating	C	Ti	
	D	Ti	
	E	Ti, N	
	F	Ti, N	
Steel Substate	G	Ti, N, Al	
	H	Fe, Cr, Ni	Ti, Al
	I	Fe, Cr, Ni	Al

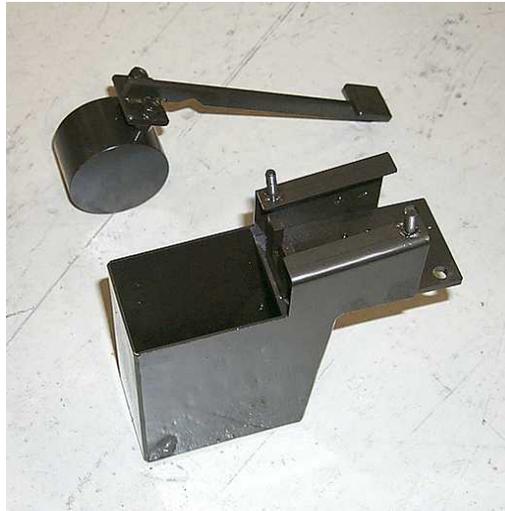
Figure 9 – Melonite Coated Components

The Melonite coating consists of two layers: a compound layer and a diffusion layer. The compound layer consists of ϵ -iron nitride (Fe_3N) that is a hard, chemically stable material and is primarily responsible for the improved corrosion resistance. The diffusion layer is γ -iron nitride (Fe_4N) and is responsible for improved material fatigue strength. Figure 9 shows typical components that are Melonite QPQ coated.

Field experience indicates that MeloniteQPQ coated components withstand Sn corrosion very well. Advantages of Melonite include good corrosion resistance, low cost, coverage of interior passages, and availability. The disadvantage is that Melonite is a coating and if damaged the underlying substrate will be exposed to the corrosive environment.

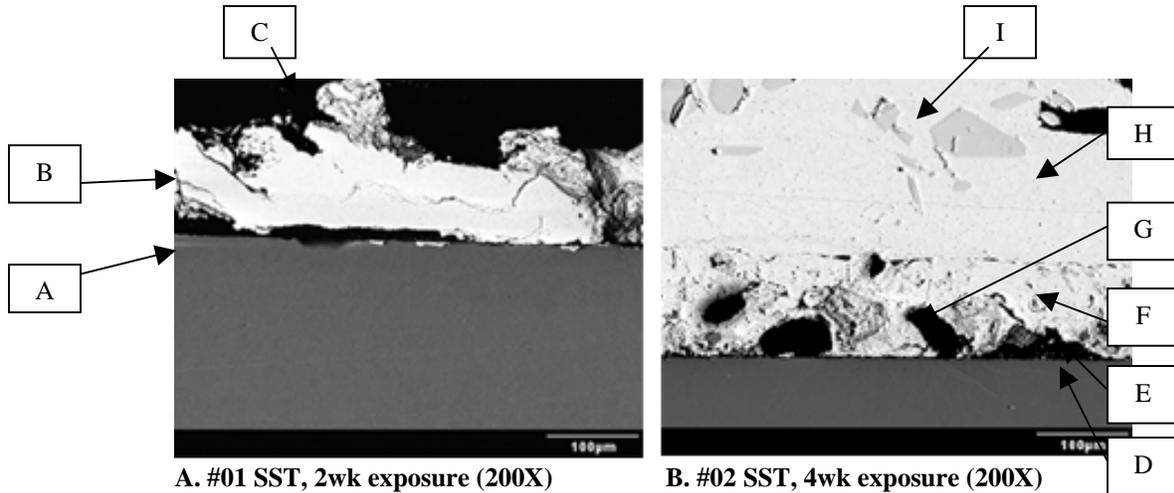
Figure 10 shows backscatter electron (BSE) images of the stainless steel strips. Table 2 lists elements detected by EDS at selected locations. Very limited wetting of the surface was observed on the samples, because BSE images did not show any form of a reaction product on the stainless steel (SST). The solder layer separated from the surfaces of the SST strips. EDS of the specimen showed Fe was the major constituent with Ni and Cr as minor elements.

Figure 10 - BSE images of SST-solder cross sections for #01 and #02 (20kV). A separation of SST and solder is seen on the left side of Fig. 10A.

Sample	Location	Flag in BSE Image	Elements Detected
#01	304 SST	A	Fe, Ni, Cr
	Solder (light gray)	B	Sn, Cu
	Solder (rough gray)	C	Sn, Cu
#02	304 SST	D	Fe, Ni, Cr
	Solder (rough gray close to SST)	E	Sn,Cu, Fe (trace)
	Solder (rough gray away from SST)	F	Sn
	Solder (black phase)	G	Si
	Solder (light gray)	H	Sn
	Solder (dark gray)	I	Sn, Fe, Cu

There was some Fe, Cu and possibly Ni detected in the solder layers. The presence of Fe in the SN100C solder suggests that a small amount of erosion of the SST surface was possible. In comparison, the same testing conducted on stainless steel samples exposed to Sn/Ag solder exhibited observable wetting and erosion after two week exposure. These results indicate a material that is many times less corrosive to stainless steel than the Sn/Ag and Sn/Cu alloys.
