# An Investigation into Lead-Free Low Silver Cored Solder Wire for Electronics Manufacturing Applications

Shantanu Joshi<sup>1</sup>, Jasbir Bath<sup>1</sup>, Kimiaki Mori<sup>2</sup>, Kazuhiro Yukikata<sup>2</sup>, Roberto Garcia<sup>1</sup>, Takeshi Shirai<sup>2</sup>  
<sup>1</sup>Koki Solder America Inc., USA, <sup>2</sup>Koki Company Ltd., Japan,

Development was done on a new lead-free low silver solder rework alloy (Sn-0.3Ag-0.7Cu-0.04Co) in comparison with a number of alternative lead-free alloys including Sn-0.3Ag-0.7Cu, Sn-0.7Cu and Sn-3.0Ag-0.5Cu and tin-lead Sn40Pb solder in soldering evaluations. Tests included solder alloy spread tests on copper, brass and nickel substrates. Soldering iron tip tests done with low silver cobalt containing alloy showed reduced erosion as compared to Sn-3.0Ag-0.5Cu solder alloy. The cobalt in the lead-free solder wire was found to create barrier layers between the iron in the soldering tip and the solder, reducing solder tip erosion by as much as 50%. In addition, Sn-3.0Ag-0.5Cu surface mount soldered component test boards were reworked at the soldered chip component locations with Sn-0.3Ag-0.7Cu-0.04Co and Sn3Ag0.5Cu wire to simulate r

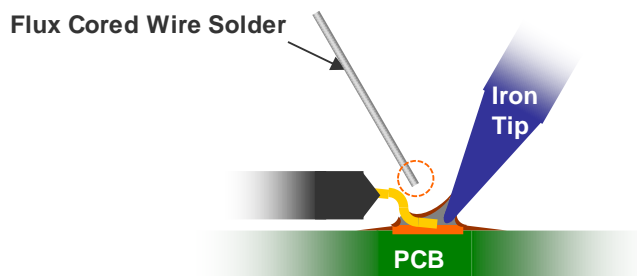
**Figure 1: A Typical Solder Wire Application**

For a quality solder joint with flux cored solder wire, the flux should remove all the oxidized layers on the component as well as printed circuit board pads. Also, care should be taken to apply the appropriate quantity of wire solder at an appropriate temperature at specific durations (Figure 1). These principals are common for both manual and automated soldering. Among these principals, maintaining appropriate temperature is difficult and is the main cause of the majority of the defects. When the tip temperature is low, solder fluidity starts to worsen and causes improper wetting of the pads. This may cause either bad solder fillet formation, insufficient through hole filling and/ or solder bridging.

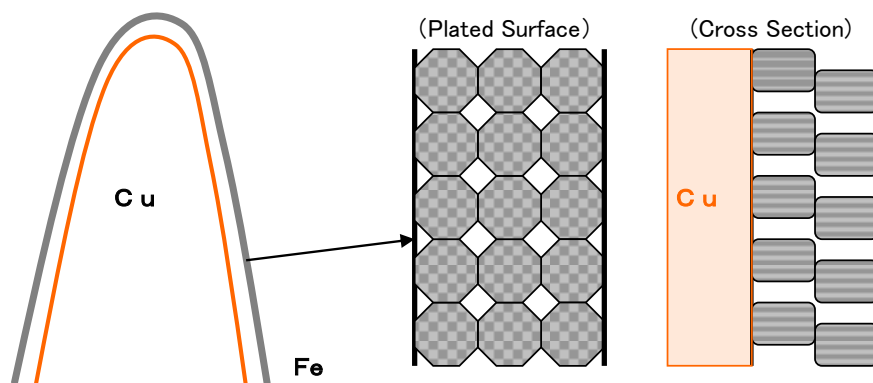
**Figure 2: Soldering tip cross section**

The conventional alloy composition of lead free rosin flux cored wires is typically by Sn3Ag0.5Cu (SAC305), which results in much higher tin content as compared to eutectic tin/lead solder alloy. Usually, the soldering tips are made up of copper and plated with iron to about 250 ~ 300  $\mu\text{m}$  thickness. The micro-structure of the plated iron shows, crystal grains aligned in a direction perpendicular to the Cu material, and since they are porous crystals, there is a gap between the crystals as shown in Figure 2.

During soldering, iron-tin (Fe-Sn) intermetallic compounds are formed on the plated surface. Although this intermetallic compound has a melting temperature as high as  $\sim 500^{\circ}\text{C}$ , it does not melt and spread completely on the Fe plated surface due to high surface tension. As a result of which there is a partial barrier to protect the copper core of the tip. As soon as the soldering begins in full flow, tin in solder can penetrate through this gap dissolving the copper tip core in the process. The dissolved copper then flows outside of the core making the core thinner and disrupting the iron plating. This is a typical phenomenon by which the tip gets eroded causing to the replacement of the soldering iron tip which increases cost.

A method of preventing such a phenomenon can be to simply increase the plating thickness of the iron to about 500  $\mu\text{m}$ , but it is not a complete solution due to the crystal lattice structure and physical properties of the material. Furthermore, it has been found that the plated iron surface gets substantially eroded due to the higher tin content in many lead-free alloys. This leads to further risk of exposing the copper core. Development work focused on evaluation of different lead-free solder alloys to reduce solder iron tip erosion.

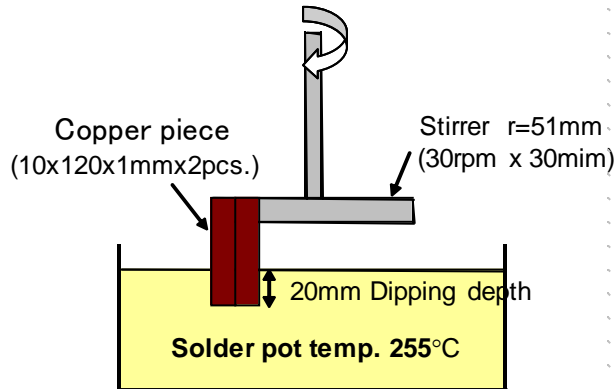
**Figure 3:** Copper Plate Erosion Test Schematic

The amount of eroded copper during soldering with different alloys (Sn3Ag0.5Cu, Sn0.7Cu, Sn0.3Ag0.7Cu, Sn0.3Ag0.7Cu0.04Co) was tested by attaching two copper piece test samples to a stirrer and applying a relatively aggressive no-clean soldering flux in a molten solder pot. After drying of the applied flux, the tips of the copper test pieces were dipped into the molten solder bath to a depth of 20mm. The test pieces were stirred for 30 minutes and the amount of Cu eroded into the solder was measured. The test equipment used is shown in Figure 3. The test piece was copper plate of 10×120 mm dimensions and 1mm thickness. The solder pot temperature was 255°C with an agitation speed of 30 rpm.

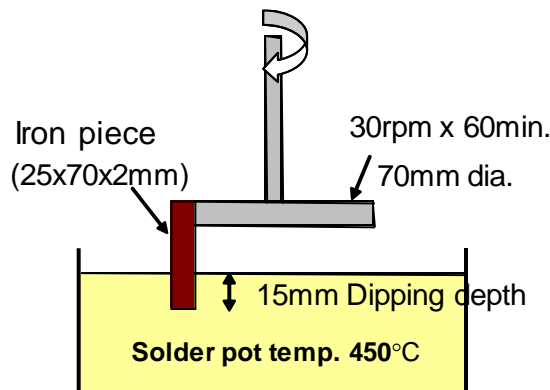
**Figure 4:** Iron Plate Erosion Test Schematic

The amount of eroded iron during solder with different alloys (Sn3Ag0.5Cu, Sn0.7Cu, Sn40Pb, Sn0.3Ag0.7Cu0.04Co) was tested by attaching an iron plate piece test samples to a stirrer and applying a relatively aggressive no-clean soldering flux in a molten solder pot. After drying of the applied flux, the tip of the iron test piece was dipped into the molten solder bath to a depth of 15mm. The test pieces were stirred for 60 minutes and the amount of Fe eroded into the solder was measured. The test equipment used is shown in Figure 4. The test piece was iron plate of 25×70mm dimensions and 2mm thickness. The solder pot temperature was 450°C with an agitation speed of 30 rpm.

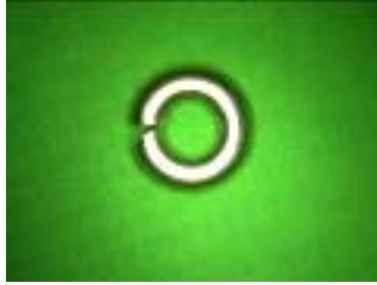
**Figure 5:** Solder ring for spreading test

Two lead-free alloys were tested in the solder spreading test, Sn3Ag0.5Cu and Sn0.3Ag0.7Cu0.04Co. To test the spreading of the solder on different surfaces, three different metal plates were used for the study. Copper, nickel and brass plates were used after cleaning / degreasing with organic solvent. One of the sides of the plate was polished with abrasive paper, then cleaned with alcohol and dried. Each resin flux cored solder wire of 0.8 mm  $\phi$  was placed in a wound circular position condition (Ring inner diameter: 1.6 mm  $\phi$ ) at the center of the respective plate as shown in Figure 5. The same ROL0 no-clean flux in the rework wire was used for both lead-free alloys tested. The test vehicle was heated by keeping it floating in a solder bath kept at 300°C for 5 sec. The test vehicle was removed from the solder bath and allowed to cool down to room temperature. Flux residue was removed with a suitable solvent.

The height of the spread solder was measured by a micrometer. Using the measured value, the spreading ratio was calculated from Equation (1). This procedure was carried out on 5 test pieces for each solder alloy/ substrate combination and the mean value obtained as the spreading ratio of the specimen.

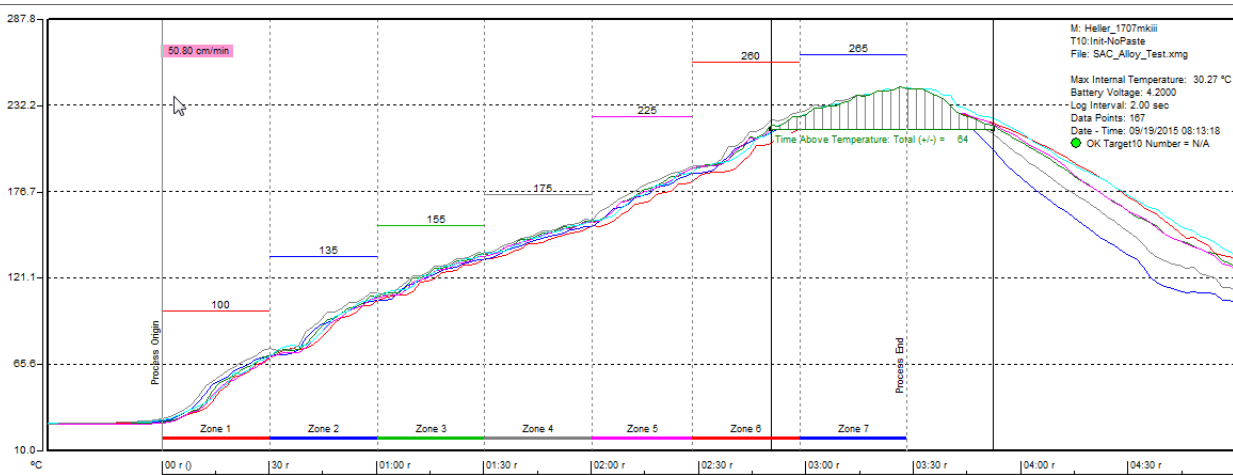
**Figure 6:** Reflow profile used to build lead-free boards.

Test vehicles were 1<sup>st</sup> pass reflow soldered in a forced convection oven under air atmosphere using Sn3Ag0.5Cu paste. The reflow profile was pre-heat for 50sec from 150°C to 200°C with a peak temperature of 244°C with Time over 217°C of 68 sec. as shown in Figure 6.

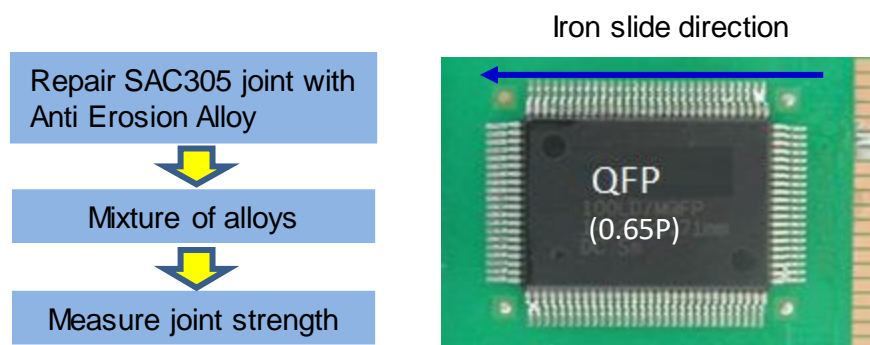
**Figure 7:** Test method

Soldered QFP component boards were then pull tested at the QFP leads at time zero and after up to 2,000 ATC cycles from -30C to +80C as indicated in Figure 7 and 8. 15 QFP leads were pull tested for each combination with the pull test results averaged for each combination.

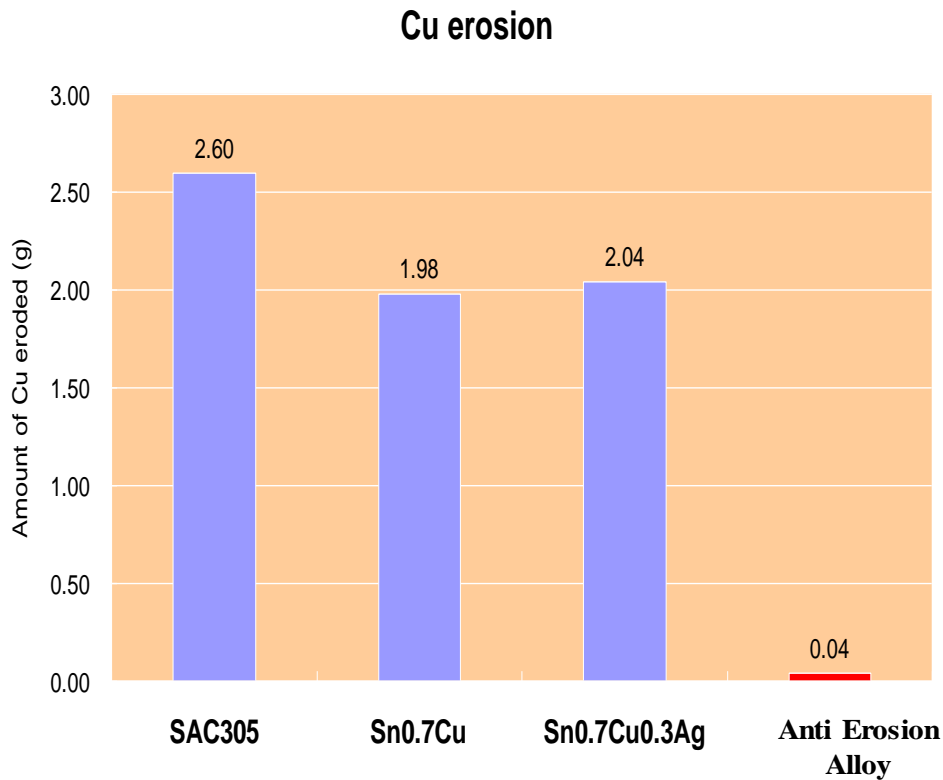
The copper plate erosion test results are shown in Figure 9. Based on the results, the anti-erosion alloy (Sn0.3Ag0.7Cu0.04Co) has less erosion than Sn0.7Cu which has less than Sn0.3Ag0.7Cu which is less than Sn3Ag0.5Cu. This shows the benefit of the cobalt addition to the lead-free solder to reduce copper erosion.

**Figure 9:** Erosion Results of Copper Plate on different alloys (Anti-erosion alloy is Sn0.3Ag0.7Cu0.04Co)

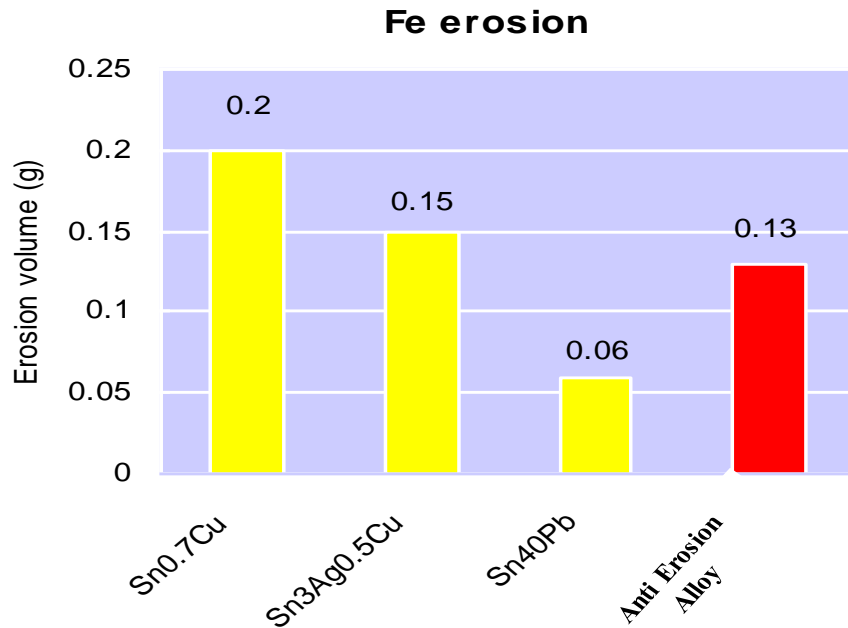
The iron plate erosion test results are shown in Figure 10. Based on the results, the 60Sn40Pb tin-lead solder has less erosion than the anti-erosion lead-free alloy (Sn0.3Ag0.7Cu0.04Co) which has less erosion than Sn3Ag0.5Cu which has less than 99.3Sn0.7Cu. This shows the benefit of the cobalt addition to the lead-free solder to reduce iron erosion and indicates the iron erosion is more dependent on the tin content of the solder alloy with higher tin content giving higher iron erosion.

**Figure 10:** Erosion Results of Iron Plate on different alloys

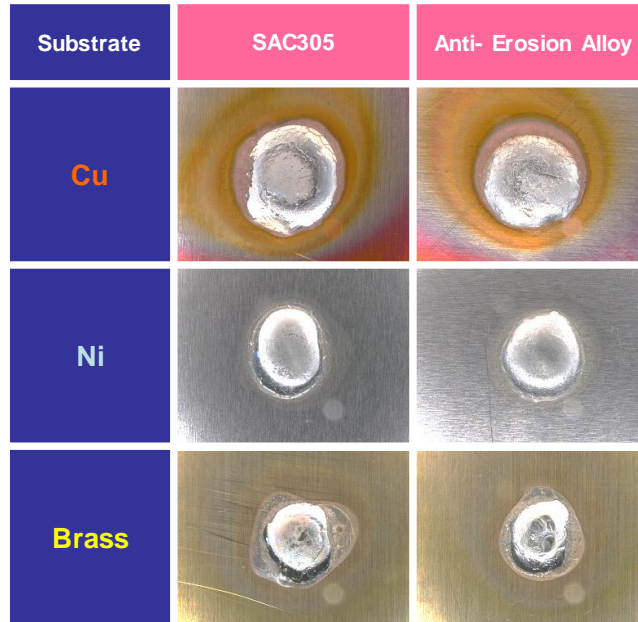
Both the Sn3Ag0.5Cu and Sn0.3Ag0.7Cu0.04Co alloys showed good wetting performance on different difficult to solder substrate including nickel as shown in Figure 11.

**Figure 11:** Wetting results of SAC305 and Sn0.3Ag0.7Cu0.04Co on different substrates (Copper, Nickel and Brass).

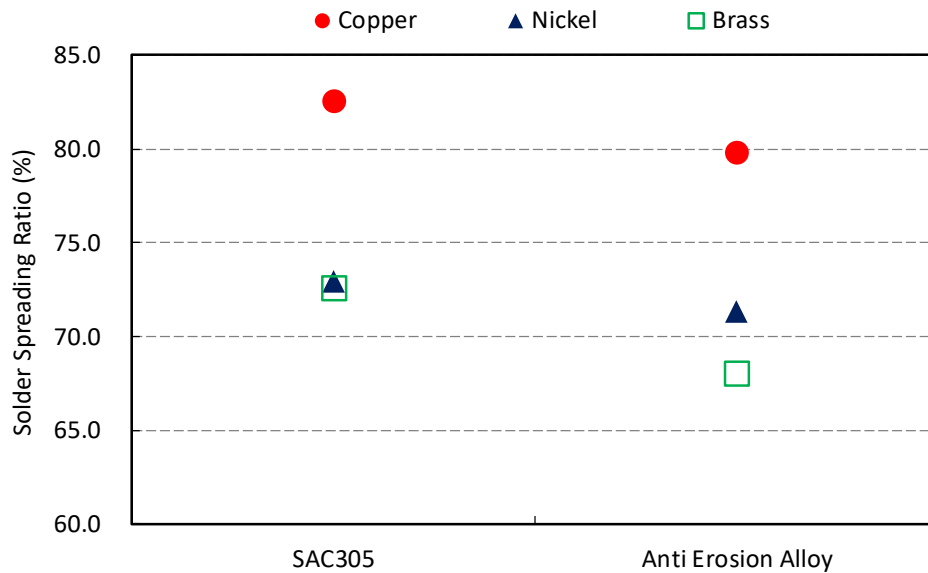
The spreading ratio of Sn0.3Ag0.7Cu0.04Co anti-erosion solder wire on different substrates was found to be similar to Sn3Ag0.5Cu as shown in Figure 12.

**Figure 12:** Solder Spreading Ratio on different substrates with the two lead-free solder alloys

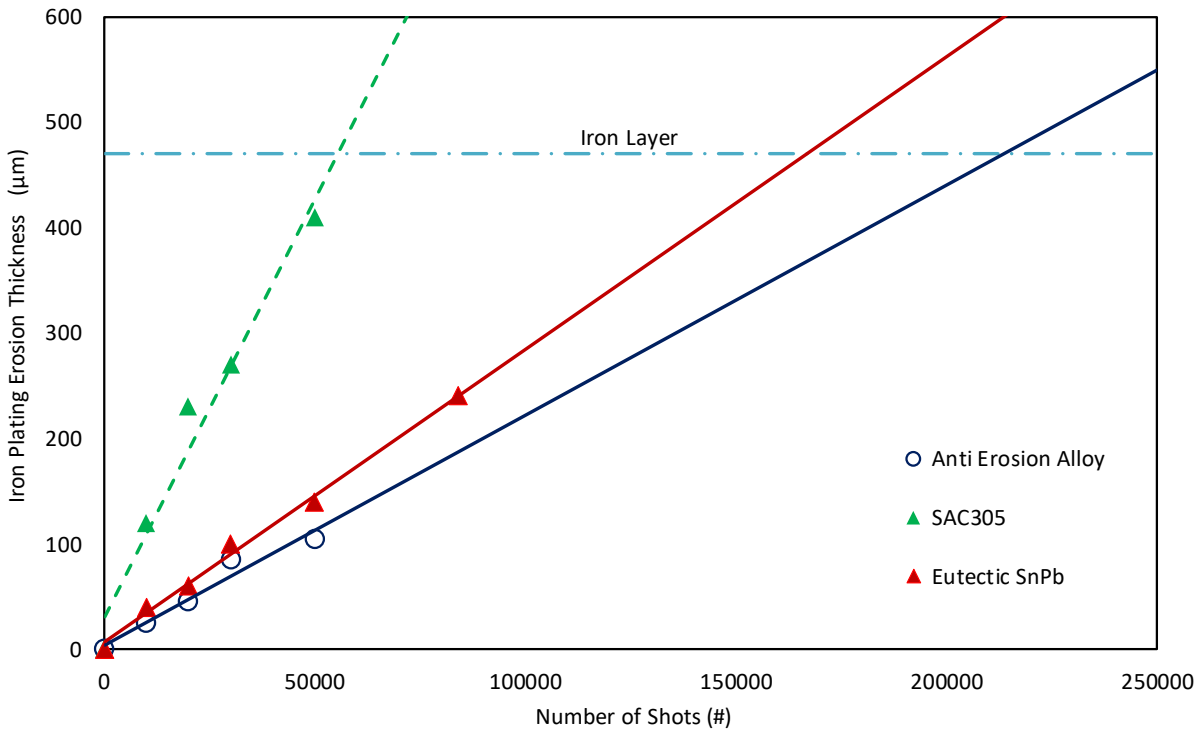
The results of the soldering iron tip erosion test are shown in Figure 13 which indicates the Sn0.3Ag0.7Cu0.04Co solder alloy has much lower solder iron tip erosion than lead-free Sn3Ag0.5Cu alloy and is similar to Sn40Pb tin-lead solder.

**Figure 13:** Iron Plating Erosion Thickness for different alloys.

The results of the soldering iron tip erosion test showed the Sn0.3Ag0.7Cu0.04Co solder alloy had much lower solder iron tip erosion than lead-free Sn3Ag0.5Cu alloy and was similar or less than Sn40Pb tin-lead solder.

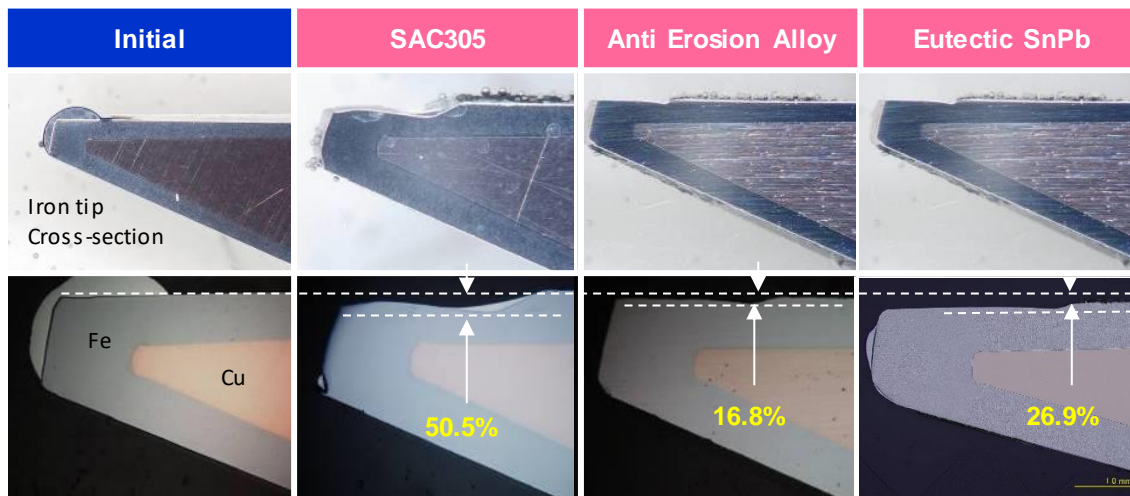
After 10,000 shots (uses), the soldering iron tips used with the three solder alloys were cross-sectioned as shown in Figure 14. Based on the results in Figure 14, solder iron tip erosion is large with Sn3Ag0.5Cu alloy but is reduced with the Sn0.3Ag0.7Cu0.04Co alloy which is similar or better than Sn40Pb tin-lead solder.

**Figure 14:** Cross Section of Iron Tips for different alloys (Sn3Ag0.5Cu, Sn0.3Ag0.7Cu0.04Co, Sn40Pb) after 10,000 shots (uses).

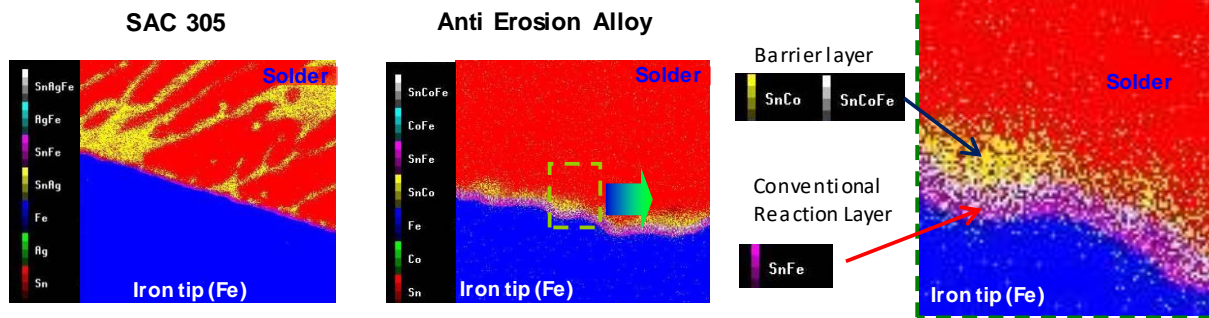
Figure 15 shows elemental analysis of the soldering iron tips with a schematic view of the reaction between the solder iron tip and the melted solder shown in Figure 16. Based on these results, there is a barrier layer being formed of Sn-Co-Fe/ Sn-Co with the Sn0.3Ag0.7Cu0.04Co lead-free alloy which is helping to reduce the solder iron erosion.

**Figure 15:** EPMA (Electron probe micro-analysis) of boundaries between solder and iron tip. (Sn3Ag0.5Cu compared with Sn0.3Ag0.7Cu0.04Co alloy)

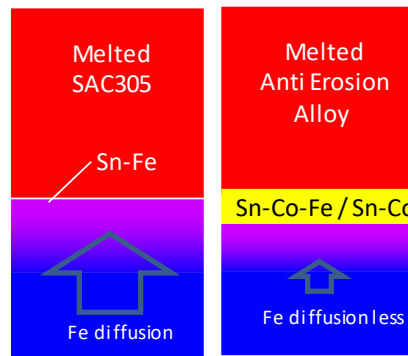
**Figure 16:** Schematic view of reaction between iron tip and melted solder (Sn3Ag0.5Cu compared with Sn0.3Ag0.7Cu0.04Co alloy)

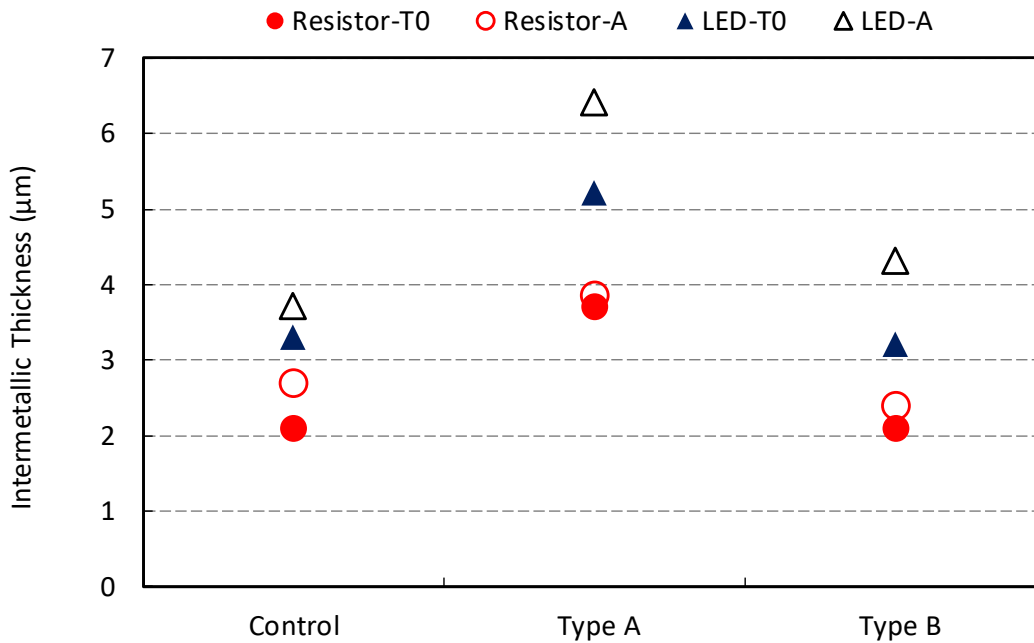
Figure 17 shows the intermetallic thickness measurements for soldered chip resistor and LED components for the 3 combinations tested (Control- SnAgCu 1<sup>st</sup> pass, A- SnAgCu 1<sup>st</sup> pass + SnAgCu rework, B- SnAgCu 1<sup>st</sup> pass + Sn0.3Ag0.7Cu0.04Co rework) at time zero and after thermal cycling. The amount of IMC formed at the board side with the resistor component is less than the LED component at Time zero and after thermal cycling. IMC grows after thermal cycling for all combinations with the less amount for the SnAgCu 1<sup>st</sup> pass Control and Combination B test cells (SnAgCu 1<sup>st</sup> pass and Sn0.3Ag0.7Cu0.04Co rework). As combination B is reworked with the Sn0.3Ag0.7Cu0.04Co rework alloy this is a good indication of reduced IMC growth with this alloy. Previous work with a similar alloy (Sn0.1Ag0.7Cu0.04Co) showed reduced IMC growth on copper at 250C compared with Sn3Ag0.5Cu, Sn0.3Ag0.7Cu and Sn0.7Cu0.05Ni lead-free alloys [1].

**Figure 17:** Board Side Intermetallic Thicknesses for different components (Resistor and LED) under different conditions (Control- SnAgCu 1<sup>st</sup> pass, A- SnAgCu 1<sup>st</sup> pass + SnAgCu rework, B- SnAgCu 1<sup>st</sup> pass + Sn0.3Ag0.7Cu0.04Co rework) before and after thermal cycling

The intermetallic thickness growth for a 1<sup>st</sup> pass SnAgCu soldered chip component reworked with Sn0.3Ag0.7Cu0.04Co rework wire was lower than the chip components reworked with Sn3Ag0.5Cu rework wire at time zero and after thermal cycling and similar to 1<sup>st</sup> pass soldered SnAgCu soldered chip components.

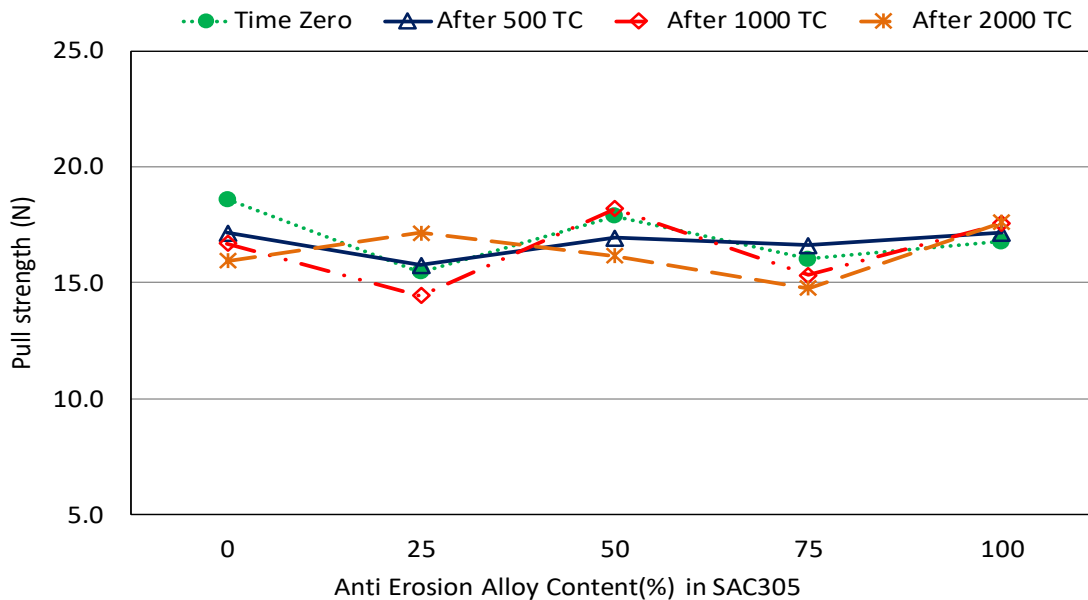
Figure 18 shows the QFP lead pull test results for the soldered QFP components at time zero and after up to 2,000 ATC cycles from -30C to +80C. Comparing Test Cell 1 (Sn3Ag0.5Cu) with the other test cells (Cell 2: 25% Sn0.3Ag0.7Cu0.04Co- 75% Sn3Ag0.5Cu, Cell 3: 50% Sn0.3Ag0.7Cu0.04Co - 50% Sn3Ag0.5Cu, Cell 4: 75% Sn0.3Ag0.7Cu0.04Co - 25% Sn3Ag0.5Cu, Cell 5: Sn0.3Ag0.7Cu0.04Co) at time zero and up to 2,000 ATC cycles there is little difference between the pull test force results. This indicates mixed Sn3Ag0.5Cu/ Sn0.3Ag0.7Cu0.04Co solder joints have good reliability.

**Figure 18:** QFP Pull Strengths Results for different solder joint alloy combinations (Cell 1 (Sn3Ag0.5Cu) , Cell 2: 25% Sn0.3Ag0.7Cu0.04Co- 75% Sn3Ag0.5Cu , Cell 3: 50% Sn0.3Ag0.7Cu0.04Co - 50% Sn3Ag0.5Cu, Cell 4: 75% Sn0.3Ag0.7Cu0.04Co - 25% Sn3Ag0.5Cu, Cell 5: Sn0.3Ag0.7Cu0.04Co)

Based on pull testing results of SnAgCu 1<sup>st</sup> pass soldered components and SnAgCu 1<sup>st</sup> pass soldered components reworked with Sn0.3Ag0.7Cu0.04Co rework wire at time zero and up to 2,000 ATC cycles there are similar pull test force results which indicate good reliability.

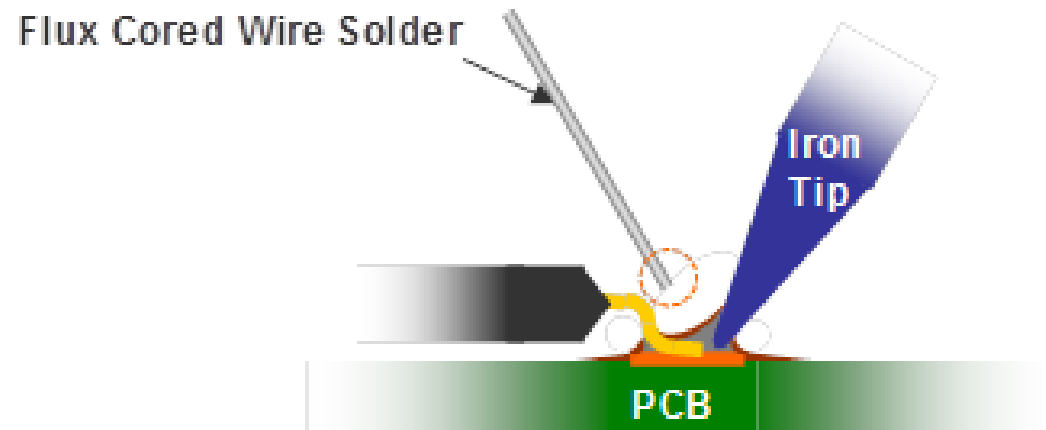
- Slide soldering is an automated process which enables a large number of connector pins to be soldered in a single stretch; therefore, it is widely used at many manufacturing factories.
- To achieve both speed and quality using slide soldering the pins or leads must wet quickly and the solder must envelop them very quickly.

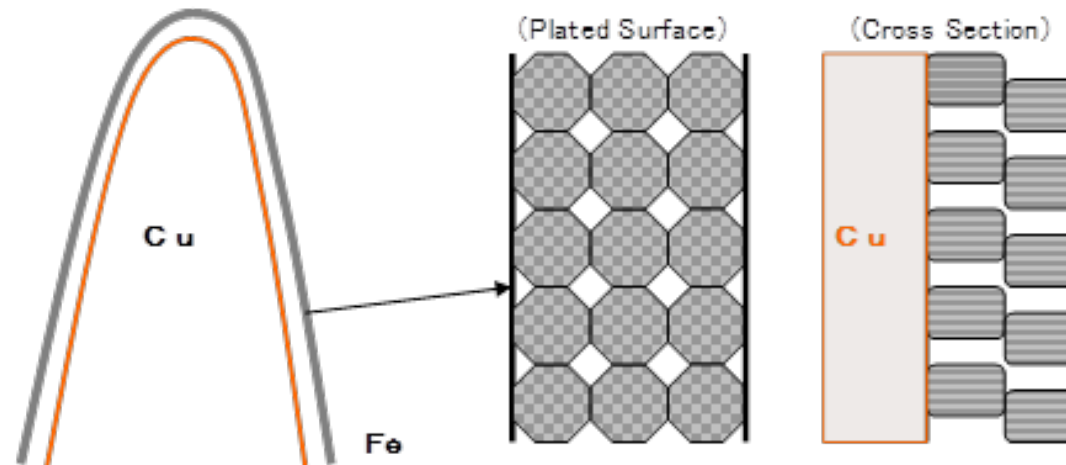
- Sn-3.0Ag-0.5Cu (SAC305) has substantially more Tin content than eutectic SnPb alloy.
- Soldering tips have copper core and are plated with iron to about 250 ~ 300  $\mu\text{m}$  thickness.
- Microstructure shows crystal grains aligned in a direction perpendicular to the Cu material, and since they are porous crystals, there is a gap between the crystals as shown.

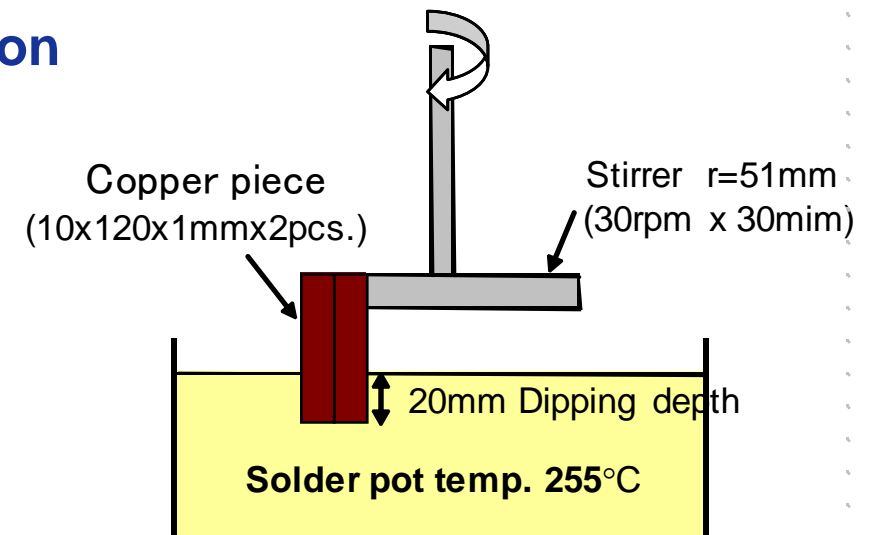
- Relatively aggressive no-clean soldering flux was applied in a molten solder pot.
- After drying of the applied flux, the tips of the copper test pieces were dipped into the molten solder bath to a depth of 20mm.
- The test pieces were stirred for 30 minutes and the amount of Cu eroded into the solder was measured.

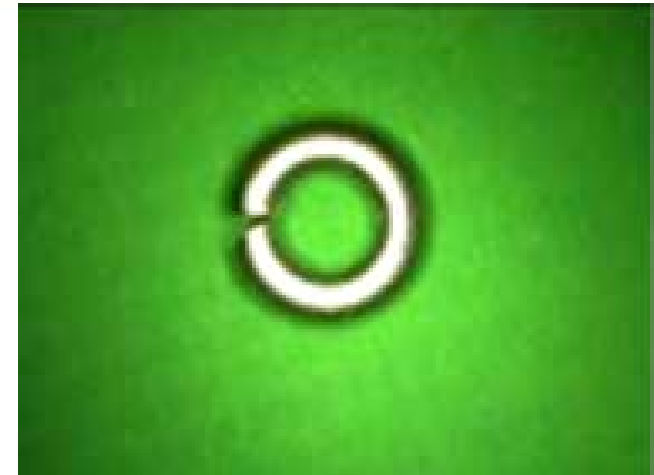
- Alloys Tested:
  - Sn-3.0Ag-0.5Cu and
  - Sn-0.3Ag-0.7Cu-0.04Co.
- Metal plates used for study: (Cleaned and degreased with Organic Solvent)
  - Copper
  - Nickel
  - Brass
- One side polished with abrasive paper, then cleaned with alcohol and dried.
- Each resin flux cored solder wire of 0.8 mm  $\phi$  was placed in a round circular position condition (Ring inner diameter: 1.6 mm  $\phi$ ) at the center of the respective plate

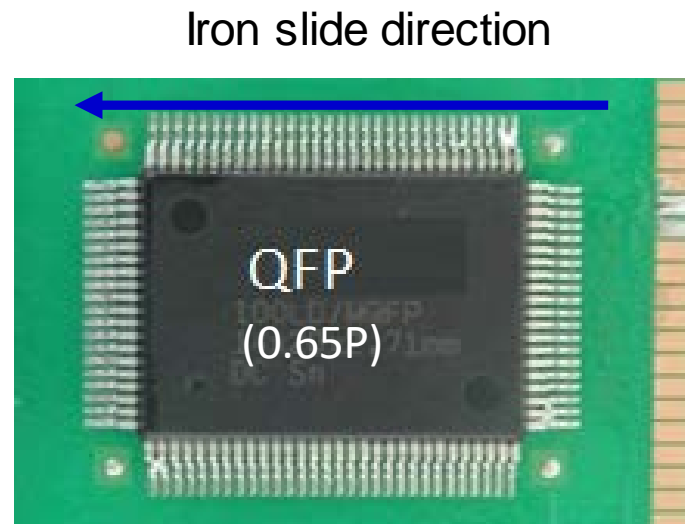
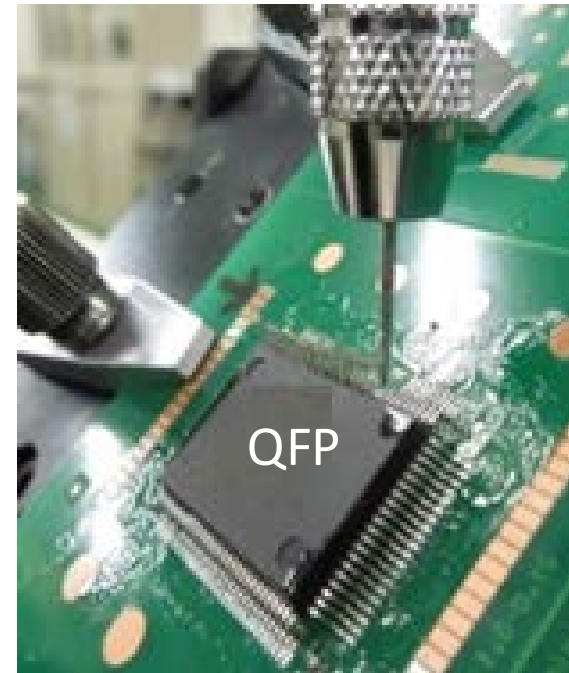
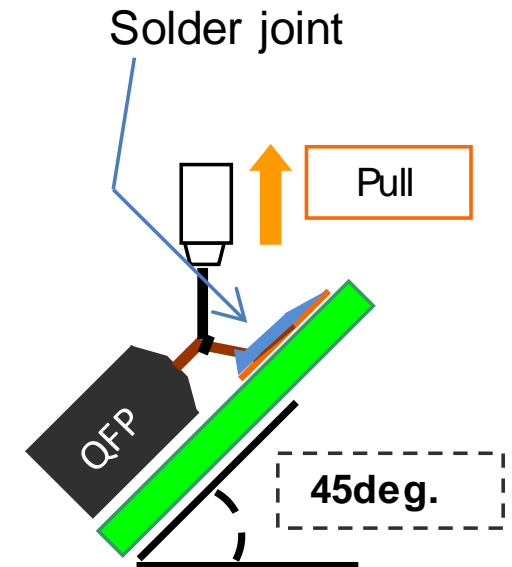
Repair SAC305 joint with  
Anti Erosion Alloy

Mixture of alloys

Measure joint strength

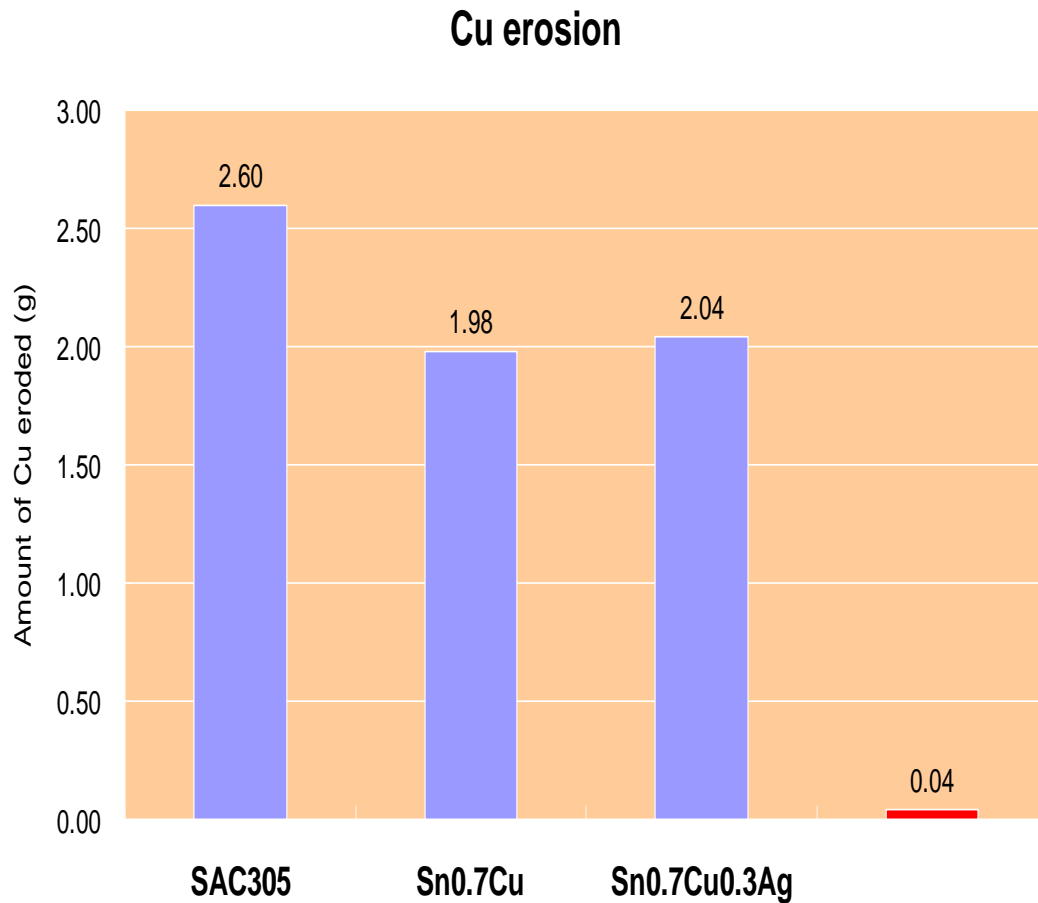
## Copper Plate Erosion Test

- Based on the results, the anti-erosion alloy (Sn0.3Ag0.7Cu0.04Co) has less erosion than Sn0.7Cu
- This shows the benefit of the cobalt addition to the lead-free solder to reduce copper erosion.

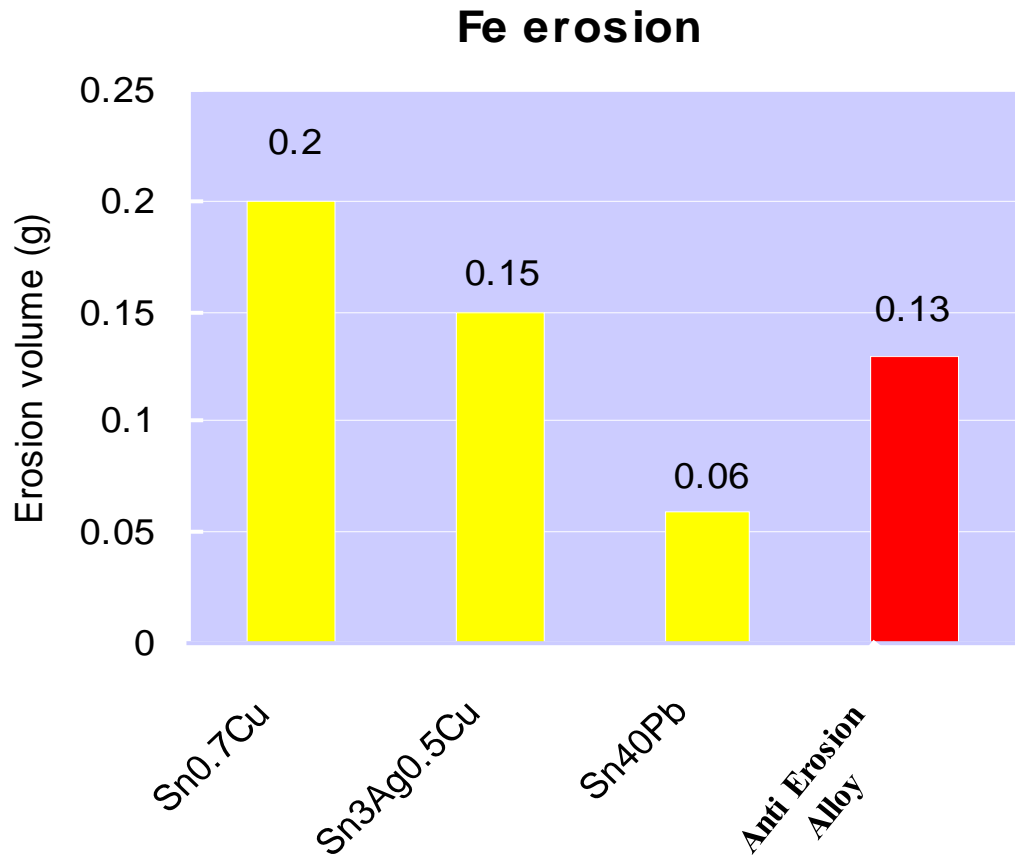
## Iron Plate Erosion Test

- Based on the results, the Sn40Pb solder has less erosion than the anti-erosion lead-free alloy (Sn0.3Ag0.7Cu0.04Co)
- This shows the benefit of the cobalt addition to the lead-free solder to reduce iron erosion.
- This indicates the iron erosion is more dependent on the tin content of the solder alloy with higher tin content giving higher iron erosion.

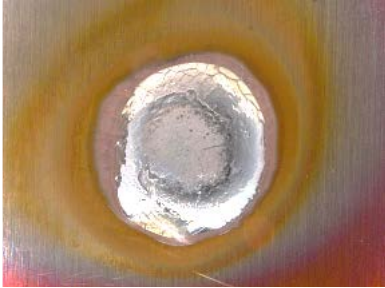
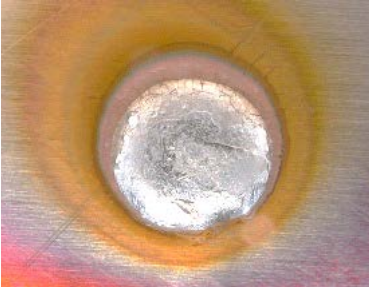
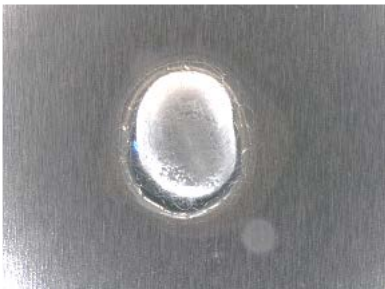
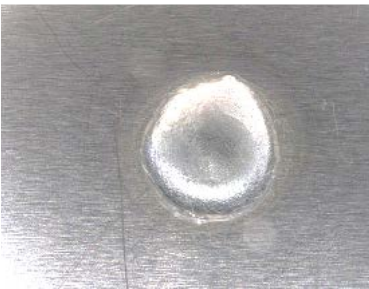
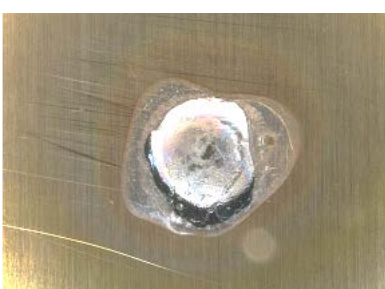
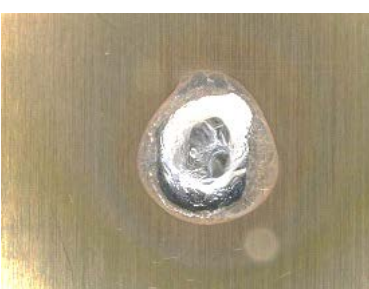
- Both the Sn3Ag0.5Cu and Sn0.3Ag0.7Cu0.04Co (Anti-Erosion) alloys showed good wetting performance on different difficult to solder substrate including nickel

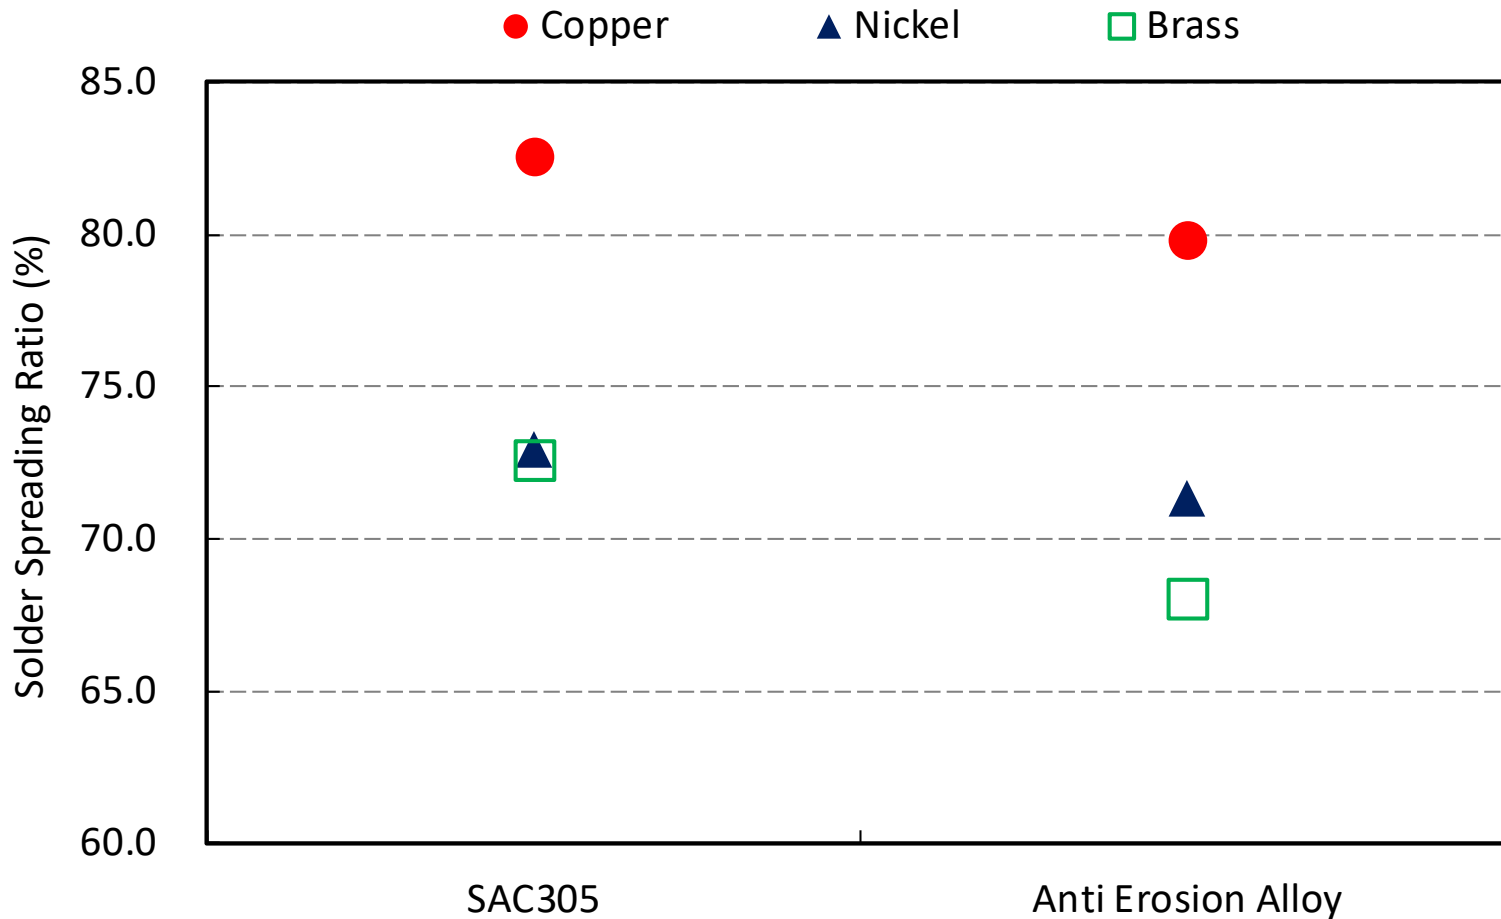
## Solder Spreading Ratio

- The spreading ratio of Sn0.3Ag0.7Cu0.04Co Anti-erosion solder wire on different substrates was found to be similar to Sn3Ag0.5Cu

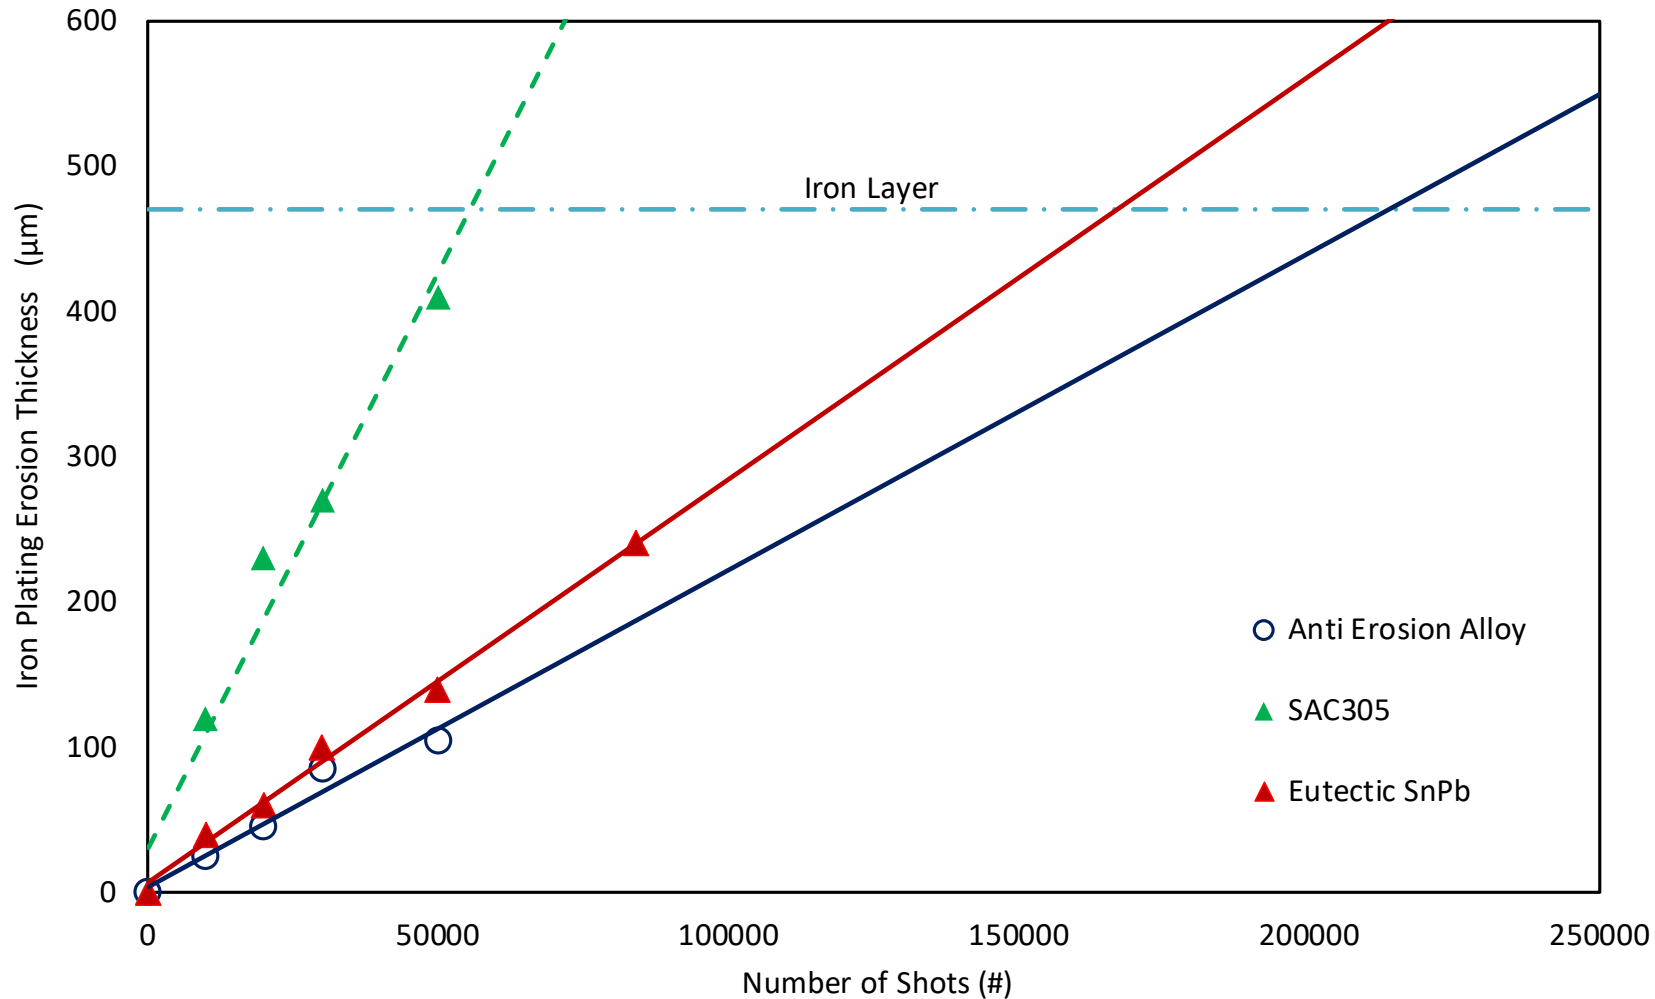
## Iron Plating Erosion Thickness

- Anti Erosion alloy has lowest solder iron tip erosion.
- It can be seen that SnPb has in fact very similar iron tip erosion as Anti Erosion Alloy.

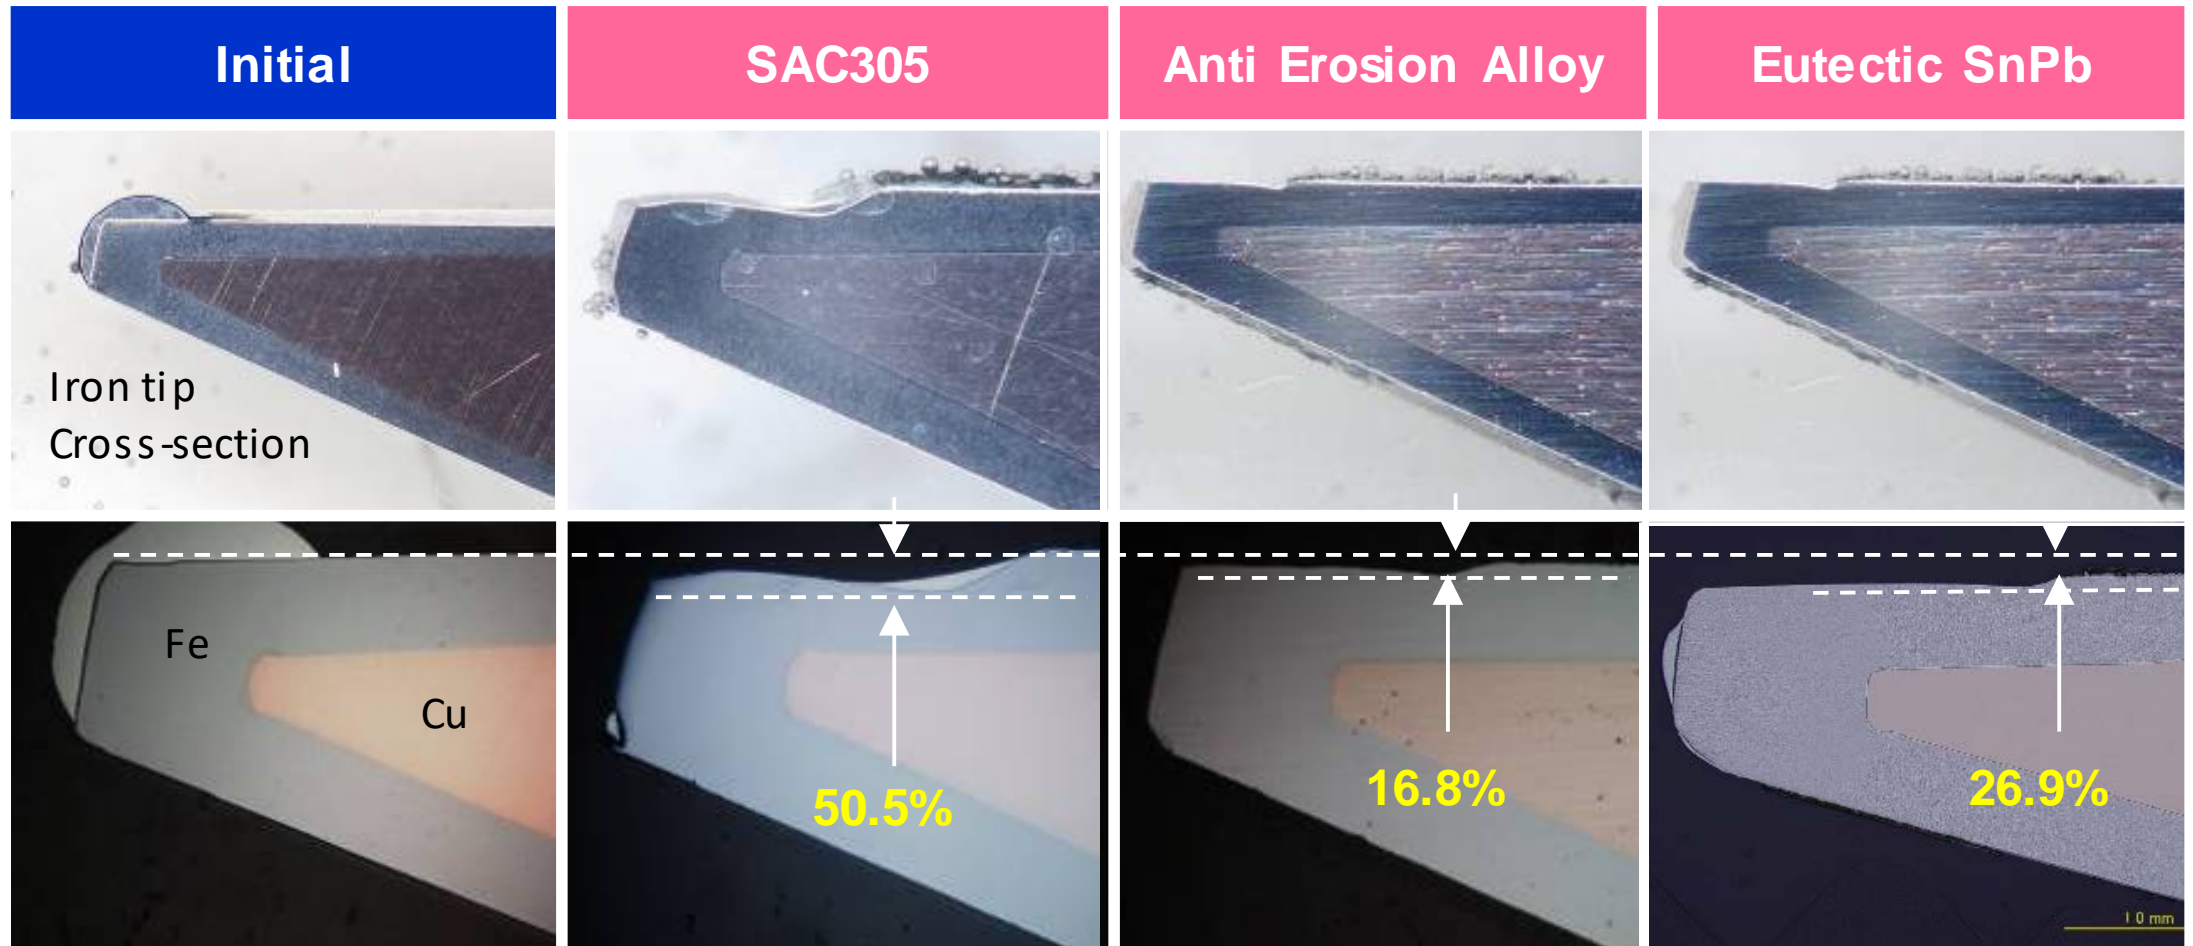
# Cross Section of Soldering Tip showing Eroded Percentages
