# An Investigation into Lead-Free Low Silver Cored Solder Wire for Electronics Manufacturing Applications

Shantanu Joshi<sup>1</sup>, Jasbir Bath<sup>1</sup>, Kimiaki Mori<sup>2</sup>, Kazuhiro Yukikata<sup>2</sup>, Roberto Garcia<sup>1</sup>, Takeshi Shirai<sup>2</sup>  
<sup>1</sup>Koki Solder America Inc., USA, <sup>2</sup>Koki Company Ltd., Japan,

Development was done on a new lead-free low silver solder rework alloy (Sn-0.3Ag-0.7Cu-0.04Co) in comparison with a number of alternative lead-free alloys including Sn-0.3Ag-0.7Cu, Sn-0.7Cu and Sn-3.0Ag-0.5Cu and tin-lead Sn40Pb solder in soldering evaluations. Tests included solder alloy spread tests on copper, brass and nickel substrates. Soldering iron tip tests done with low silver cobalt containing alloy showed reduced erosion as compared to Sn-3.0Ag-0.5Cu solder alloy. The cobalt in the lead-free solder wire was found to create barrier layers between the iron in the soldering tip and the solder, reducing solder tip erosion by as much as 50%. In addition, Sn-3.0Ag-0.5Cu surface mount soldered component test boards were reworked at the soldered chip component locations with Sn-0.3Ag-0.7Cu-0.04Co and Sn3Ag0.5Cu wire to simulate r

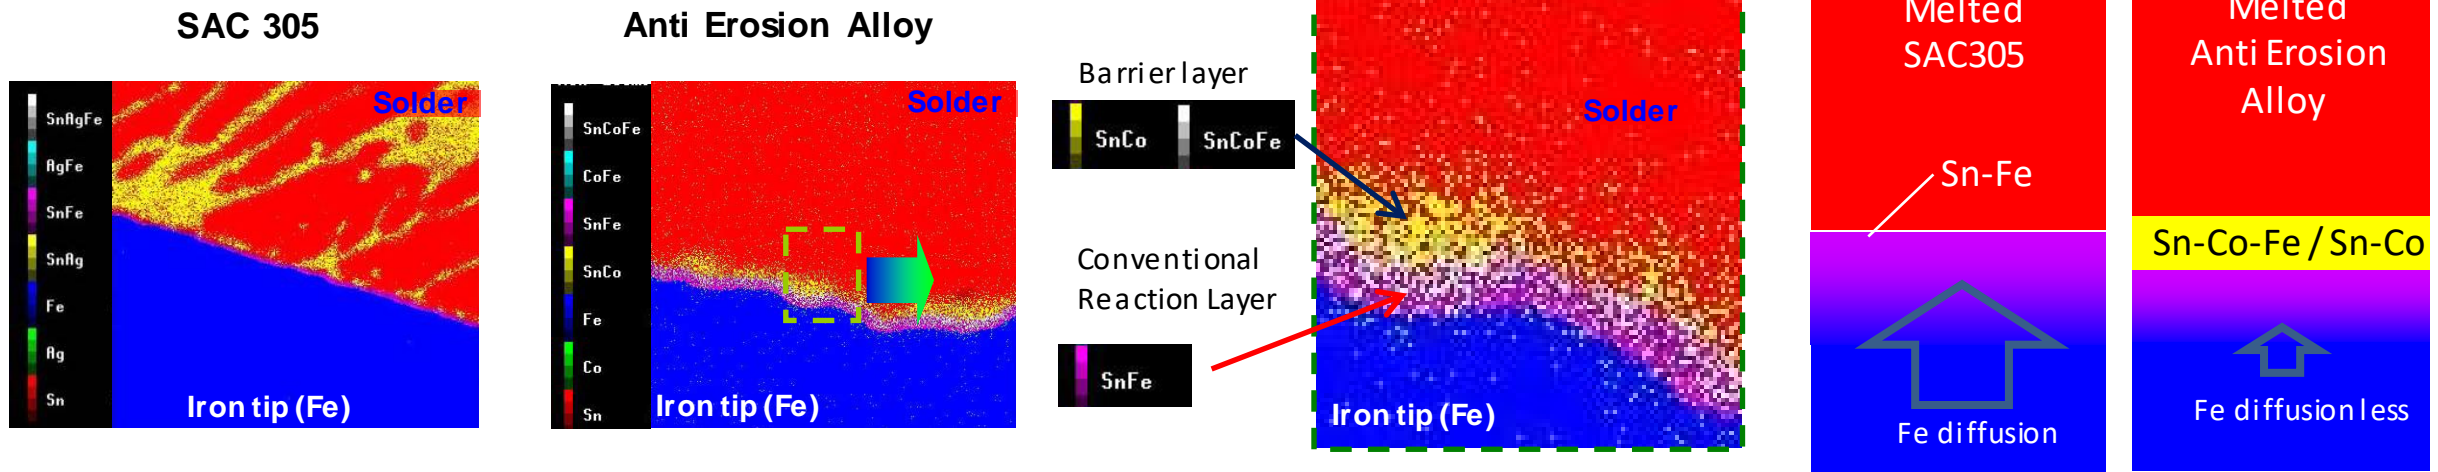
## Mechanism of Anti Erosion

- The barrier layer being formed of Sn-Co-Fe/ Sn-Co with the Sn<sub>0.3</sub>Ag<sub>0.7</sub>Cu<sub>0.04</sub>Co lead-free alloy helps to reduce the solder iron erosion.

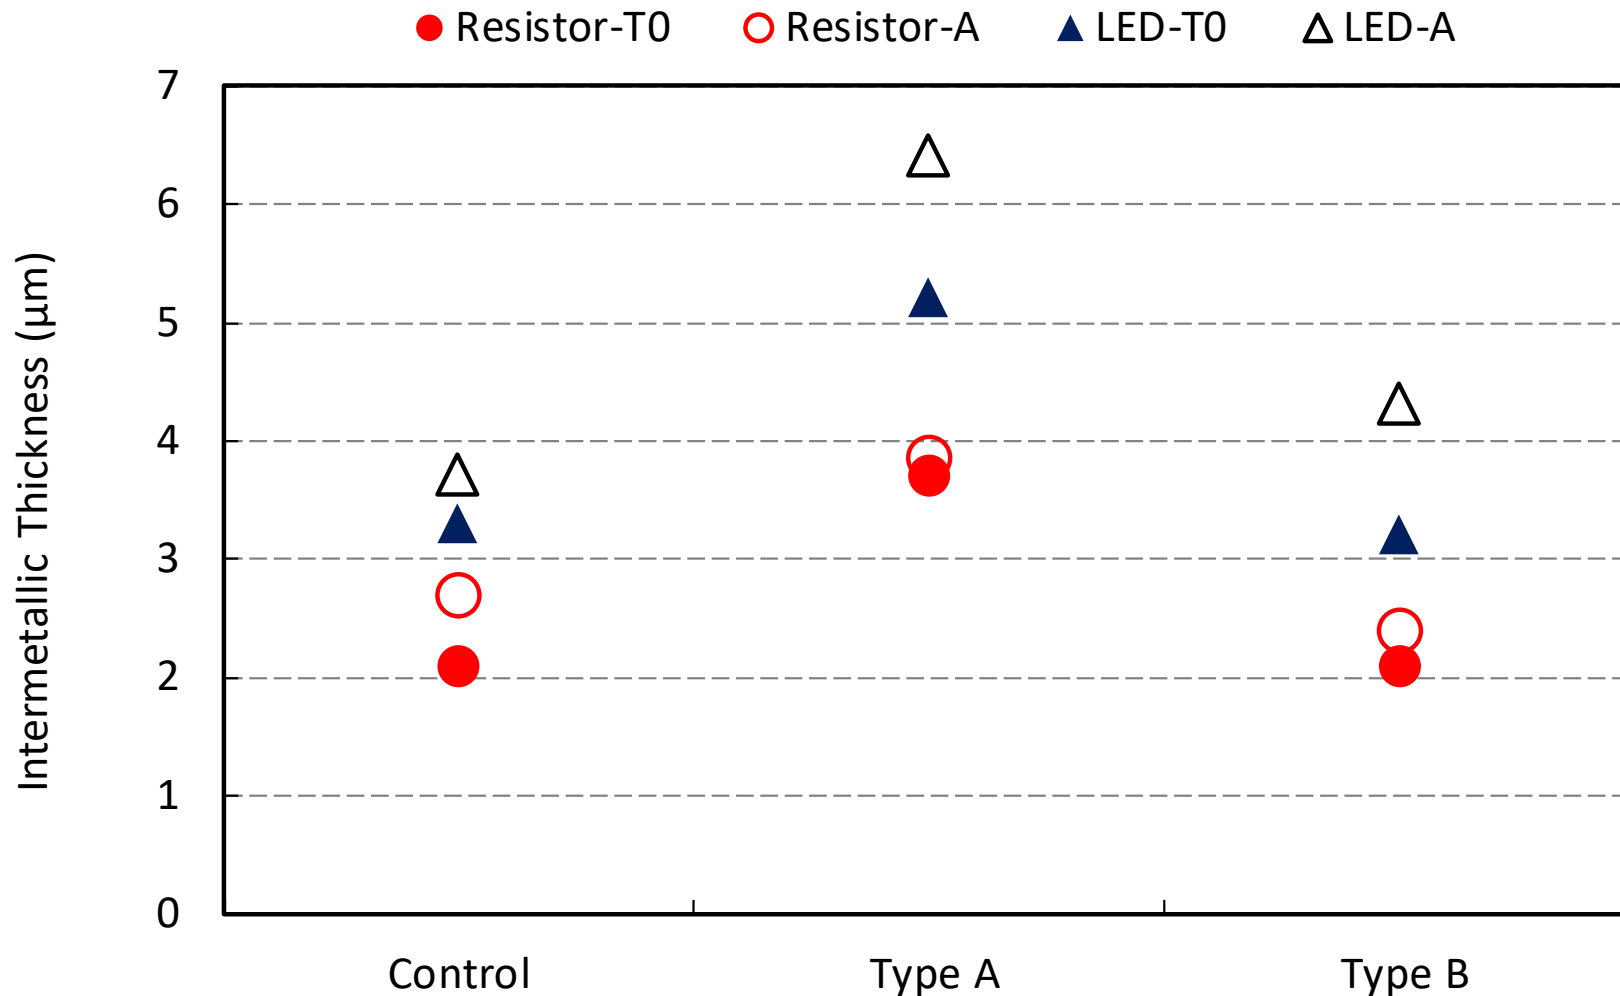
## Intermetallic Compound Thickness Measurement

- Control: FPY SAC 305, No Rework
- Type A: Reworked with SAC305 wire
- Type B: Reworked with Anti Erosion Wire
- Amount of IMC with Type B is significantly smaller than that of Type A

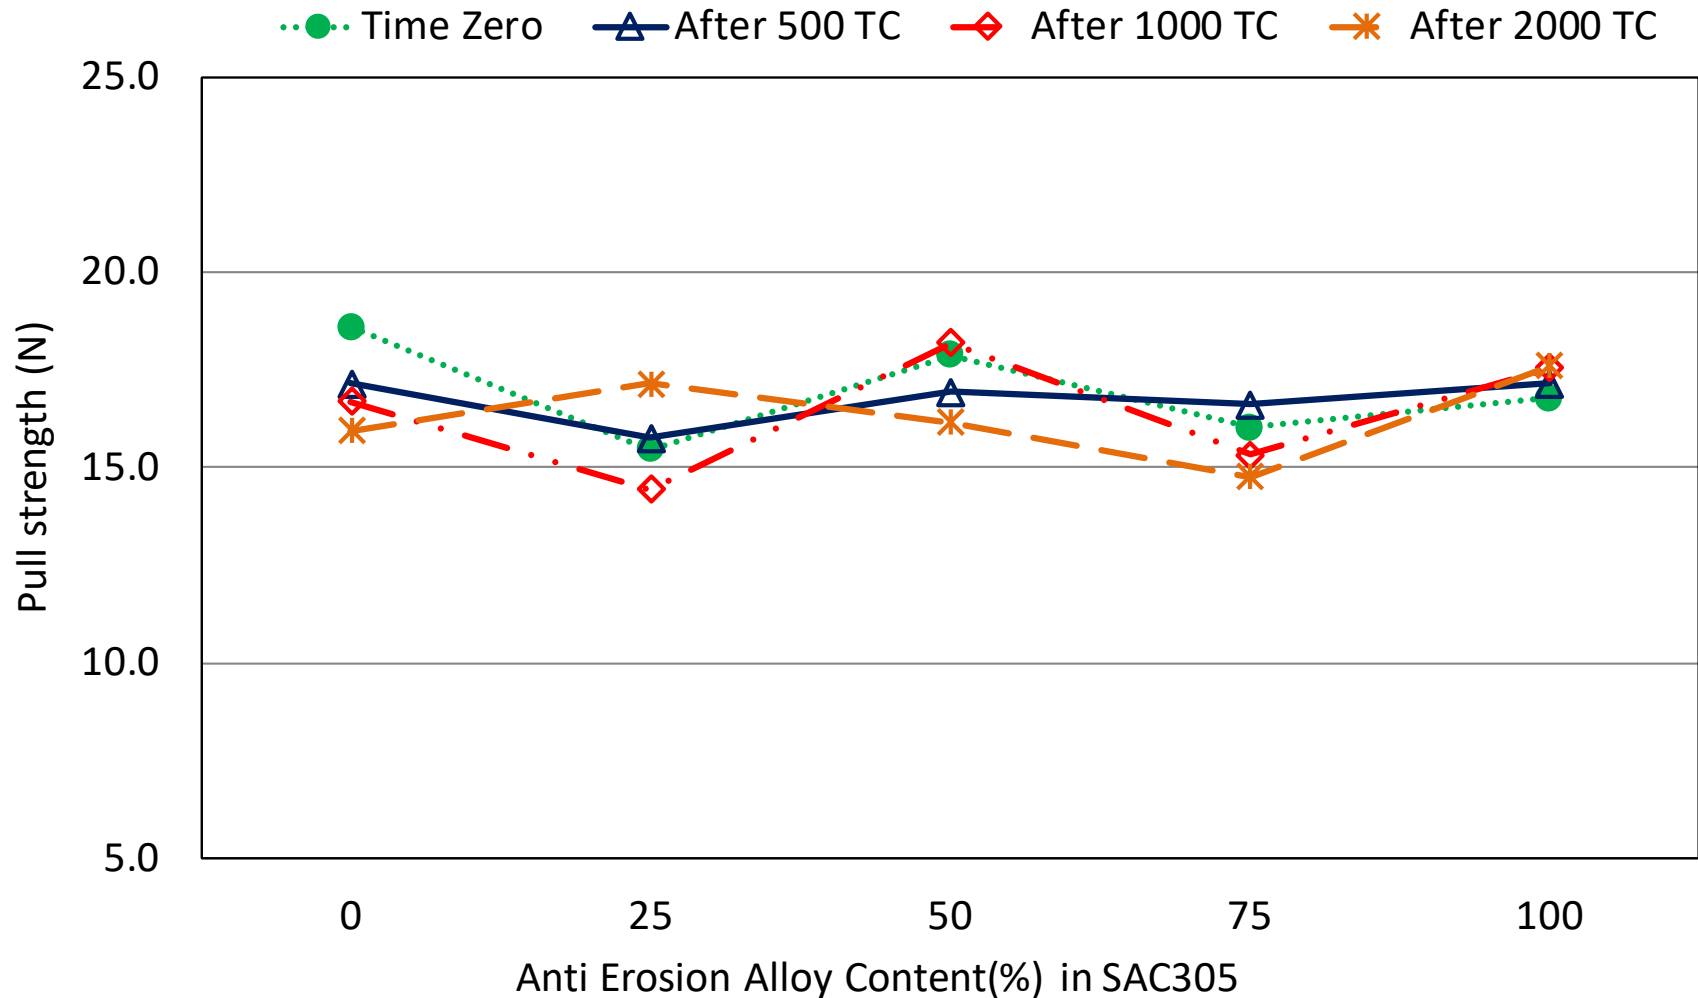
## Pull Strength Results

- From Time Zero up to 2,000 ATC cycles there is very little difference between the pull test force results.
- This indicates mixed Sn3Ag0.5Cu/Sn0.3Ag0.7Cu0.04 Co solder joints have good reliability.
